Critical Incident Notification

A556 / A50 Mere Articulated HGV overturn

Date of incident: 2016-05-31

Site: A556 / A50 Mere site compound – Contracting

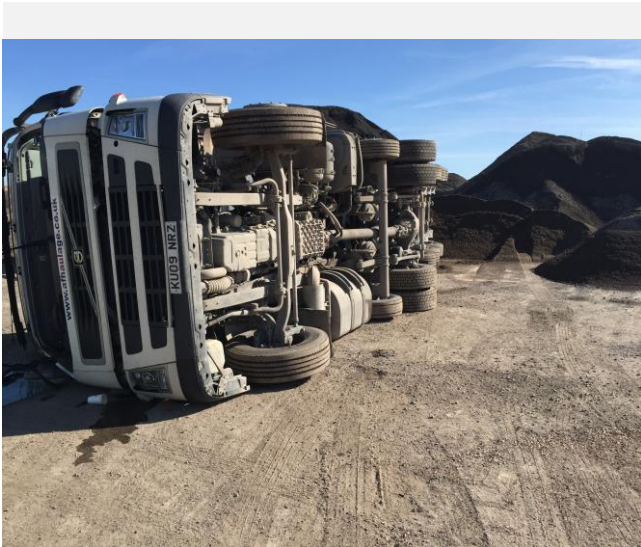
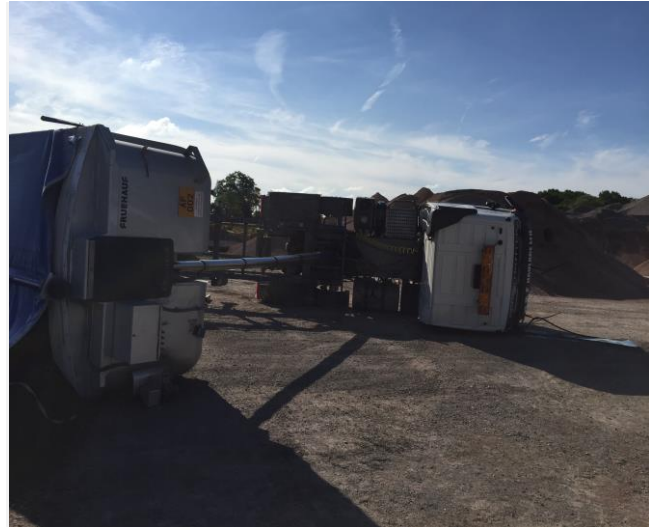
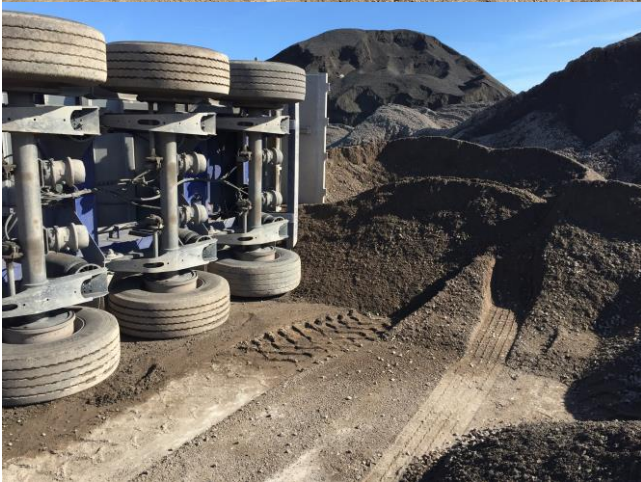
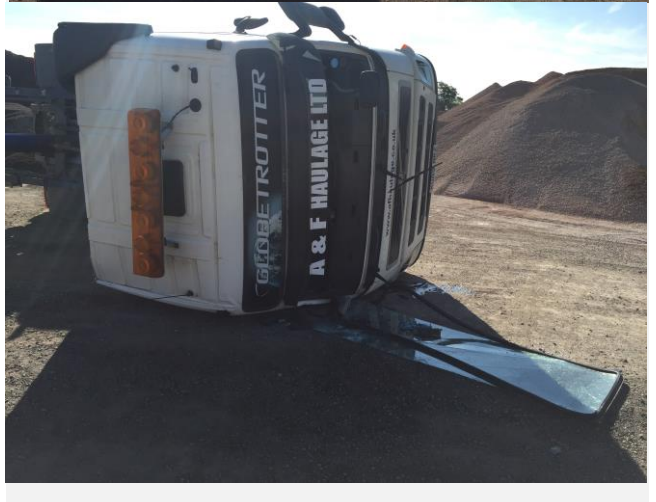
- Incorrect positioning of vehicle by the driver
- The driver wasn't driving his usual vehicle and had not used this one for at least 12 months
- No inclinometer was fitted to the vehicle
- Vehicle mounted stockpile creating an uneven tipping platform at 12 degrees
- The delivery driver had been to the site 17 times previously and received a site specific induction on tipping procedures on February 24th 2016
- Site tipping area was at less than 1 degree crossfall and constructed of hard compacted materials
- Daily site inspection of the stocking area had been carried out
- Weather conditions were dry and sunny with good visibility, and wind speed was 7.2 km/hr
- Driver reported to the batching cabin on arrival and received instructions to proceed

- Area made safe and investigation started
- All deliveries stopped, the client imposed a temporary ban of articulated vehicles
- Review of current local tipping risk assessments / procedures, new procedures approved by the client and implemented on site Friday 3/6/2016 at 7:00am. Key employees and all delivery drivers have been re-inducted to site
- Toolbox talk generated and communicated to site employees regarding positive interventions when witnessing unsafe acts
