HiPo: Uncontrolled Vehicle Movement

Highways - Initial Incident Notification

SAFETY ALERT

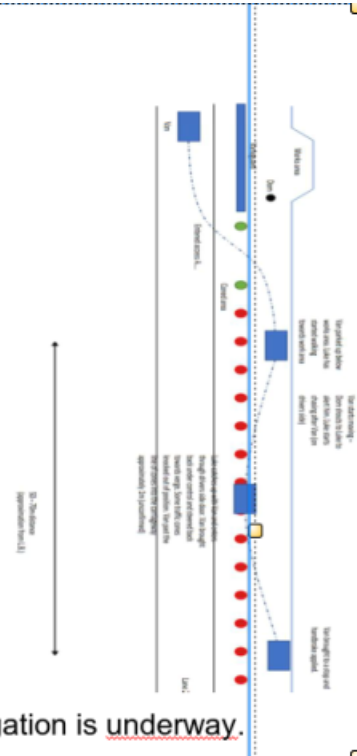
A vehicle belonging to a Drainage Subcontractor pulled into the works. The driver left the vehicle and walked to the nearby work area, but the unattended vehicle began to roll forwards, along an incline (see diagram) towards the live motorway. Upon noticing the van was rolling, the driver ran after the van and managed to catch up with it after it had travelled approximately 50m. He climbed into the van, stopped it and drove it back into a safe position. Several of the cones which demark lane one were pushed out of position. Investigations have identified that the event didn't lead to the public having to take evasive action and there were no injuries or damage as a result. The driver has stated the handbrake was only partially engaged when the van was initially parked, which led to it rolling away.

Ensure hand brakes are fully applied and vehicle is left in engaged gear. A full investigation is underway.

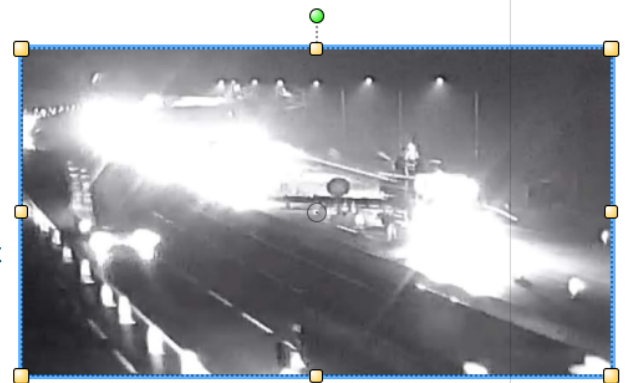
A lorry mounted crane was being used to deliver vehicle restraint barrier units within a two-lane closure. Whilst in the travel position, the crane boom extended out above live lane 3 then dropped across the live lane, causing live lane traffic to stop. No collision occurred.

Initial Investigation findings indicated that the crane movements were due to the operator unintentionally operating the remote control.

All plant and equipment must be fully isolated and shut down when not carrying out a work task. Remote controls must be isolated when not in use.

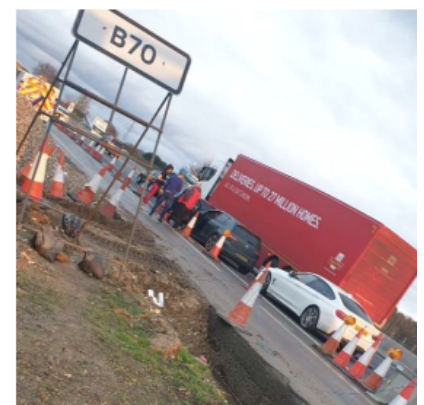
Whilst a lorry was passing through the works it caught the base of a cone and knocked it into the live lane. Cars in the live lane stopped quickly resulting in a road traffic collision. Initial findings show that the cars were lightly damaged, and after exchanging details they continued their journey.

All access and egress must be kept clear of equipment to ensure the maximum clearances are maintained. An investigation has commenced.

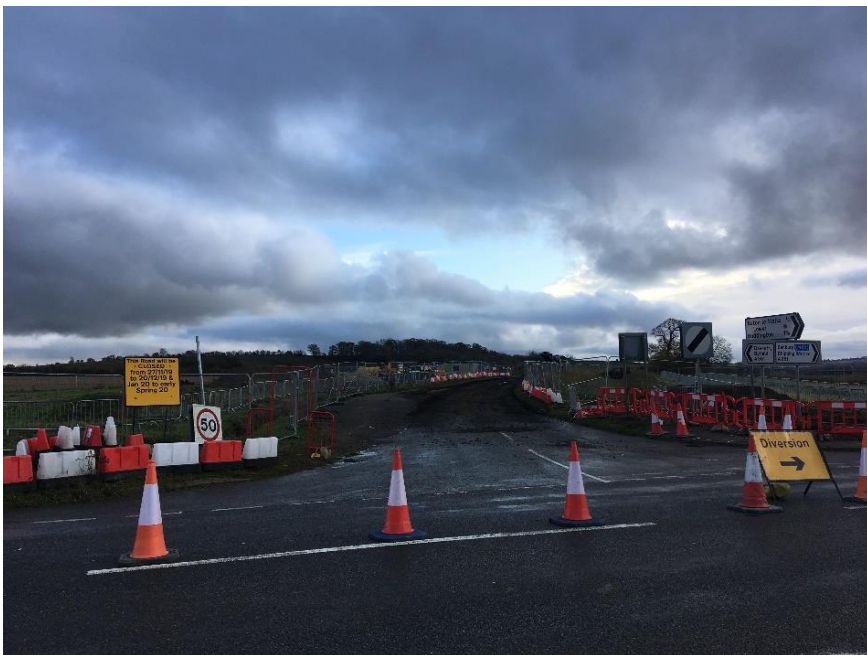
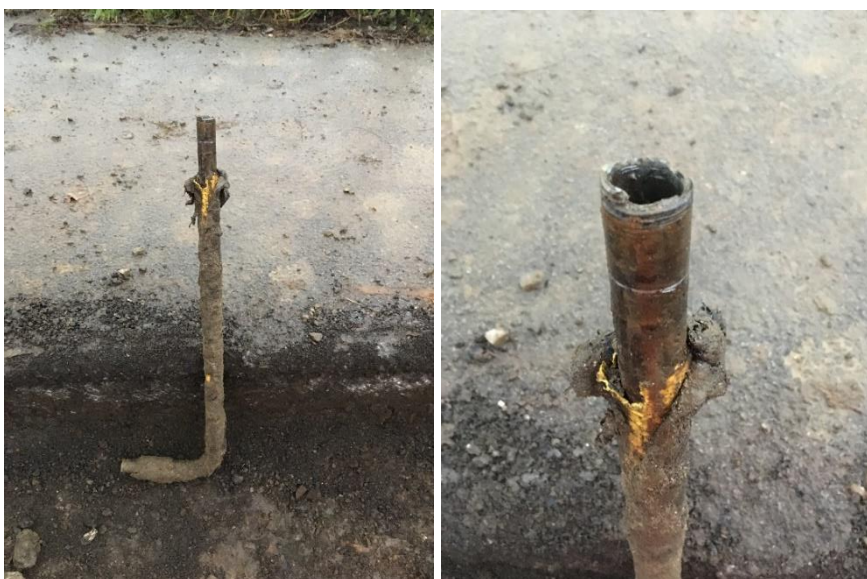
At approximately 11:30 on the 27th November, a Planer at Welsh Road East clipped an uncharted 20mm gas pipe pressure release valve (PRV), for a medium pressure gas main, located approximately 225mm below ground level; it is believed that the Planer knocked the cap off.

The service was completely uncharted and had been previously tarmacked over by an unknown party. The only services that were known about in the area were a BT cable at 750mm and Gas main at 800mm and these had exclusion zones set up to avoid them.

Extensive trial holes on Welsh Road East also gave no indication that the pressure valve was there. SGN inspector arrived within the hour and then the Gas team arrived another 30 minutes later to uncover the service fully and to repair the damage/make safe.

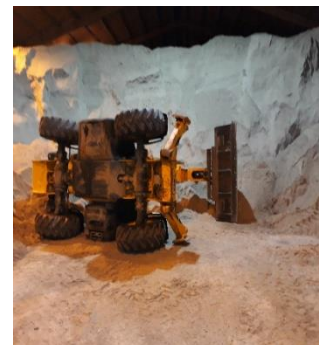
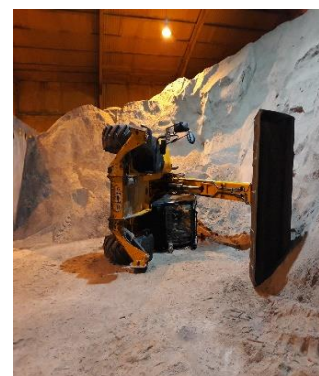
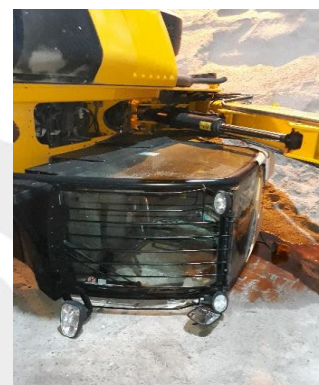
A serious incident occurred when a loading shovel working in Kirby Misperton depot turned over onto its side. At the time of the incident, the vehicle was working in the salt barn loading salt onto gritters in preparation for winter maintenance activities to take place later that same evening.

As the loading shovel reversed with the boom up, it appeared to mount the salt whilst undertaking a turning manoeuvre which caused it to turn over coming to rest on the driver's side. Fortunately, the highly experienced driver was wearing his seatbelt at the time of the incident, no injuries, but he was shaken.

Please carry out a review of this type of work or similar activities in your division.

- Personal factors (competency)
- Job Factors (equipment and location)
- Management Factors (has a risk assessment been carried out?)

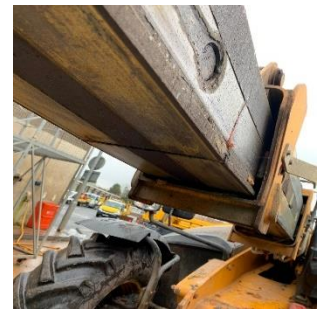
During the daily visual inspection of the JCB 535 Telescopic Handler machine (loadall), used for depot activities, the machine (plant) operator identified a significant crack within the extension boom of the machine.

Picture 1 – The JCB 535 Telescopic Handler (Loadall) Machine being used

1. Identify any item of machine/ plant that uses telescopic extension booms.
2. Undertake a full visual check of the extension boom and with the boom in a fully extended state (this machine has a 9-metre reach).
3. Record the inspection on the machine Defect Report log sheet.
4. In the event of ANY defects being located on the extension boom contact your line manager immediately.
5. Ensure continued daily visual inspections are undertaken on this type of equipment BEFORE work commences and including a FULL visual check of the extended boom.
6. Check Plant Operators are appropriately certificated
7. The machines are used STRICTLY in accordance with the user manual

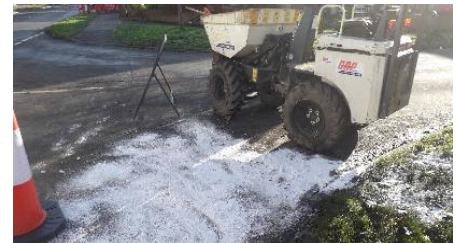
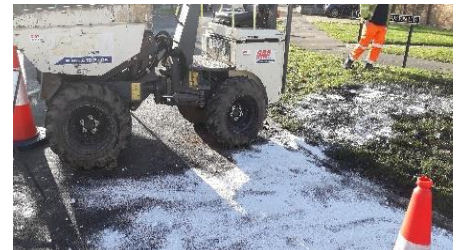
The operative turned the dumper in a bell mouth of the road and at the end of his manoeuvre. This resulted in the immediate cause of the incident as he turned too sharply and at speed resulting in the dumper falling over onto its side.

The operative was trained to use a dumper in October 2019 and was an inexperienced user. Although the operative was new to the site and was unfamiliar to the Supervisor and Chargehand.

- Training and competence levels to be checked with all operatives when being inducted to site
- Buddy system to be in place for inexperienced worker
- Ensure plant movements on site are planned thoroughly and where relevant, traffic management plans are in place

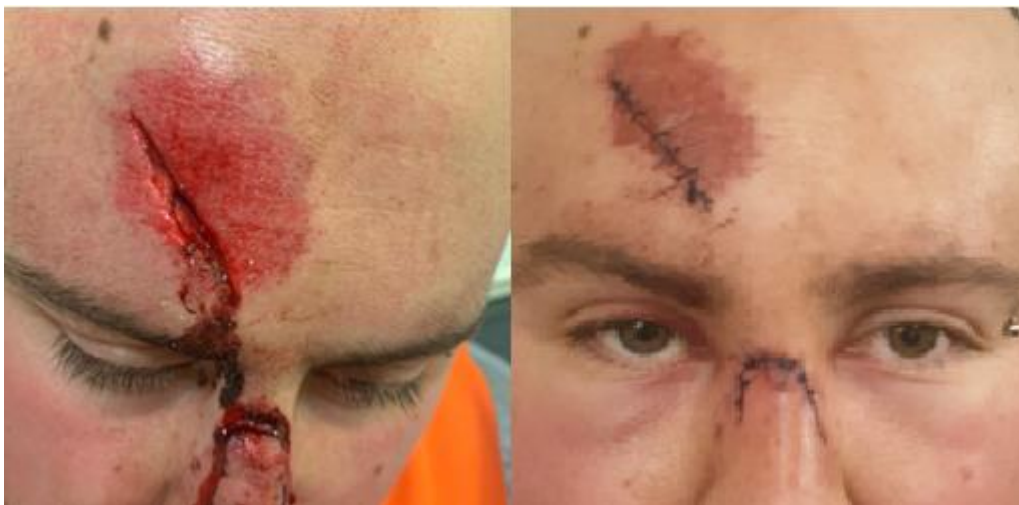
On the 17th of December an operative was injured whilst securing a 14t long reach excavator onto a drag trailer. The operative sustained cuts to the bridge of his nose and forehead both requiring stiches. This incident had the potential to cause serious life changing injuries.

- Both the excavator operator and injured party knowingly worked within the swing radius of the long reach excavator.
- The excavator operators coat had hooked over the left control lever when he had accessed the cab. Once the 'dead mans' arm was lowered the excavator arm immediately slewed to the right contacting the injured party in the ribs and causing him fall and hit his head on the ground.
- The injured party is recovering well and is expected to be back at work soon.

- Never enter the exclusion zones around any item of plant unless they have been disabled and you have received the 'Thumb's up' (or similar approved acknowledgement) signal from the operator.
- Prior to starting any plant or equipment ensure that all controls are free from obstruction and not engaged in an operating position.
