Balfour Beatty Incidents

Feb / March 2021

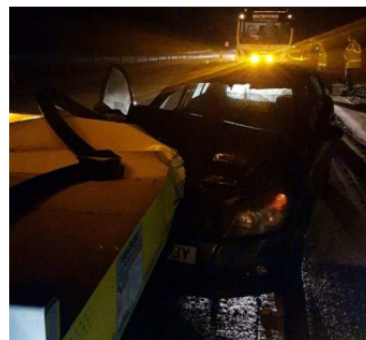
HiPo: Impact Protection Vehicle (IPV) Strike

IPV struck by member of public car.

A Balfour Beatty Traffic Management Subcontractor was installing a Lane 1 closure on the A50 dual carriageway to facilitate tree works. The advanced warning signs had been erected and the IPV was positioned in Lane 1 to protect the taper installation. The IPV was struck by a car driven by a member of the public, and the car impacted the crash cushion. There was significant damage to the car, but the crash cushion worked effectively and there were no injuries to the car's occupants. The impact moved the IPV forward and the IPV driver was shaken but uninjured.

The Police attended the scene and we do not know yet whether they intend to take action against the driver. Initial checks have confirmed that the necessary warning signs were in place and the light arrow and beacons were working correctly on the IPV.

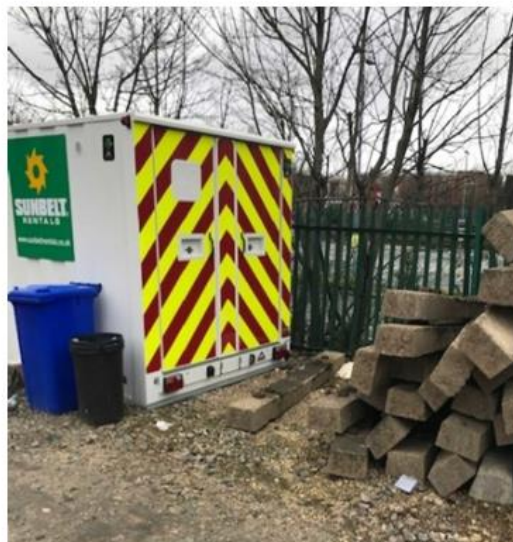
RIDDOR, Specified injury: Fractured Wrist

A CRSA sub-contractor operative tripped on a concrete sleeper whilst attempting to access a welfare unit toilet, fracturing their left wrist.

On CRSA East the Site Access Controller attempted to access a welfare toilet within a satellite compound at Charlotte Road, Sheffield. As the injured party attempted to open the door, she tripped backwards on a concrete sleeper and used her left arm to break the fall, fracturing her wrist.

- The location has been secured and the area isolated.
- A review of satellite compound welfare arrangements, including lighting levels, underfoot conditions and ensuring walkways are clear has begun
- Material stacking and storage has been reviewed.

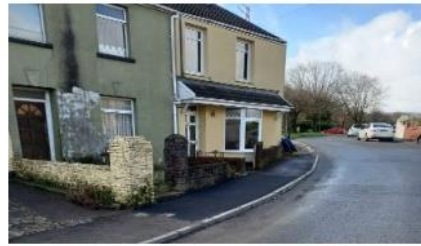
>3-day LTI Back Injury

A Balfour Beatty operative injured his back handling a piece of Tarmac during reinstatement works.

A piece of tarmac approximately 1m x 0.5m and 70kg was left on the side of the excavation, close to a front garden wall.

While the supervisor answered a phone call, the IP decided to pull the piece of tarmac further away from the wall to enable the Hiab to pick it up without damaging the wall.

The operative has stated that he suffered a spasm in his back after pulling the piece of tarmac. He continued working on site and completed his shift. The IP phoned the following morning to say that he was not fit to return to work. The IP is expected to return on Monday.

- Balfour Beatty incident reporting protocol to be briefed to all Supervisors.
- Project Manager to carryout welfare phone calls to IP.

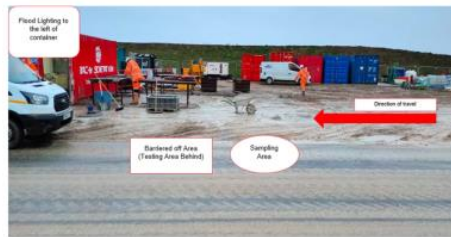
HiPo: Reversing Vehicle

Vehicle reversing without vehicle/plant marshal.

A concrete mixer truck was delivering concrete to the Long Itchington South Portal. On arrival to site the driver reversed the vehicle towards the concrete testing area that was set up outside the laboratory.

The lab technicians, from their position at the doorway to the lab unit, noticed that the concrete wagon had started to reverse towards the testing area. They moved towards the reversing vehicle and tried to stop the driver from reversing several times (shouting and waving to get the driver's attention). However, the driver failed to notice the initial attempts to stop him and continued to reverse, resulting in his vehicle striking a wheelbarrow that was located in the testing area.

- The incident was initially reported by the site team as an observation and then elevated to an incident and HiPo once more details were established, hence the delay in reporting.
- People/Plant interface controls need to consider all operations associated with the activity, including requirements for sampling and testing concrete
- Reversing on site must always be assessed using the hierarchy of eliminate, minimise, mitigate
- The role of the PVPC is essential to make sure that plant movements are implemented in accordance with the PVPMP
- The position of task lighting needs to be carefully planned so that it does not interfere with rear-view mirrors or reversing aids.

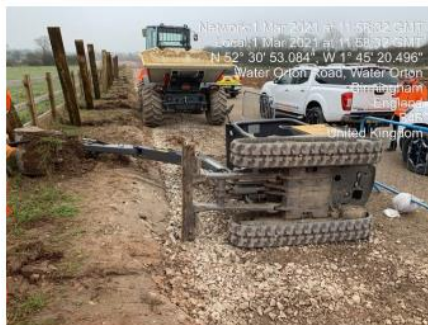
HiPo: Overturned Excavator

A 2-tonne excavator overturned.

The excavator was digging footings for a site hoarding. The operator had extended his main boom and dipper arm to the maximum extent and excavated a heaped bucket of soil. As he removed and lifted the bucket from the ground he slewed to his right and continued to raise his bucket causing the machine to topple over. The operator extracted himself from the machine uninjured.

- Driver competence and experience of operating mini excavators
- The orientation of this machine and why its tracks were not extended
- The selection of this machine for the task
- Supervision

As an immediate step, the use of all excavators less than 6 Tonnes is being reviewed and their use only permitted where there is a clear need and a site-specific risk assessment in place.

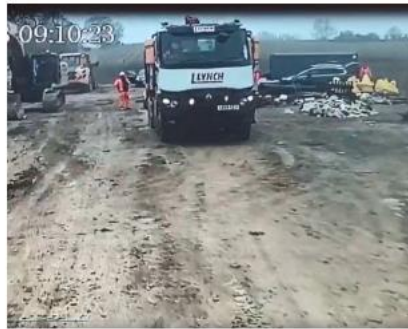
HiPo: People/Plant Interface

Reversing grab wagon came within close proximity to one of our workers.

The IP was leaving the materials storage yard in order to relocate to a new working area approximately 7 miles away. As he was proceeding to his personal vehicle he positioned himself behind a stationary grab lorry. The IP's attention was momentarily diverted, and at the same moment the grab lorry began to reverse. As the IP turned their attention back to the lorry, it was sufficiently close that the IP had to take evasive action. Although shocked the IP did not require or seek first aid and there are no known reported injuries at this time.

- All work was stopped immediately.
- All A14 work stood down for a safety briefing by the Senior Management Team.
- Materials storage yard closed down and moved to Brampton where there will be a vehicle marshal at all times.
- Full investigation co-ordinated with full cooperation from all parties involved.

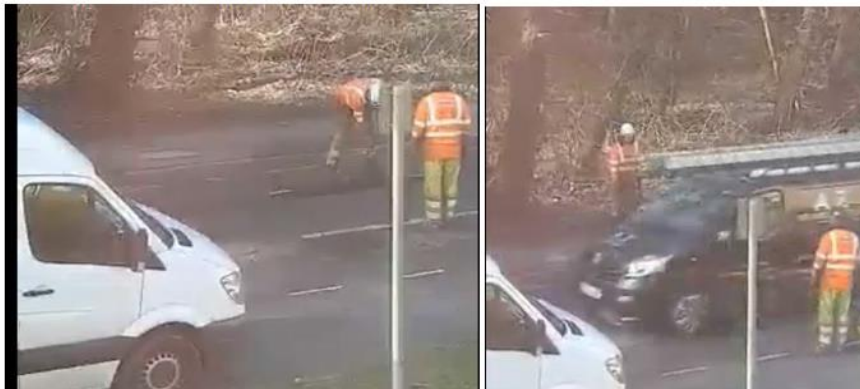
HiPo: Live Carriageway working

Supply chain operatives working on live carriageway with no Traffic Management (TM).

A member of the public recorded a two-man supply chain gang, working on a 30mph road with no TM in place.

- The gang involved have been removed from site with a further investigation ongoing.
- The project team has been re-briefed.
