# Weekly Best Practice - Safety Alerts

Sept / Oct

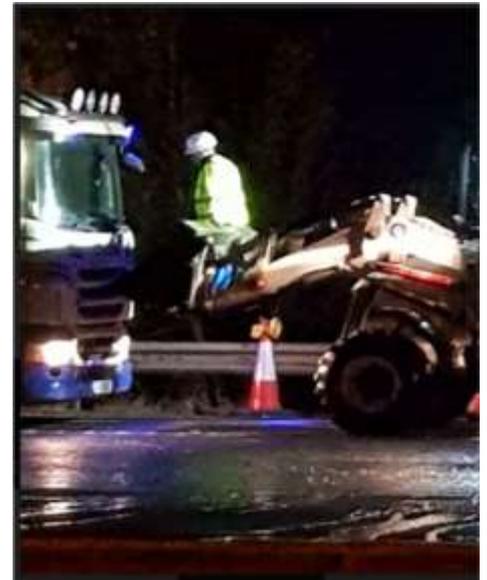
On the M4, a sweeper driver was witnessed being lifted in bucket of a JCB.

Surfacing works were being carried out at the M4 SMP project. A sweeper driver noticed that the flashing beacons were not working on his sweeper.

The sweeper driver asked the operator if he could be elevated in the bucket to reach the beacons to fix them. The operator agreed to do this so the sweeper driver proceeded to climb into the bucket. The bucket was then raised to approx. 1.5m to allow the sweeper driver to fix the lights. It was at this point a member of the project team witnessed the event from the opposite carriageway and raised the alarm with the supply chain supervisor and works were stopped

Surfacing works were suspended on the project, and a full investigation is being carried out by the supply chain partner and project team, focusing on the unsafe acts of the individuals involved.

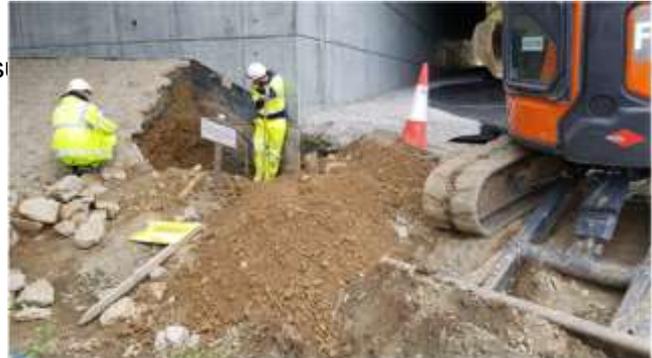
On Monday the 17 September an unauthorised & uncontrolled excavation was carried out in the control area of the Shell pipeline.

While excavation works were planned within the control area the work was not due to commence until Tuesday 18 September when the agreed Shell supervision was scheduled to be on site to monitor the activity. The excavation was within 4m of the pipeline

The excavation crew have been immediately stood

down pending investigation. All earthwork/ roadwork activities have been stood down to review all safe systems of work, permitting and briefing documentation. No works will recommence on Pitmedden road until a review of the remaining work's scopes has been undertaken on site with a Shell pipeline monitor, and a satisfactory closure of the incident investigation.

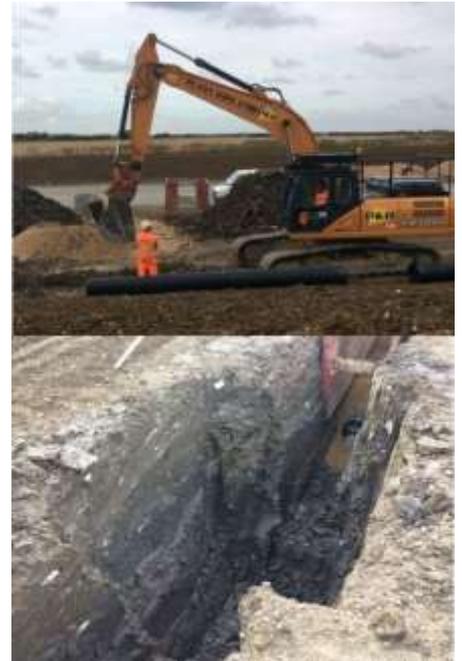
On Wednesday 12<sup>th</sup> September a drainage operative was observed working next to an operational excavator whilst stood at the edge of a 3m excavation on the Highways A14 project.

A drainage team were in the process of excavating a trench to enable the installation of surface water drains and inspection chambers. The operative stood adjacent to the operational excavator and close to the edge of the trench in the belief that he needed to check the levels of the trench as it was being dug. Works were stopped the area made safe.

Operations must be assessed against the hierarchy of control to eliminate the need to work adjacent to operational plant and vehicles. Workers and supervisors must be fully conversant with people plant interface standards and safe systems of work established with the workforce. Controls must also be in place to prevent falls.

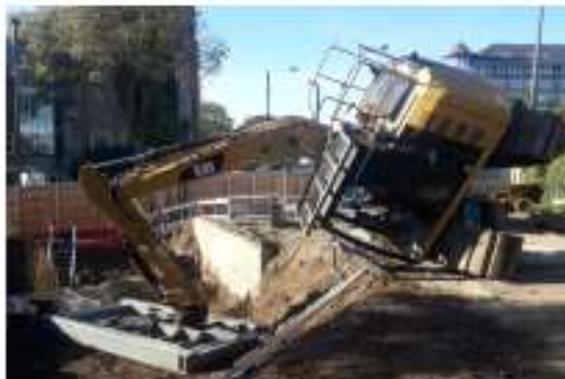
Dyer & Butler are currently undertaking works in Feltham to construct new sheet piled retaining walls in order to strengthen the existing infrastructure so that widening works can be carried out to the adjacent highway. On the morning of the 26th September 2018, the piling contractor was attempting to dismantle some of the piling equipment in readiness for it to be removed from the site. Due to the space on site being restricted, it soon became apparent that the large steel frame that is used to transport the piling rig needed to be moved to allow access to the other equipment. The frame in question weighted in the region of 3 tonnes.

In order for the frame to be lifted clear of the area, an operative from the piling contractors asked a nearby excavator operator if he could assist. In response to this request, the excavator operator moved the machine into position and allowed the metal frame to be connected to the excavator via a 2 leg lifting chain. The safe working load of the excavator was 1.2 tonnes and therefore, this operation was outside of the safe working load of the machine. The safe working load was indicated on the boom of the excavator.

Once connected to the load, the excavator operator started to lift the metal frame. Part way through the lifting operation, the excavator operator slewed the machine to lift the frame over an embankment. As the weight of the load transferred through the machine (now with its tracks side on to the load), the weight of the load caused the machine to overbalance causing it to partially overturn. No-one was injured as a result of this incident, but this is being treated as a high potential incident.

Initial investigations have found that the lifting operation was undertaken as an unplanned, action between two parties (i.e. the piling contractor and groundworks contractor) and as a result, the activity was not subjected to the normal safety controls and processes that must be in place when undertaking all type of lifting operation.

- All lifting operations on site must be authorised, properly planned and executed safely. The plans for managing both routine and complex lifting operations are contained within the Company Management System.
- The Safe working Load (SWL) of any lifting equipment, or accessory for lifting **must never be exceeded** under any circumstances.
- If you are asked to carry out any operation that you believe is unsafe, or cause harm, injury or loss to others, STOP work and report the matter to the Site Agent, or use the close call reporting system.
