# Major Projects, Connect Plus Services: Traffic Management Vehicle Good Practice

# UKCS Scotland SBU, Central DU, Crystal Rig Sub-Stn: High Potential Incident – ADT Overturn – 16/08/16

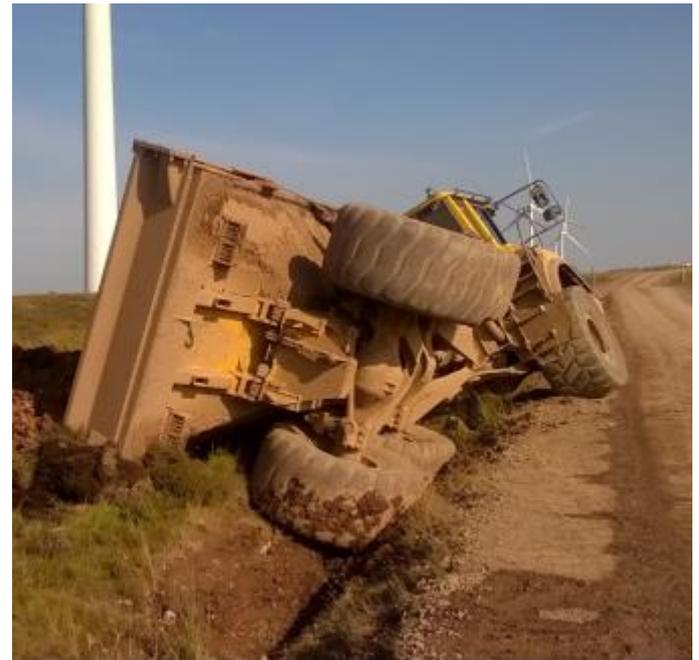
- A fully loaded Articulated Dump Truck overturned when travelling from site to a borrow pit along the wind farm access road. The driver swerved to avoid sheep that had run out onto road and ran into a ditch.

- The driver had not initially noticed the proximity of the sheep as he had been looking at the road ahead to ensure no vehicles were coming towards him as there are few passing places on the road.
- The front left wheel clipped the edge of verge, the driver attempted to turn back out onto the road but the rear tyres were too close to the verge and the back box slid into the ditch. The back box tipped over in the ditch and the front remained upright.
- The incident happened 100yds just after the top of a steep hill after a right hand turn on a shallow incline so the ADT could not have been travelling at speed.

- The Driver was D&A tested and returned a negative result.
- It was concluded that the incident was caused due to driver error who should have attempted to stop as opposed to swerve out of the way. Drivers should not be putting their own safety at risk to avoid livestock on the road.

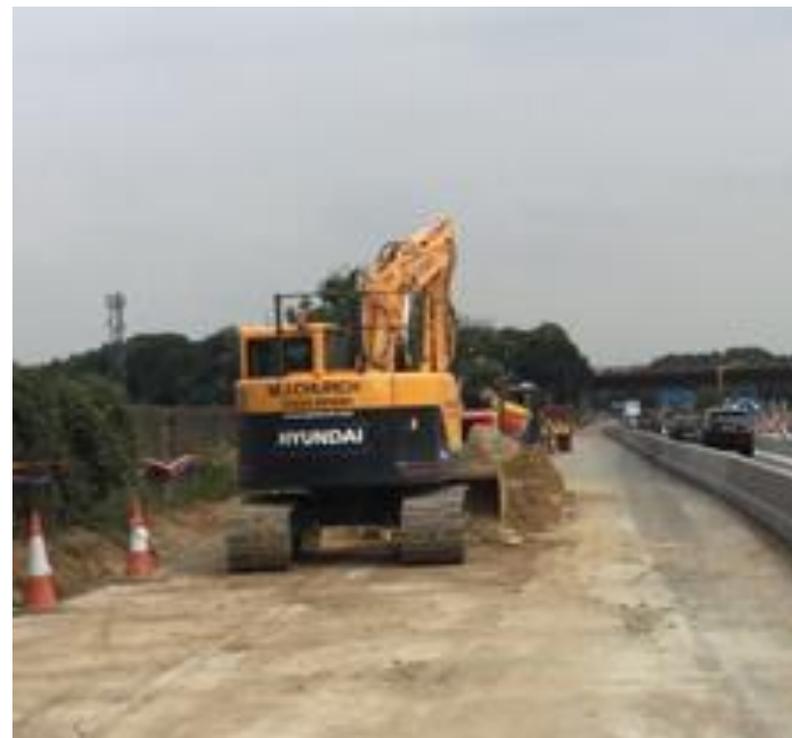
- During the loading of concrete and waste material into an 8 wheeler tipper a lump of concrete dropped over the side of the lorry body, bouncing onto the Barrierguard and falling onto the edge of live carriageway.

- A 13 ton excavator using a grading bucket was loading an 8 wheeler tripper situated 1 meter behind the Barrierguard when a piece of concrete about the size of a football fell onto the Barrierguard and subsequently onto the edge of the live lane on the M3 motorway slip.
- This resulted in 2 vehicles sustaining punctures to front nearside tyres. The local Highways England Traffic Officers implemented a rolling block to allow the safe recovery of the piece of concrete.

- A full investigation is currently being carried out. All loading of waste material behind Barrierguard without an adjacent lane closure in place is suspended until the actions from the investigation are in place.

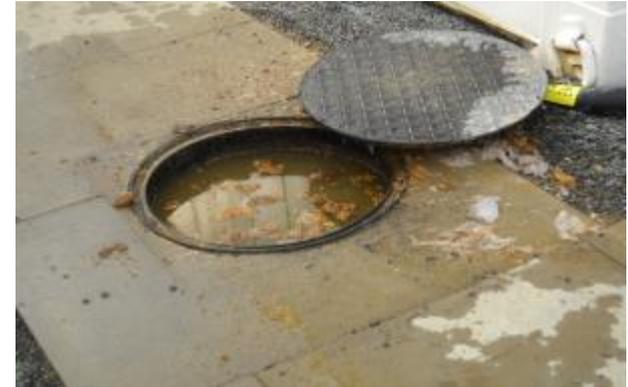
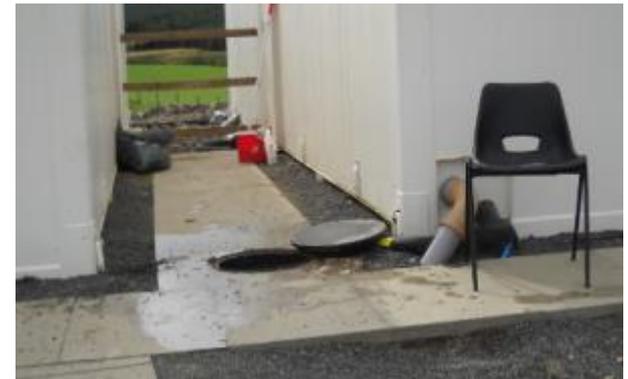
INSPECTION CHAMBER AT ACCESS 1  
WELFARE AREA (Post -incident)

- Whilst cleaning the welfare facilities the cleaner exited the toilet unit at Access 1 on Clyde Ext Wind Farm stepped onto a 450mm polypropylene foul drainage inspection chamber cover which then inadvertently tipped/slipped out of the frame seating.
- This resulted in the IP's left leg & torso entering the inspection chamber (900mm deep) resulting in personal injury i.e. fractured rib on left side.

- Physical environment - the tipping of the cover was due to the cover being inadequately secured plus the inspection chamber was full of fluid/excrement due to the outlet to the septic tank being blocked.
- The investigation team's perception is that the flushing of toilets or use of hand basins within both the office and welfare temporary accommodation units had the adverse effect of causing an upsurge on the inspection chamber cover i.e. partially removing it from its seating within the frame.

- Light duty inspection chamber cover to be adequately secured to inspection chamber frame i.e. insertion of screws.
- Inspection chamber maintenance regime to be implemented to prevent any build up from future blockages i.e. weekly inspection

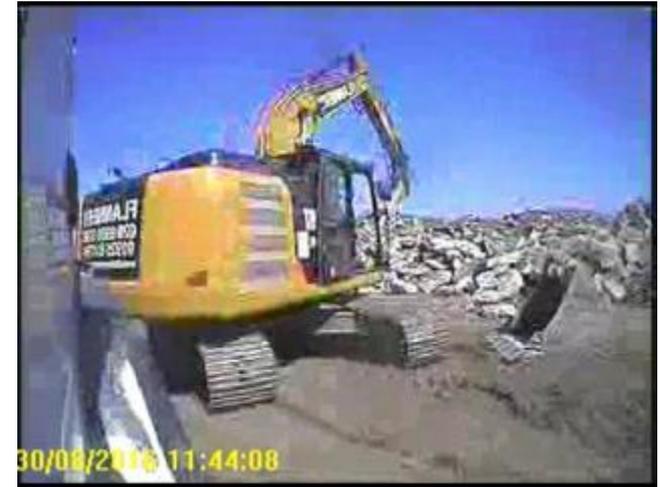
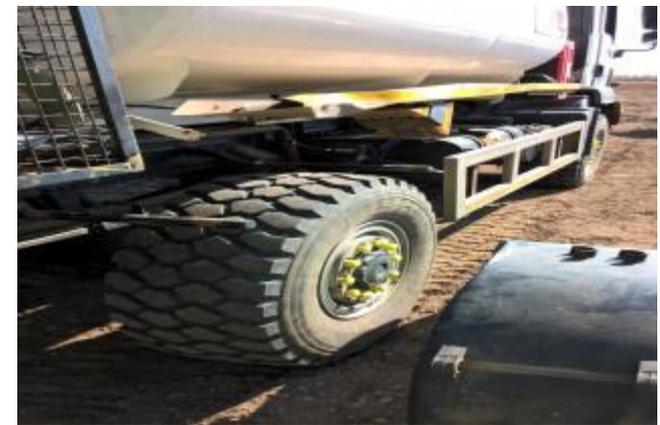
- A 32t excavator slewed round striking a T&M Fuel Bowser with its counterweight. This resulted in some minor damage to the bowser's side rail and mud guard (the excavator sustained paint scratches).

- Following refuelling activities the fuel bowser driver had returned to his cab, walking between the excavator counterweight and the bowser (approximately 30 seconds before the excavator started to slew).
- Although the excavator's 'blindsight' mirror was found to be defective, the excavator driver would have had sight of the bowser from his cab. However he had made an assumption that the bowser had left the area and proceeded to slew round.

- The bowser driver had removed the excavator's key from the ignition whilst he was fuelling the machine, and had returned these just before walking back to his bowser
- The plant operator did not get positive visual confirmation that the bowser was clear of the area recommencing operations.
- Additional controls are now being considered to specify the location of the bowser when it parks up prior to refuelling ( in clear line of sight)
- All plant operators have been reminded about the need for daily plant checks to ensure safety critical equipment is in good working order

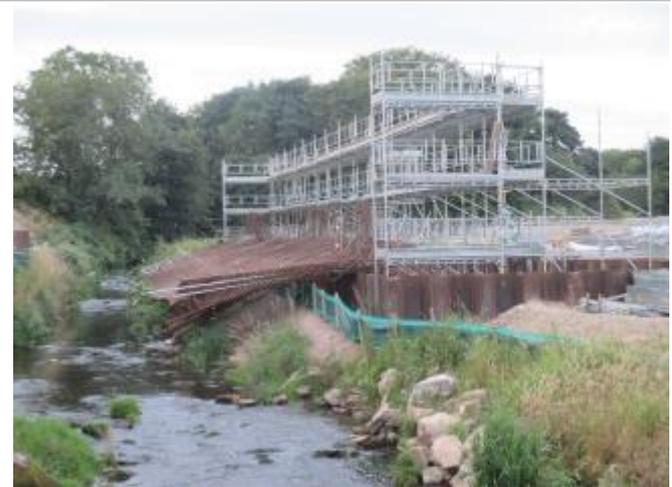
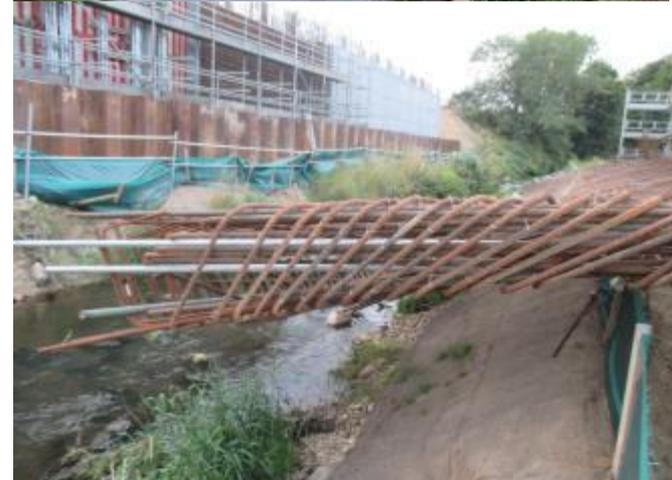
- A rebar wall collapsed at structure PS54 (North Section). No one was working at the time at the location and no one was injured

- Rebar cage comprising generally of 32mm and 20mm high tensile reinforcement. Cage size of circa 40m (L) x 7.5m (H) x 1.2m (W) – weight 65 Tonne, located in cofferdam collapsed unexpectedly on 30<sup>th</sup> August 2016 towards Goval Burn.
- A scaffold erected to the rear of the rebar remained in place but sustained some damage – potentially from energy of rebar collapse.

- Rebar design should always be checked to ensure it has been designed to free stand or adequate Temporary Works installed.
- Industry Guidance regarding the stability of Re-Bar should be re-read and understood by all relevant Temp Works Coordinators.
- Post installation inspections are necessary to ensure the cage structure has been installed correctly and is stable.
- The Project Director held a Safety Stand down to reinforce his Zero Harm commitment and make it clear to everyone that nothing is so important that it cant be done safely.

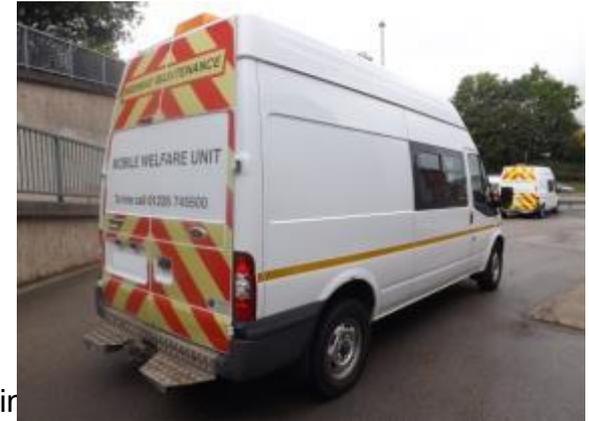
- An operative was struck by a reversing welfare unit at low speed (<3 mph) causing injury to his left hand and leg.

- The vehicle arrived at what they believed to be the works location. In the vehicle were the driver and a plant operator.
- The plant operator exited the vehicle and walked behind it standing with his back to the van.
- After approximately 1-2 minutes the driver decided to reverse back and in doing so struck the operative at low speed knocking him to the ground
- The IP was then sent to A&E as a precautionary measure where it was discovered he had broken a metacarpal bone in his left hand

- The site reversing policy was not followed. Failure to follow the project reversing policy increases the likelihood of reversing accidents
- The driver failed to positively identify that the person, which he knew was in the vicinity, was in a place of safety before moving the vehicle
- The reversing alarm was not audible above the background noise level
- The welfare vehicle has no visibility immediately to the rear, nor is it equipped with a rear facing camera. This is now being mandated by the site team.

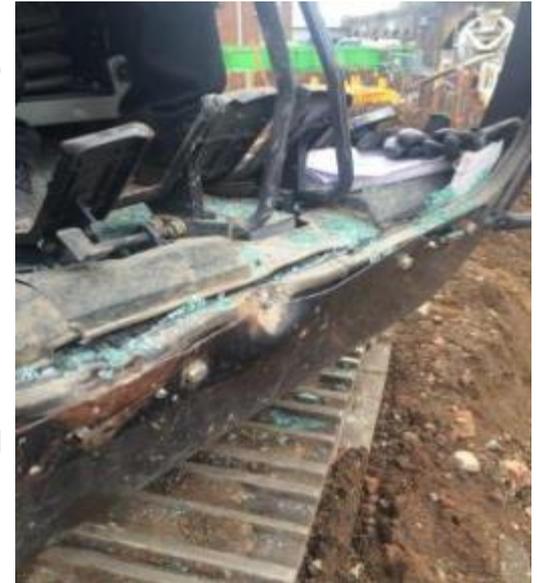
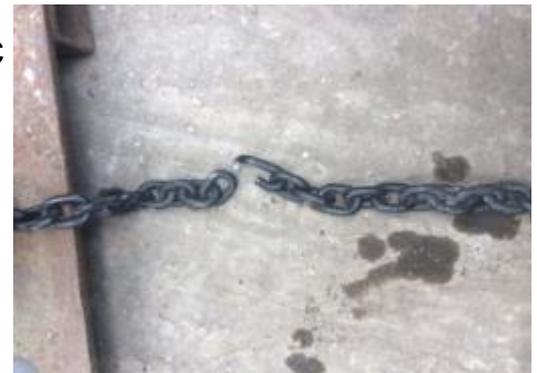
- During the lift of a 750kg sheet pile to its final location and before being driven into the ground by an excavator mounted vibrator, the chain with which it was suspended from broke causing the sheet pile to fall approximately 1m.
- Upon hitting the ground, the sheet pile bounced back towards the cab of the excavator, with the sheet pile striking diagonally the windscreen/front of the cab, striking one of the travel levers, and a brake lever, which in turn struck the IP's leg

- The IP left the cab of the machine by his own means, and was found with a minor cut to his right leg, he did not appear to have sustained significant injury, he was taken to hospital for further examination. He received stiches, and was discharged on crutches, to return for further assessment when the swelling had subsided.
- The chain, a 8mm pitching chain of 27 links 8mm grade 8 chain- with kupler – 5/8 safety pin bow shackle-with chain tag, is used as part of the system for lifting the sheet piles, The chain arrived on site 31/8/16(record of it's delivery annotated in the Daily Site Diary, is a new chain and came with a manufactures certificate & EC declaration of conformity dated 29/7/16 and has a SWL of 2tonne

- The Subcontractor and the Site team have arranged for an extra hole to be made in each sheet pile to allow the insertion of a 'safety' chain, which is to be attached to the main excavator lifting anchor point
- The damaged chain has been returned to the manufactures for the steel to be analysed in the Laboratory for defects.

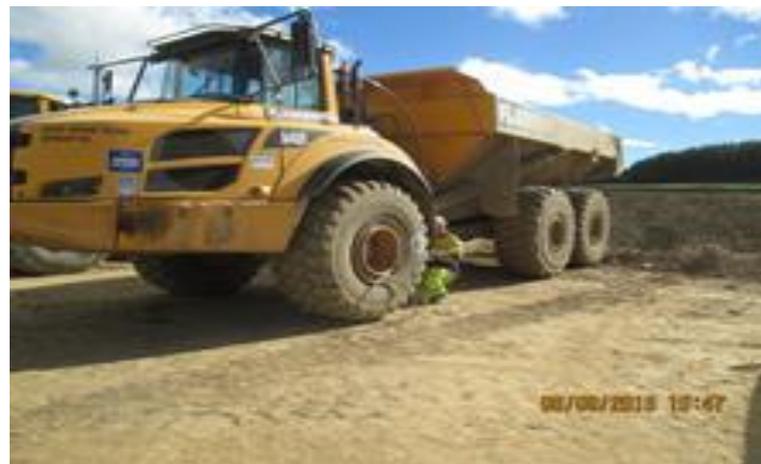
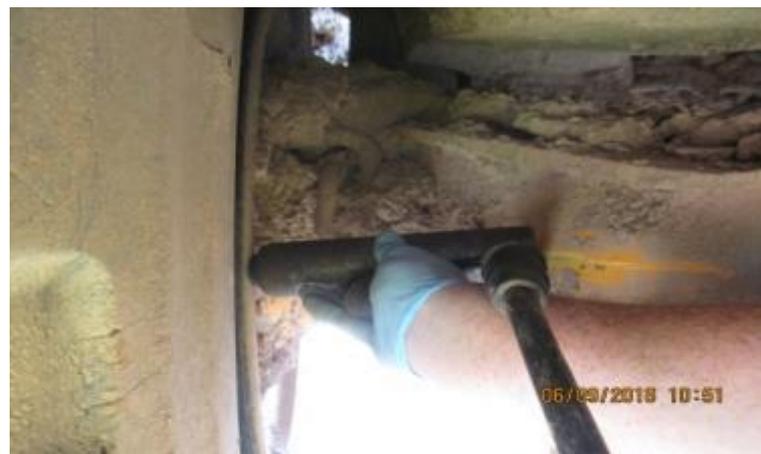
- In the AWPR Centre Section a tyre fitter was injured whilst changing an ADT tyre and has not yet returned to work.

- The tyre fitter had been called onto site to replace a punctured tyre on an Articulated Dump Truck. He had been on site several times before.
- A portable hydraulic jack was being used by the fitter to take the rim off the wheel. During this operation, the jack slipped and flew off under pressure, hitting the fitter on his forehead.
- He sustained a cut to his head. He was taken to hospital where he received 5 stitches and glue.

- A joint investigation has been carried out between Kal Tire and AWPR
- Tyre changing equipment to be reviewed to ensure it is fit for purpose and in good working order.
- Approved Procedure and Safe System of Work to be reviewed and guidance re briefed and re issued to all fitters.
- All BB projects to review their fitters 'SSoW'

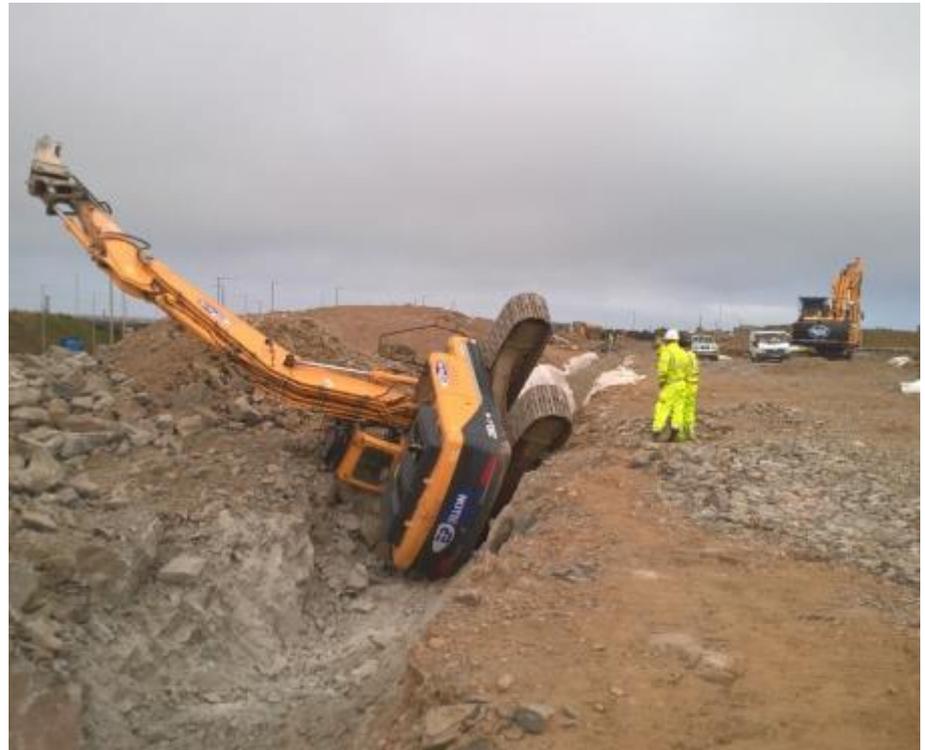
- An Excavator overturned into a ditch on the South Section of AWPR.

- A drainage team had encountered hard ground so a machine with a breaker attachment was called in to assist.
- The excavator was operating within an exclusion zone.
- The machine had to straddle the trench at 90 degrees, with its tracks positioned across trench.
- When the driver slewed around, the edge of the tracks slipped into the trench resulting in the excavator toppling into the trench.
- The driver was shaken but unharmed.

- A full investigation has been completed.
- Change and unplanned improvisation is causative – If anything changes ‘Stop’
- All drivers were stood down and made aware of this and other recent events.

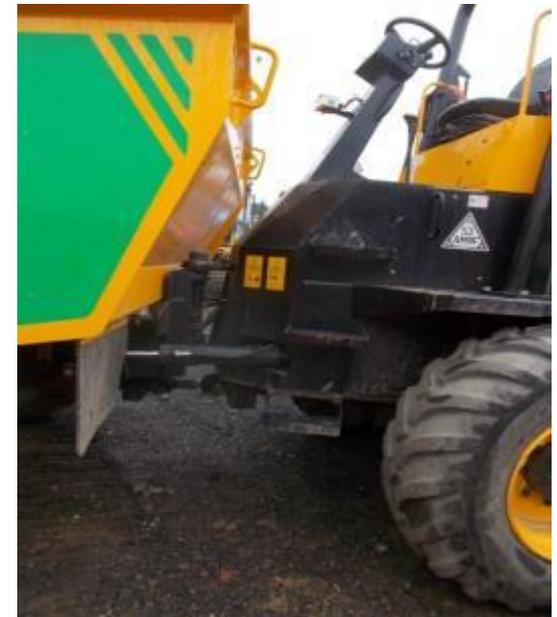
- A BB Operative misjudged his footing when climbing down from a 9t dumper and missed the bottom step. The Operative landed awkwardly on the ground and fracture his right ankle.

- The Operative was working on night shift and was using the dumper to tow a tower light unit in the project compound.
- Ground conditions were good, appropriate boots were being worn, the compound was illuminated and the operator was descending the steps in the approved way.
- The bottom dumper step is offset to the left compared to the one above (see picture to right). The steps are also painted black with no contrast against the black dumper body they are fixed to. It is considered that these two factors may have contributed to the Operative missing the bottom step.
- During interview the Operator advised that he had recently missed the step on another occasion but had not been injured or thought enough of it to raise the issue as an observation.

- Operators should be briefed on this incident to raise awareness, the colour of steps should be reviewed with suppliers to make them more prominent, especially where dumpers are to be used in low light / shadow conditions.
- Steps must be kept clean and ground conditions reviewed at locations where Operators will be required to dismount dumpers and boots must be fastened to offer good ankle support.

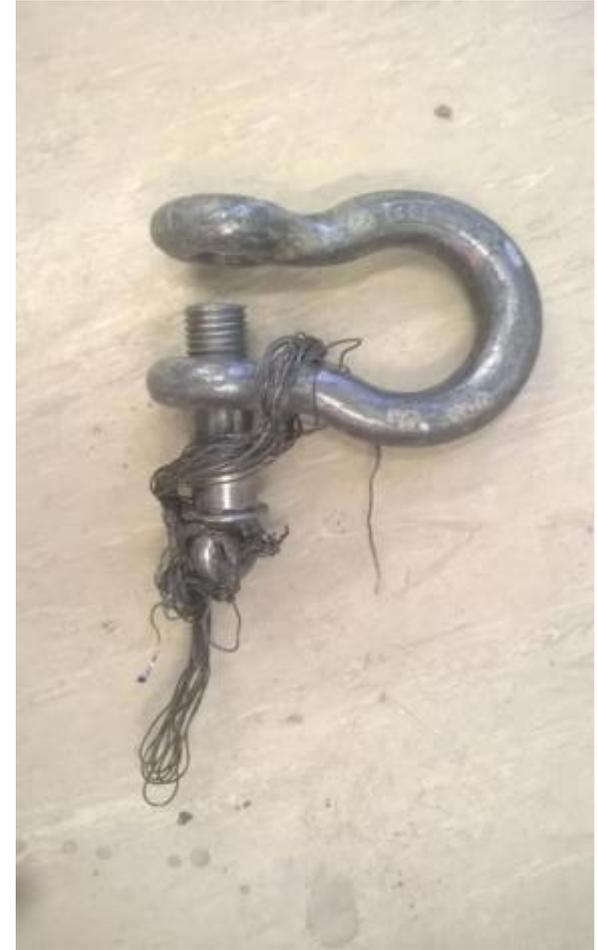
- During a pile casing installation, a bow shackle fell to ground (approx. 4 to 5m) within the exclusion zone.
- The Site Supervisor reported the incident to the Senior Contracts Engineer and explained that no operatives were in the exclusion zone at the time of the incident.
- A little later a second incident occurred. Both the section engineer and the senior contracts engineer were out on site and observed the second shackle falling and that the operative and supervisor were within the 10m exclusion zone.

- Steel tying wire used to secure the shackle pin snapped and the pin worked loose due to the vibration.
- A 10m exclusion zone was not put in place that operatives had previously been instructed to do.
- A previous incident had occurred and alternative methods of work had been trialled without success

- A Principal Investigation is currently underway but early signs are that the site operatives did not comply with instructions to maintain a 10m exclusion zone.
