Aberdeen Western Peripheral Route: 11KV Overhead Cable Strike – HiPo L4

Aberdeen Western Peripheral Route: Tree Felling Incident – HiPo Level 5

Major Projects, Highways, M5:

UKCS North & Midlands, East DU:

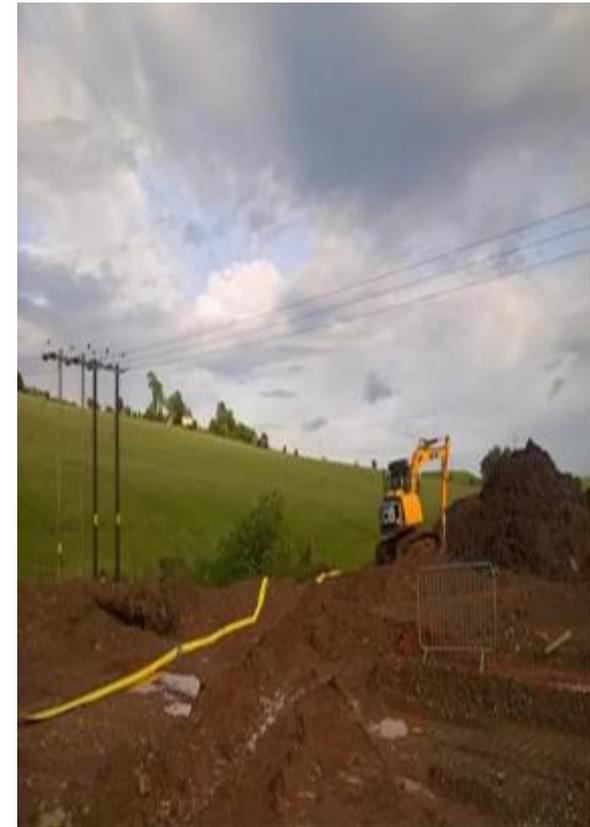
This incident is a HiPo but may also become a Dangerous Occurrence. A HFACS Investigation is underway. Excavator working on water management works tracked through the GS6 boundary and under the live 11kV OHL. The arm of the excavator made contact with the overhead line. The OHL discharged on contact with the excavator arm.

The excavator had initially tracked up the cut using the GS6 goal posts to cross under the line and had parked on the north east side of the goal posts. He then tracked along the demarcation boundary, running parallel to the line, before crossing the line at the extremities of the works / edge of cutting – in effect turning 90 degrees. The fence creating the OHL exclusion zone along its length in this location had been removed to carry out pumping works and hadn't been re-erected. Something had changed and their focus No injuries were sustained; SSE attended site and initially reported that there was no damage but subsequently it was confirmed that there was an outage.

The SEPA Emergency works are currently high priority for the project but the work must continue to be safely planned and executed in line with the Risk Management Process. Task Specific risk assessments and Task Specific briefings must be conducted for every operation – an area the investigation is currently focussing on. The South Section were all stood down immediately until they had been re-briefed and a further project wide briefing has been held to re-brief all operatives as part of their morning “putting to work” briefings. D&A testing was undertaken for the driver which returned negative. The driver has admitted that he was in the wrong and should not have crossed the boundary – he has been dismissed. A more robust ‘goal post / OH exclusion’ inspection regime has been introduced across all sections with daily records being collated centrally

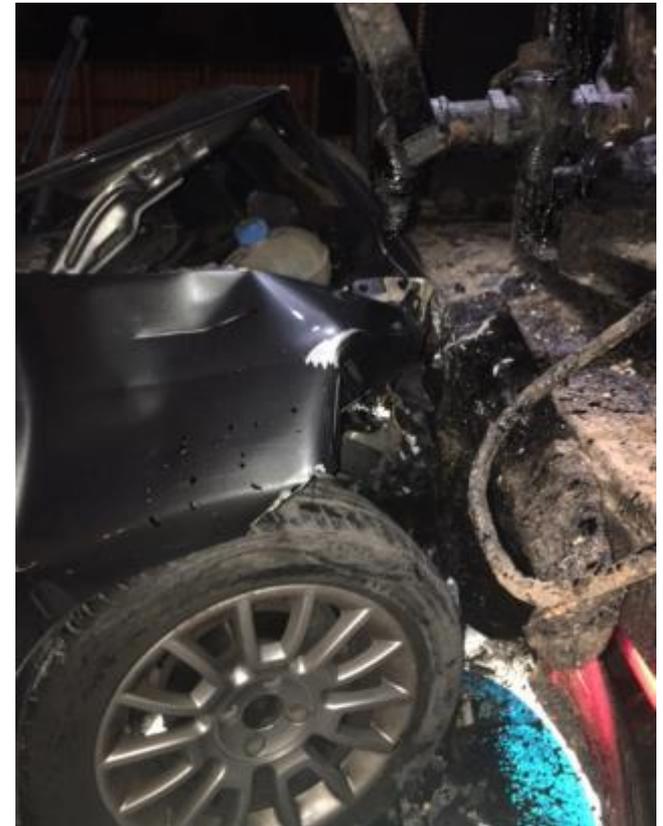
Errant vehicle entered total closure of slip road at speed colliding into the rear of a loop cutting vehicle. No physical injuries sustained. An operative suffered psychological injuries resulting in lost time.

We were loop cutting at 02:43 on Saturday 23rd July working within an overnight closure on M60 junction 23 exit slip when a drunk driver ignored the signs, cones and T/M vehicle driving at speed struck the rear of the loop cutting vehicle. An operative was stood on the flatbed of the vehicle and was knocked over causing minor bruising. He was taken to hospital for further checks and later released. The incident was captured on CCTV and driver arrested at the scene and subsequently charged with drunk and dangerous driving.

We must assess if the T/M in place is adequate to prevent an errant vehicle incursion and wherever possible install additional physical barriers to protect the workforce from being harm. Our HiPo Investigation is on-going to identify further control measures and working closely with Highways England to raise public awareness for roadworker safety.

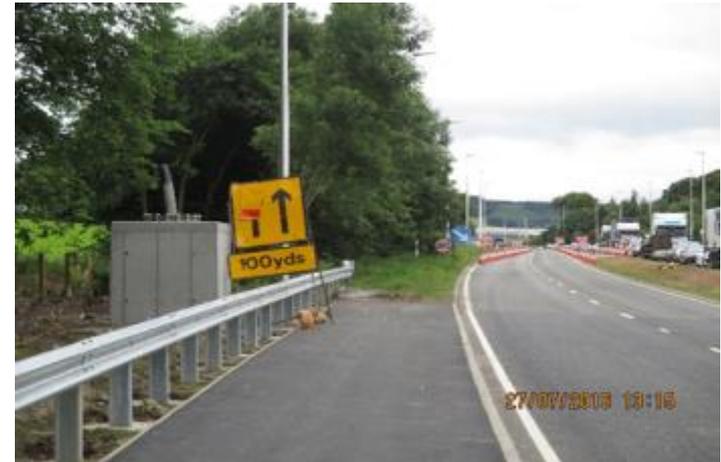
During the removal of 12x trees from the verge along the A96 to allow the construction of the hard standing, one of the trees fell onto Lane 1 of the live carriageway.

As the tree fell onto the road a motorbike had to swerved around the tree and into the coned lane 2. Directly behind the motorbike was a silver VW golf carrying a child in the rear was unable to react, drove over the tree causing significant paint damage to the underside of the front valance. Initial findings indicate that the work was unplanned, the RAMS had not been reviewed in the last 6 months, no Task Briefing Sheet had been prepared for the works and the operatives had not attended a DAB before commencing works. Supervision on the day was also lacking for the amount of work being carried out.

The tree was felled in an area behind the yellow TM sign. At the time of the incident the TM was not as per this picture. When the incident occurred lane 1 was open, lane 2 was closed and a 30mph limit was in place.

Works must always be suitably planned and set to work by a competent supervisor ensuring the workforce are competent, inducted, briefed on their SSoW (inc Task Briefing Sheet specific to the works) and given a daily activity briefing at the start of the working shift. Also, tree felling must also always take place in a zone large enough to receive the tallest tree being felled with an adequate safety zone beyond to ensure under no circumstances can a tree breach the boundary of the works.

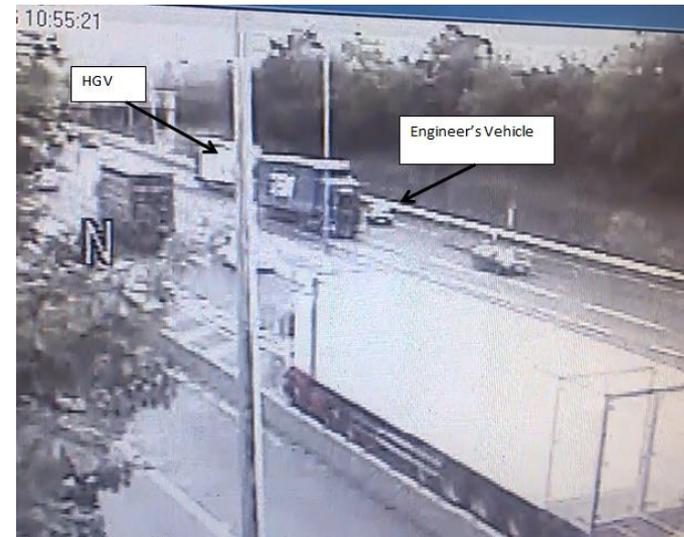
An employee left a works location, entered the live carriageway and came into close proximity with an HGV.

An engineer was travelling through the works to the next location and found that his route was temporarily blocked. He took the decision to reverse back to the closest access point within the works and attempt to re-join the carriageway at this location.

The engineer looked in his mirror prior to pulling out and did not see the HGV until he was fully committed.

The HGV caught the vehicle in a glancing blow breaking off the wing mirror and continued on its journey.

Regardless of circumstances safety rules must be followed when entering and exiting works areas

Drivers must be fully alert and composed when attempting to enter/exit works areas

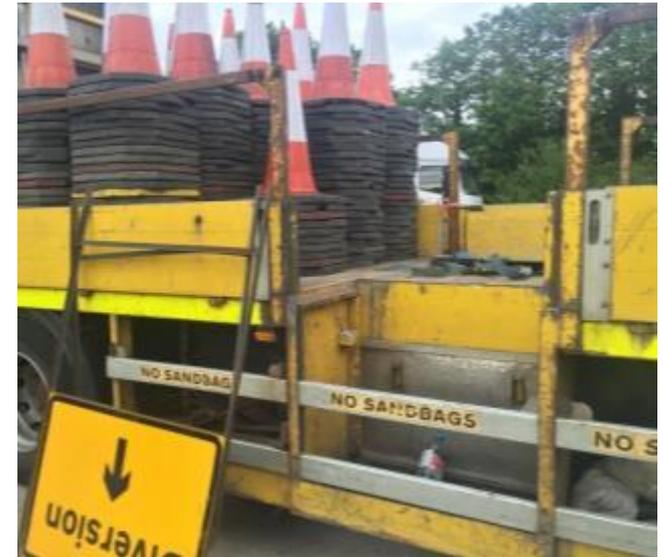
A Traffic Management (TM) Operative suffered a penetrating wound to his arm pit from the foot of an upside down sign as he exited the rear of a Traffic Management lorry.

The TM Operative was preparing signs for the night, (loading / unloading from the lorry). The Operative was getting down from the vehicle, standing on the bar at the well, stepping / jumping forwards from the vehicle. As he moved forwards the foot of a sign that was stacked upside down against the vehicle (situation recreated in photo) went into his right armpit. The sign foot punctured the skin causing what appeared to be a deep wound.

The correct method of dismounting the vehicle was not followed. The IP should have stepped down backwards using the rung below. The A1 CH2MC had built up an impressive record of no lost time accidents during the main phase of the works. Unfortunately, there has recently been a run of three lost time accidents. To address this a series of stand down briefings across all shifts is planned to take place on Monday 8th August.
