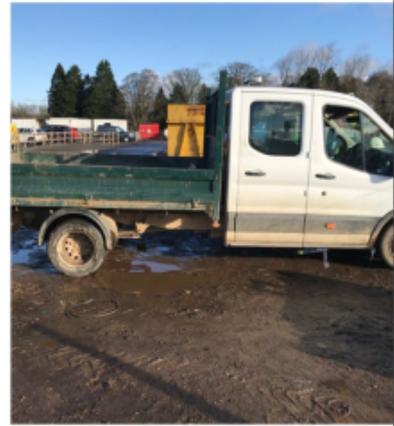
While transporting material on the public highway for the A85 Crieff Road Project, UKCS Scotland & Ireland, a LGV (double cab 3.5T tipper) was pulled over by the Driver & Vehicle Standard Agency and escorted to the nearest weighbridge. The vehicle was overweight resulting in the receipt of a 'weight prohibition'.

The site is nearing completion and the operatives were tasked with spreading top soil around various locations. They were loading the tipper from a stockpile and transporting the loads on the public carriageway (an on-going task), but there was no axle weight system fitted to the vehicle to assist the operative in assessing the weight.

- The vehicle did not comply with the Balfour Beatty Specification. All projects should re-check that vehicles meet this [specification](#).
- Assessments are to be carried to determine whether the vehicle selected is right for the job. Double crew cabs can carry very little in terms of a load. In this instance, it would have been suitable for only two men and four wheel barrows of top soil

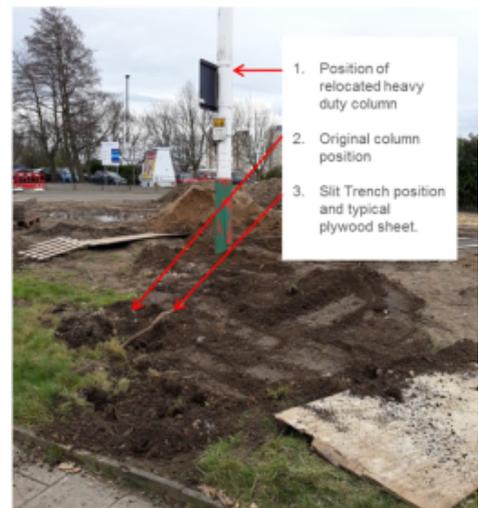
An operative inadvertently put his leg into a trench, suffering soft tissue damage.

On the UKCS Living Places Sunderland PFI, a slit trench was dug in order to remove a heavy duty streetlight column which was to be relocated. The IP lifted the ply sheet which was covering the trench and in doing so his leg fell into the hole.

The excavation had been dug and covered by the client the previous day. The IP reported unfit for work 24 hours after the event.

All accidents or injuries must be reported as soon as possible. Ensure all tasks are properly considered and suitably planned. Review and re-brief incident reporting procedure to relevant personnel.

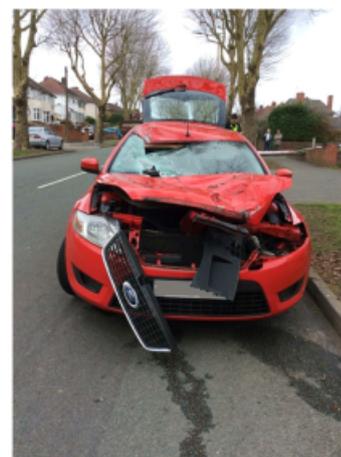
On the Gas & Water GDSP project, a grab wagon has pulled over a telephone pole, which entered the live carriageway and struck a member of the public's vehicle, causing significant damage.

A subcontractor operative working in a residential area, was moving from one location to another, when the boom of the grab caught an overhead phone line. The cable did not break and instead, the wooden pole snapped, leaving a stub of between 2' and 3' and swinging the post out into the live carriageway into the path of an oncoming vehicle.

Investigations are ongoing and the case is subject to legal privilege. However, immediate lessons learned are that we must always ensure that equipment is correctly stowed for travel prior to leaving site and particularly when operating on a public highway. We must also adhere to any audio and/or visual alarms fitted to vehicles and not tamper or disable them.

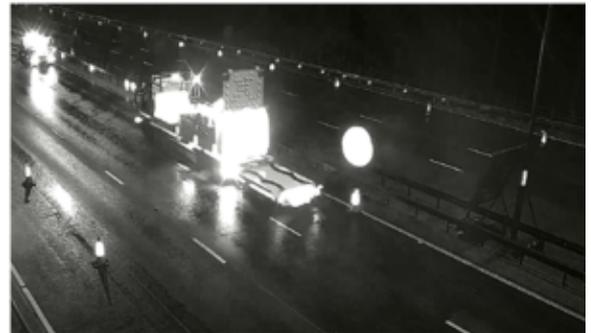
On the M4, Highways Project an IPV reversed in the live lane of the motorway.

During night time works, a Traffic Management contractor was tasked with installing a lane 3-2 closure on the A track carriageway, westbound. While removing the lead taper at the end of the shift, the IPV proceeded to reverse in live lane 3 which is not in line with the Safe Systems of Work.

The TM crew involved were suspended, the traffic management safe system of work was reviewed, a safety stand-down was held for all TM personnel and a full investigation is underway.

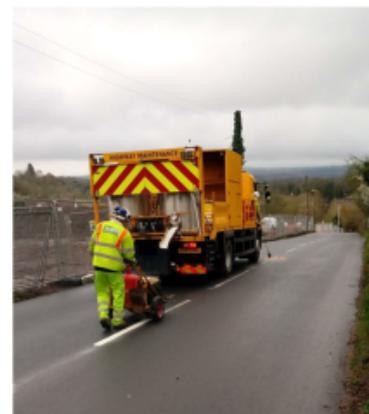
On Monday this week, we mobilised the BBLP Highways contract in Telford and Wrekin. Due to training and inductions of the TUPE staff, the only work being undertaken was emergency response (using crews from Herefordshire) and lining (by a subcontractor). The lining crew was witnessed working unsafely.

On day three of the contract, a newly inducted BB supervisor was undertaking inspections of the lining works. On arrival at site, the supervisor witnessed the lining contractor working unsafely – the driver was using a thermal lance whilst driving the lining vehicle and a second operative was using a lining pram with inadequate controls, traffic management and safety clearance. Our supervisor stopped the work, the contractor was stood down, and a HiPo investigation commenced.

The supervisor demonstrated our golden rules, stopped the work and reported the safety breaches. Never commence work without adequate Traffic Management in place.

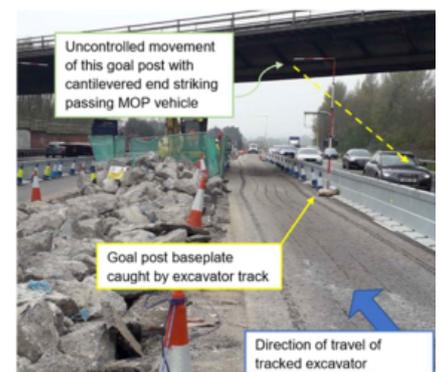
As an excavator was tracking past an overhead line pole on the Highways M4 J3-12 project, its track caught the base plate of the goal post, causing the post to fall onto the vehicle restraint barrier and the T-bar to catch the roof of a passing car.

The excavator was passing under bridge and the goal post was in place as an over-height warning. The goalpost was positioned adjacent to the live lane and held in position with a base plate that was loaded down with sandbags. The excavator was a 22.5 ton machine taking up most of the carriageway width. There were PVMs in front and behind the machine but they failed to see the goalpost in time to prevent it from being hit.

The positioning of the goal post should have been moved away from the live lane side of the site haul road to prevent it falling into the live lane.

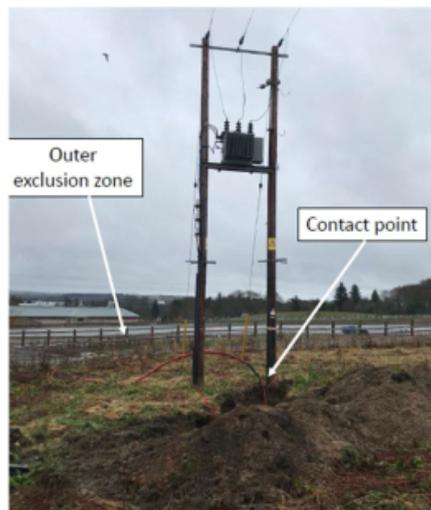
On the Major Projects' AWPR project, operatives were strimming the area adjacent to the Craibstone compound using hand held strimmers (with metal blades), when one operative strimmed too close to a post, which had a diverted 11kV cable attached, striking the cable.

Subcontractor Landscape Matters were strimming an area designated for planting around the Craibstone office. A team of two operatives were using hand held strimmers with metal blade attachments to remove the infestation of dock and gorse prior to planting and seeding. A crowd barrier exclusion zone was erected around the timber 'H' pole, which transferred an 11kV underground cable to overhead lines.

Once the general area had been strimmed, the team were advised to also trim within the exclusion zone. During strimming within this area, one of the operatives strimmed too close to the timber pole and came into contact with the plastic sheathing protecting the cable. The sheath was severed and the 11kV cable subsequently damaged.

The incident was immediately reported to SSE and power restored. A full investigation is underway.

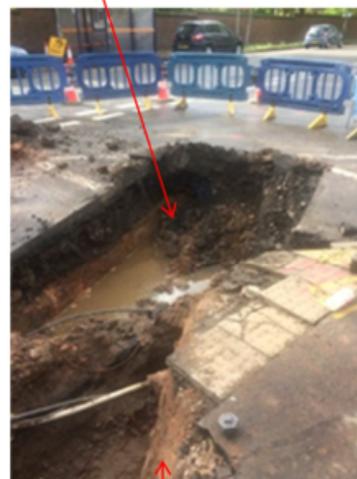
On the Gas & Water GDSP Project, during an activity to expose an existing gas main, the operational team damaged an (HV) electric main, when a large stone was pulled onto it by the mechanical excavator.

The team then trial-holed by hand and exposed tiles covering a number of (LV) electric cables and what they thought was the (HV) electric main. While excavating away from this area an excavator bucket was permitted to enter the area to remove the spoil. However, in doing so, the bucket pushed a large piece of stone into the side wall of the excavation which made contact with an (HV) electric main, causing an outage.

Position of damage

(HV) electric main thought to be exposed at this location

Always ensure you use all available methods to prove the route, line and depth of all utilities; especially when the initial CAT scan does not agree with the onsite utility plans – which are only ever indicative.
