SAFETY ALERT

April 2019
Ref 026 19

Ringway North Yorkshire – Deadweight Roller Incident

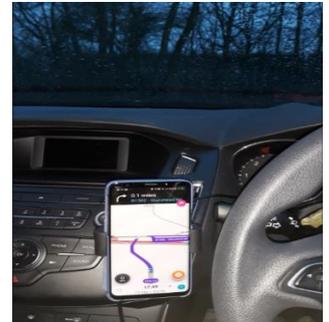
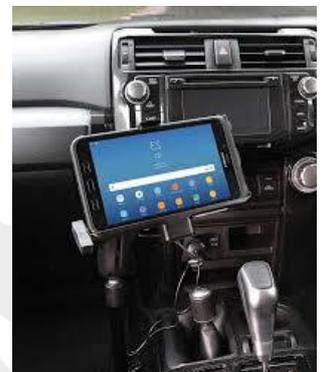
The employee involved in this incident admitted that he was distracted due to looking down at 'WAZE' on his mobile phone. The phone was found not to be mounted in a suitable bracket.

They must be mounted securely where they do not cause a distraction to the driver. Example of a vent mounted holder, thus leaving the screen clear to view the road. Where compatible via Bluetooth: the directions can be played through the vehicle's speakers.

If we are expecting driver to use mobile phone or access any apps which are contained on them, we MUST provide suitable cradles.

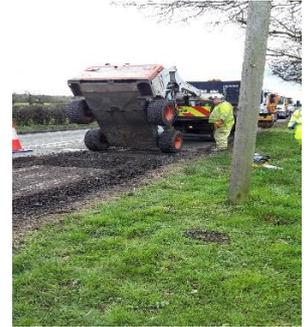
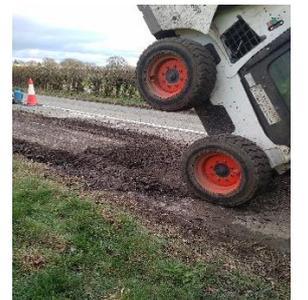
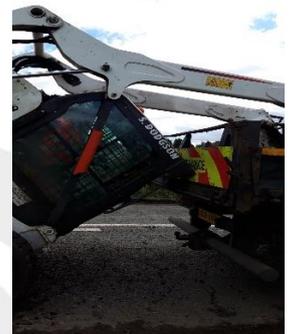
At the time of the incident, the Bobcat attachment was used to load the planings into the rear of a 7.5 tonne vehicle, approximately one metre in front of the planed out patch. On the third occasion that the Bobcat loaded the planings onto the bed of a 7.5 tonne vehicle, the Bobcat tipped forward with the sweeper attachment coming to rest on the back of the lorry.

- *The sweeper attachment collects arisings when reversing. When the sweeper bucket was full, overflow planings formed a ramp*
- *At the time of the incident, the front wheels hit the edge of the planed out area as the rear wheels hit the ramp made from accumulated planings. This happened at the precise moment the sweeper attachment of the Bobcat had been raised into its extended position ready for tipping. This caused the Bobcat to overbalance which resulted in the Bobcat tilting forward onto the lorry bed*
- *The unusual number of vehicles within the closure resulted in a restricted working areas which influenced the movements of the Bobcat not allowing sufficient space to off load the spoil on a level surface.*

When planning works, sufficient space must be given for loading vehicles on level ground. Vehicles are not to be loaded on uneven surfaces. If this is not possible, the work must stop and be redesigned.

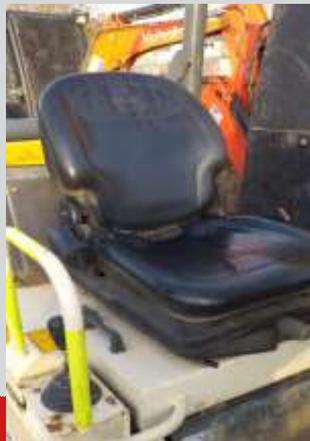
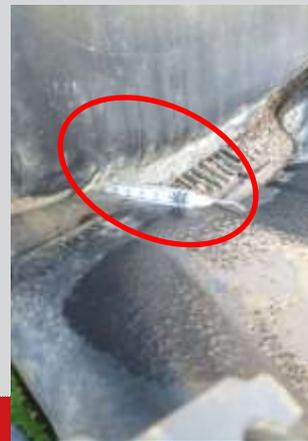
One of our workers recently discovered a syringe that had been maliciously placed on the seat of a mini digger. The syringe had been placed at an angle intended to cause harm to the operatives.

- Actions to be applied to prevent reoccurrence;
 - Secure the site - use fencing or barriers where appropriate, to prevent access to the site and equipment
 - Secure the equipment - ensure vehicle cabs, where provided are secured at the end of the shift
 - Visual Check - as part of the normal daily checks, visually inspect the cab for signs of abnormalities or tampering
 - Report it - any suspicious activity should be reported up to the site supervisor immediately and recorded on Airsweb
- If you find a needle;
 - Make the area safe
 - Report it to your supervisor or line manager
 - Arrange collection

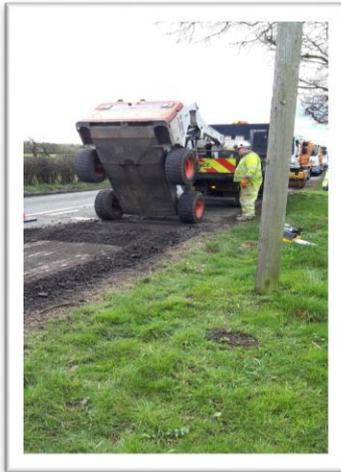
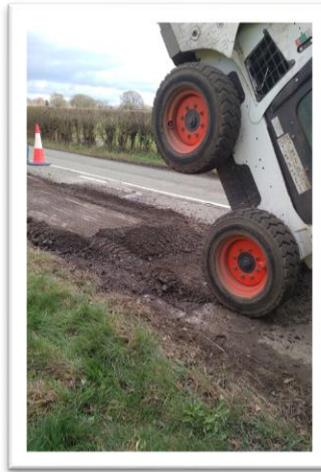
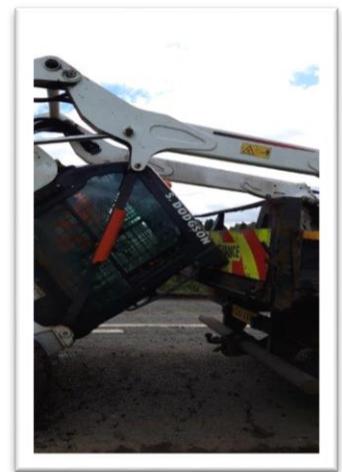
At the time of the incident, the Bobcat attachment was used to load the planings into the rear of a 7.5 tonne vehicle, approximately one metre in front of the planed out patch. On the third occasion that the Bobcat loaded the planings onto the bed of a 7.5 tonne vehicle, the Bobcat tipped forward with the sweeper attachment coming to rest on the back of the lorry.

- The sweeper attachment collects arisings when reversing. When the sweeper bucket was full, overflow planings formed a ramp
- At the time of the incident, the front wheels hit the edge of the planed out area as the rear wheels hit the ramp made from accumulated planings. This happened at the precise moment the sweeper attachment of the Bobcat had been raised into its extended position ready for tipping. This caused the Bobcat to overbalance which resulted in the Bobcat tilting forward onto the lorry bed
- The unusual number of vehicles within the closure resulted in a restricted working areas which influenced the movements of the Bobcat not allowing sufficient space to off load the spoil on a level surface

When planning works, sufficient space must be given for loading vehicles on level ground. Vehicles are not to be loaded on uneven surfaces. If this is not possible, the work must stop and be redesigned.

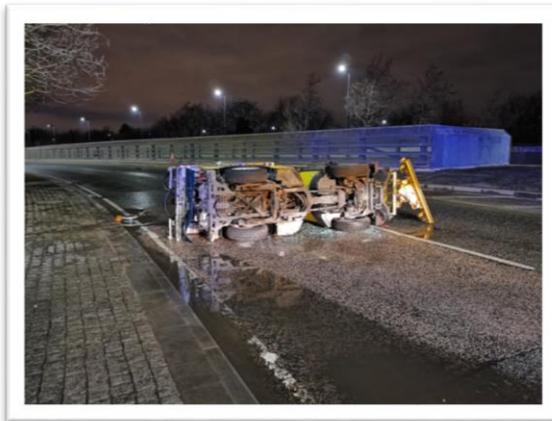
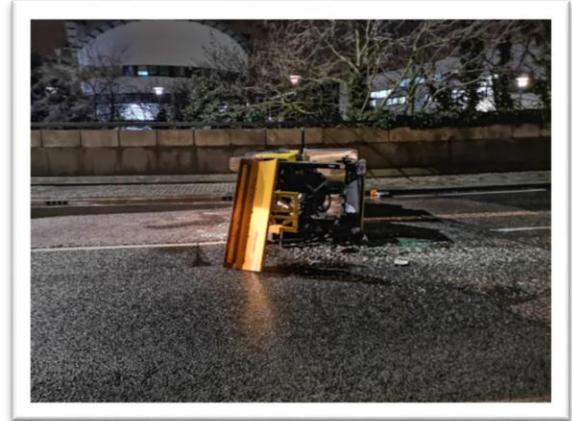
The Multi-Hog had driven approx 1mile from Armada way depot onto the A1020. The A1020 follows a roundabout route through London's Docklands where the road is relatively straight, upon exiting the roundabout the operative lost control. During attempted correction manoeuvres it is believed the back left tyre came into contact with the kerb causing further inbalance and the Multi-Hog overturned.

- The incident occurred at 22:00 and ice formation was not expected until 01:00-09:00
- The road surface was wet
- The Multi-Hog was fully loaded with 700litres of liquid solution.
- The operative had been trained in the safe use of the equipment for this activity

- To undertake a full investigation
- Multi-Hog is not to be used for winter service until final investigation is completed
- TBT delivered to all operatives with instruction to ensure tank is empty to / from route
- Multi-Hog to be assessed for future suitability with a view to changing specification
- RAMS to be reviewed for use of vehicle for Winter Treatments

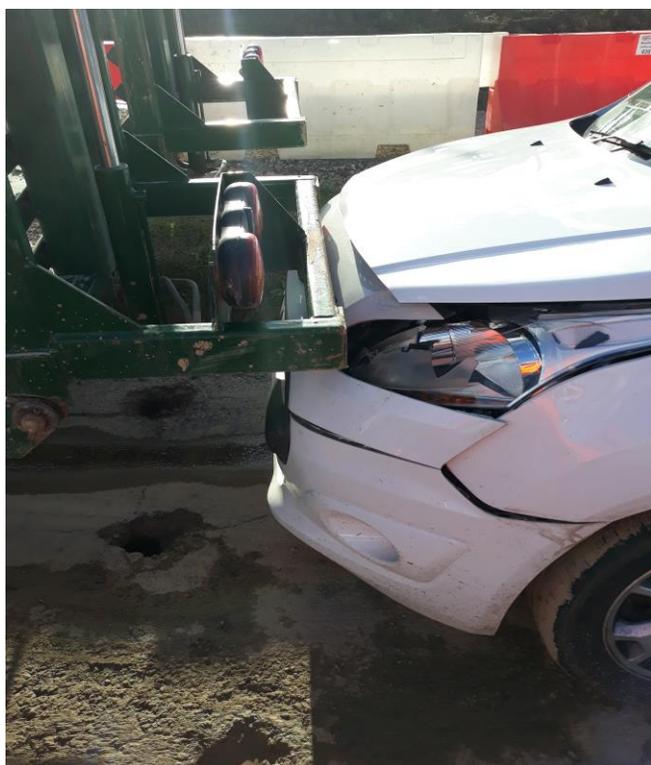
Photo below shows the resting position of the Trailer after impact with the parked site van.

At this point, due to the back of the trailer being situated on the lower part of the low-loader ramp the weight transferred lifting the trailer draw bar ring off the hook resulting in the trailer rolling off the ramp onto the access road and into a parked van approx. 30ft. behind, causing damage to the bumper, bonnet and light of the van.

- The incident was reported to site management who made the scene safe and initiated the investigation process.
- Any activities involving the delivery or collection of plant were ceased until the site process for managing this type of activity was reviewed and re-briefed to all concerned.

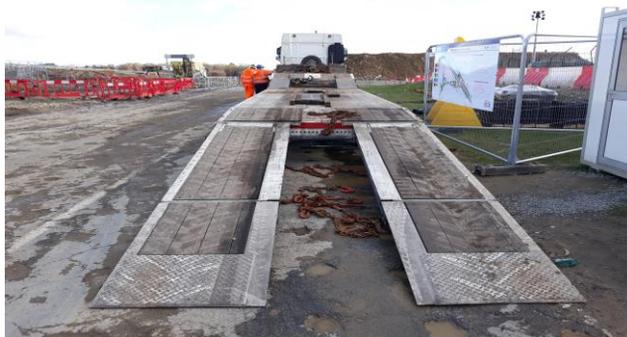
Photo below shows the Low-loader which the Trailer rolled off once disconnected from the tractor

- There was an assumption made by the Tractor Operator that when the hydraulic brake hose was disconnected from the Tractor, it would engage the Trailer brakes.
- The manual brake handle wasn't identified during the Operators pre-use checks on the Trailer during the pre-use visual inspection.
- Lack of clear process for undertaking reasonable checks before Low-loader operations commenced.
- The Low-loader was not long enough to hold the Tractor and the Trailer whilst connected.
- The Operator did not hold a Load and Secure competency card.

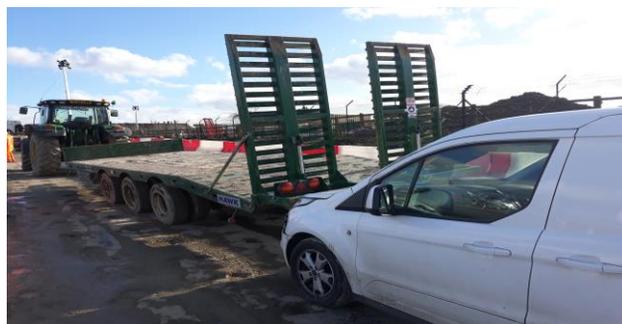
Photo below shows the full length of the Trailer and the Tractor that it was disconnected from whilst on the Low-loader.

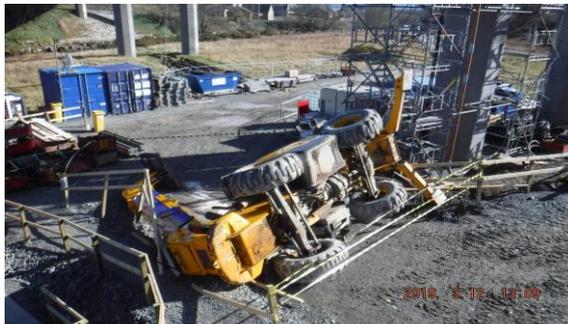
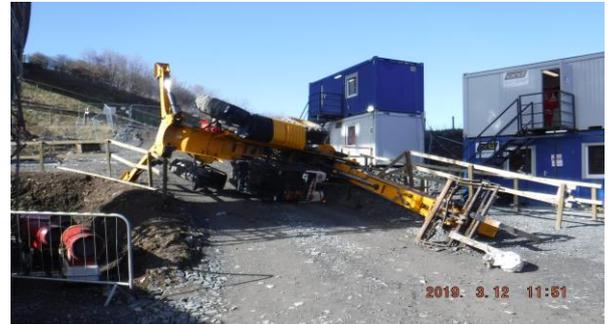
The CPCS qualified Driver hooked the fitting bag onto the left-hand fork of the machine (from the perspective of the cab), entered his cab seat, set his outriggers/stabilisers down and attempted to boom out. The machine prevented this motion due to the gradient, so the driver readjusted his stabilisers to level the telehandler.

The first section of the boom was then able to extend, and immediately the machine started to tilt to the left. Fortunately, no injuries were sustained by the driver or any other persons. A full investigation is ongoing.

1. Suitable lifting areas identified and highlighted within the lifting plan. These areas should be located on firm level ground
2. A suitable method statement and risk assessment must be in place for the task briefed to operatives
3. A common schedule of lifts detailing the items to be lifted, including weights to be available and briefed to the operator
4. Ensure operator competency cards are in date – NPORS /CPCS
5. LOLER certificates available on site and in date
 - a. 12 months for telehandler
 - b. 6 months for lifting accessories
6. Telehandler defect sheet to be completed, daily and weekly register completed
7. When defined by the risk assessment, a competent banksman should be available and means of communication identified
8. If the telehandler is required to cross or drive on a public road, the operator must hold a valid driving licence

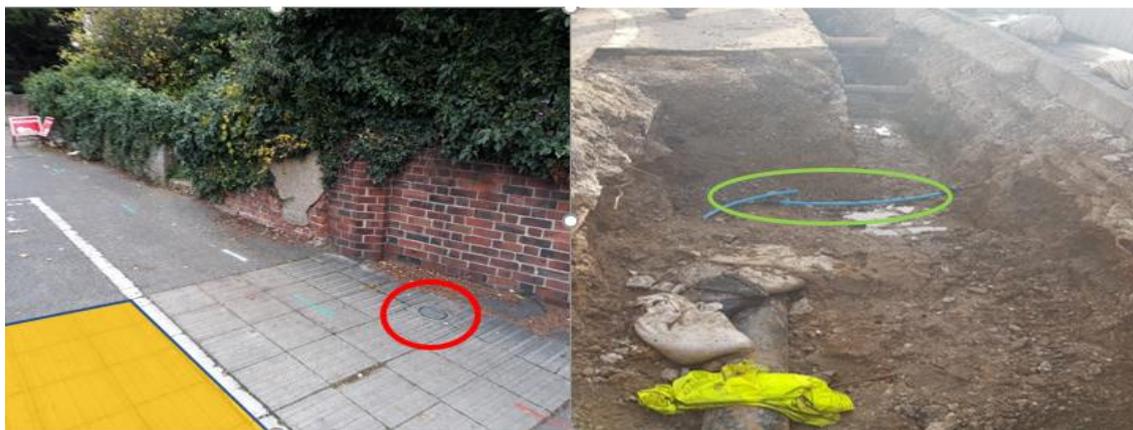
In February this year, a lead water service pipe was damaged by an excavator bucket during excavation works for a gas main trench. The photos below show before and after, (photos are from different directions) with the completed plastic repair to the right (circled green) and water valve box in the footway to the left (circled in red). The excavation area is highlighted yellow in the left-hand photo.

The importance of the water valve is that this was not picked up and highlighted at a number of stages throughout the planning of the works and this was a key significant finding leading to the damage.

The root cause from the investigation showed that they did not have a formal process for handover of information between the CATman/UST and their site team responsible for the works area.

Therefore, they have implemented a formal handover of information where the CATman/UST walks through the traced works area and explains what they have located to ensure full understanding from the operational team. The information from this is recorded on the 'Safe Dig – Avoidance of Services Checklist' form and signed by both.

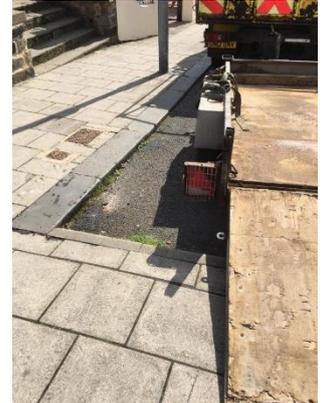
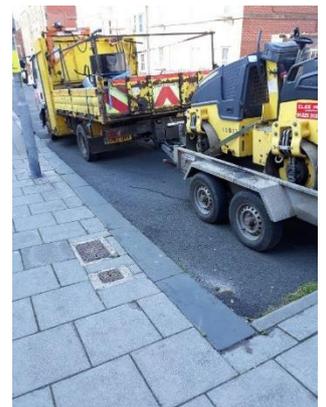
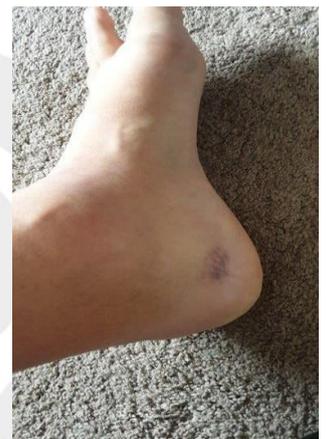
Upon arrival at site, the works vehicle parked up leaving a gap of approximately 500mm between the trailer it was towing and the kerb. The IP exited the vehicle on the passenger side and waited while the ganger working opposite to him, undid and removed ratchet straps which had been used to secure a rideable roller on a trailer. Once removed, the Ganger passed the IP the ratchet straps for him to unhook on his side. Once done, the IP placed the straps on the trailer and stepped backwards, tripping up the shallow kerb located behind his feet. This caused him to fall to the ground. He sustained bruising and a sprain to the ankle.

The incident could have been avoided had the works vehicle and trailer been parked aligned closely with the kerb. This would have removed the kerb as a potential trip hazard when removing the roller from the trailer.

A site-specific risk assessment/5 minutes on safety must be undertaken upon arrival at every site. This should identify the potential hazards and controls required to undertake the operation safely prior to work commencing.

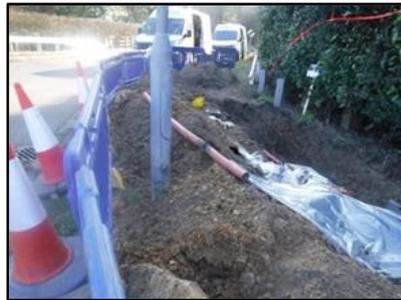
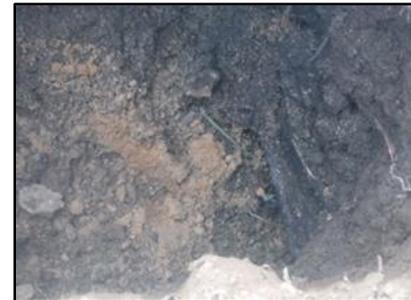
Design and pre-construction activities had confirmed a need to upgrade the existing safety fence through a prioritisation based upon potential risk presented by failure of the existing fence. On the day of the incident a supply chain partner (SCP) was driving safety barrier posts into the verge at depth determined through testing. A trial hole had been dug to confirm the position of the cable identified in the UST survey and had exposed a black cable, understood to be the HV cable in question. The SCP's own survey did not pick up any other cables in the area. On completion of the post installation adjacent to the trial hole it was identified that power had gone down in the local area which identified that the high voltage cable had been hit. Nobody was injured as a result of the situation although there was high potential for severe consequences to have occurred.

- The design did not consider in full the additional risks presented by the presence of the HV cable shown on stats plans, and the range of potential construction options to remove any risk of impact entirely.

- A LV cable was uncovered in the trial hole but was mistaken for the HV cable shown on the drawings. There is a requirement to ensure site personnel can clearly identify different types of electricity cable.

- For such activities, perpendicular trial trenches (rather than trial holes) from boundary to carriageway should be dug during the design phase at regular spacing's to ensure that all services are identified, and that none are missed.

- Detection equipment must be fully utilised (power, radio and active mode including use of genny) to maximise ability to trace such cables.

When undertaking any excavation work in the vicinity of HV cables the cables should be positively located and observed through either trial trenches or other appropriate methods (also refer to PAS128).
