# SHE ALERT

Ref: SHE H125 A 19 Ride on roller  
Issued by: Kier Highway SHE  
Department  
Date: 25/03/2019

## Overturned Rider on Roller

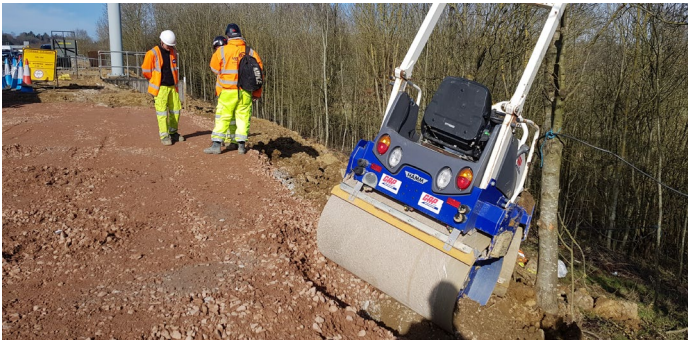
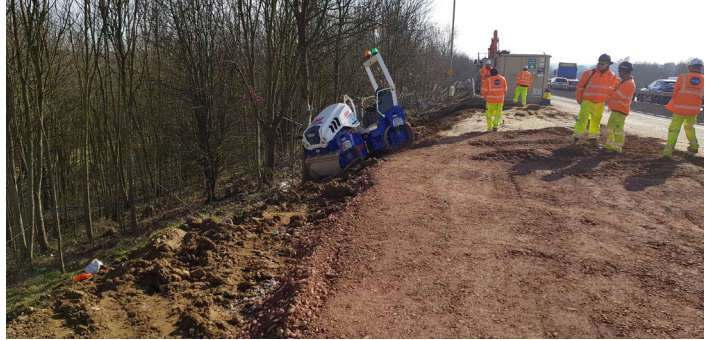
Whilst a piling mat was being constructed, which forms part of the permanent works for an emergency refuge area, an operative was compacting 150mm layers of materials driving a 2.5t, 12D Hamm, 120 ride on roller.

During compaction, the operator drove too close to the edge of the platform and as he reversed back to pass, the back end of the roller began to slip over the edge of the platform. The roller tipped over slowly on its right-hand side with the operator still at the wheel.

The roller was operating too close to the edge of the platform

No Physical measures were considered or installed to prevent the roller from coming too close to the edge

Do not operate rollers too close to the edges of slopes and embankments

Ensure physical protection is provided to prevent plant from coming too close to slopes/embankments (barriers, blocks,)

Consider the use of remotely operated compactors.

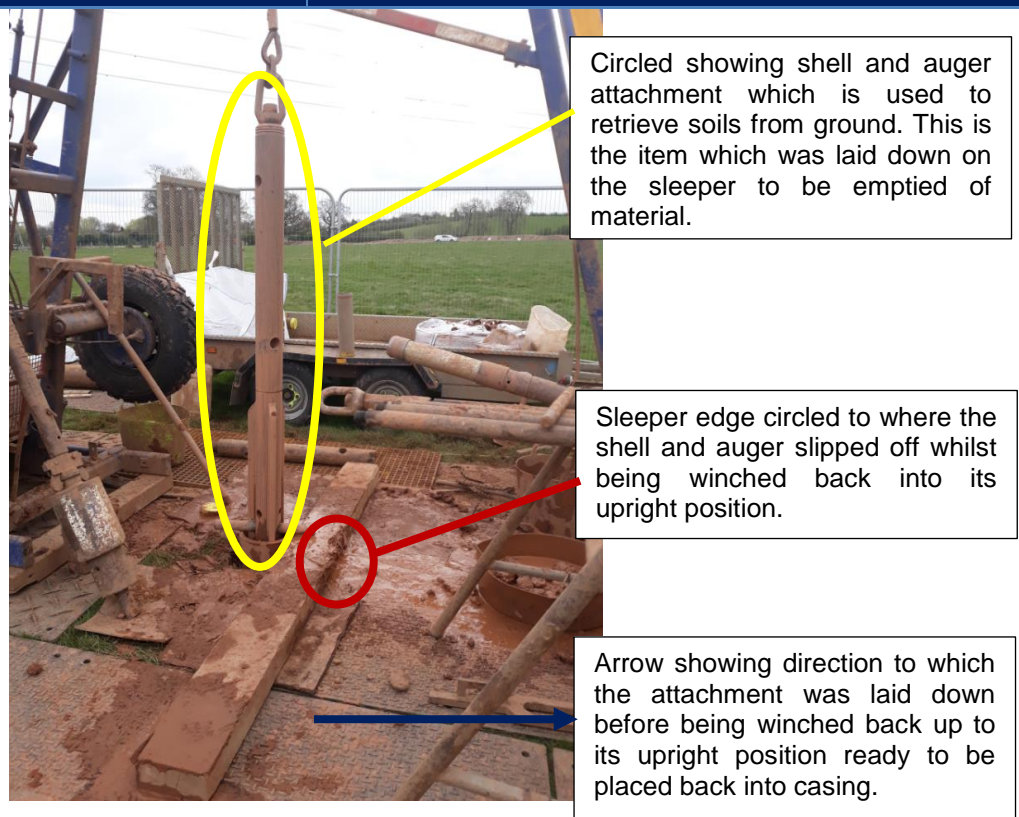
**Insert relevant photo(s)**

Whilst undertaking GI with a cable percussive rig within area B11, the team on site were undertaking a standard practice manoeuvre of laying down the shell and auger attachment to clear it of material build up post ground sample. The process for this is to winch the attachment up and out of the casing and lay it down on the raised sleeper (used to offset centre of gravity and minimise manual handling). Once the shell had been cleared the lead driller started to winch the attachment back up to its upright position to place back into the casing. As the driller's assistant was attending this, the attachment slipped off the sleeper and landed on the bridge of the Drillers assistants' left foot. The protective wellington was removed immediately but the sock left on due to there being a sighting of blood. First aid was given by lead driller with the double bandaging of the foot. The Lead driller then took the assistant to the nearest A&E where the IP was advised he had sustained a fracture.

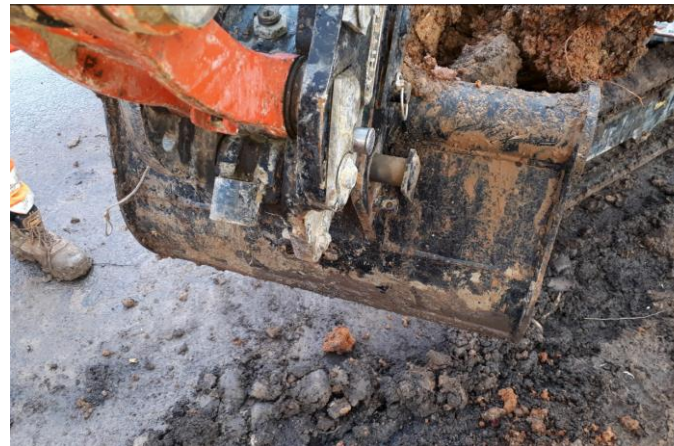
Identification during routine safety tour of a HS2 prohibited semi-automatic quick hitch on 9<sup>th</sup> March 2019. The required safety pins were not correctly installed. There was no exclusion zone for the slew area of the excavator.

The image below shows the attachment with pins not correctly inserted on a semi-automatic Quick Hitch

- Plant standards to clearly state requirements for direct attachment or attachment of accessories by "second generation" and later fully automatic Quick Hitches ("Double Claw"/ "Twinlocking" Lock Type)
- Plant Arrival checks to identify suitable Quick Hitch systems fitted to excavators
- Operators to be trained in specific Quick Hitch device and safe attachment routine
- Process to be in place for plant operators to check, test and record correct attachment of accessories in a safe area
- Dedicated and segregated areas to be established and used for storage, exchange and attachment testing of excavator attachments
- Exclusion zone to be in place which excludes all personnel from the area into which an excavator attachment can fall when in use (including in any accessory exchange area)

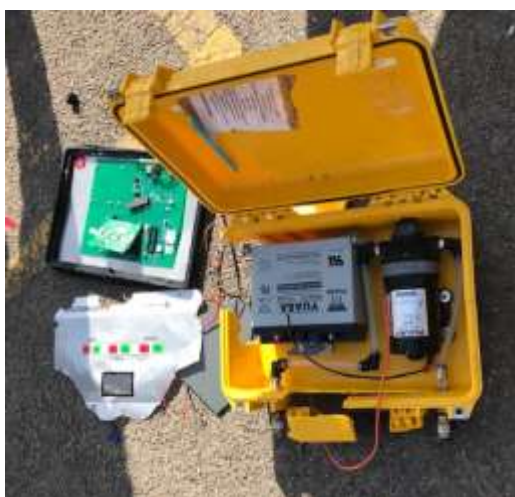
Due to an incorrect battery being fitted in this equipment a build up of hydrogen gas caused the peli case and digital circuit board to explode outwards.

Photograph shows damaged Peli case and circuit board

The plant approval certificate Plant/9585 is now withdrawn and this equipment must not be used.

Users of this piece of plant must place it in quarantine until the TfL Plant Engineering team have investigated and resolved the issues.

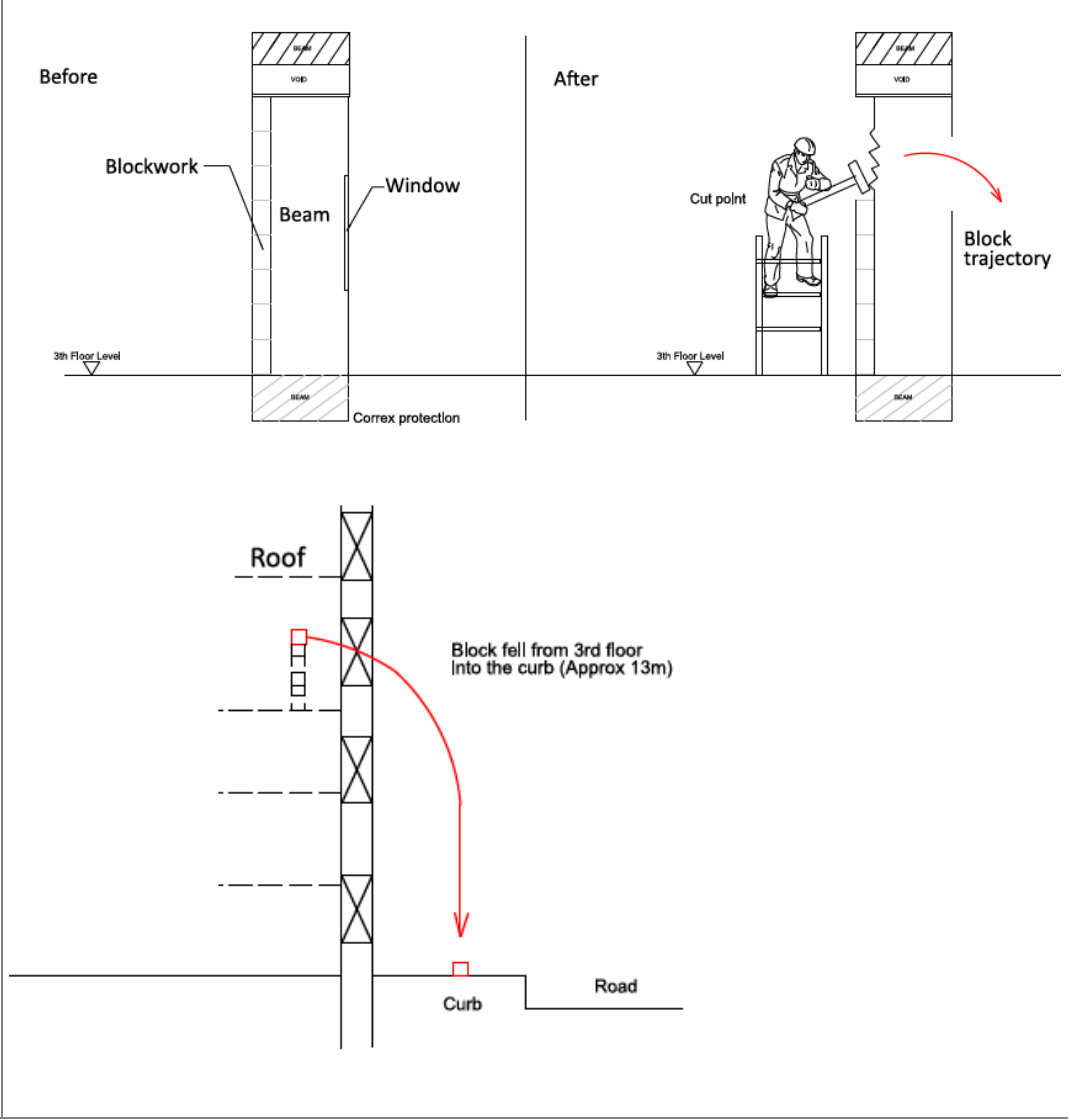
<p><b>Photos / Diagrammes</b></p>	<p style="text-align: center;"><b>Sequence of the Incident</b></p>

<p><b>Key findings</b></p>	<p>As a result of the historical and largely undocumented structural changes, there was a lack of information available to the site team to identify accurately, the layout and construction methodology of the structure, including the bathroom wall being demolished.</p> <p>The pre-soft strip survey did not identify the difference in fabrication of the walls blocking the windows. This resulted in a failure to identify wall construction and thus the incorrect selection of the most appropriate method of demolition.</p> <p>As insufficient structural information was available, the RAMS did not identify different wall construction methods and that there were windows in close proximity to walls that were to be demolished. This feed into the Task Briefings, SoS and Cascade briefings not identifying the risk of falling objects.</p> <p>The operatives had previously encountered stud walls and assumed that this wall was the same.</p>

<b>Recommendations and key points to be discussed in team talks or meetings</b>	<p>Permit to Demolish to include a check to ensure that the structure has been surveyed both internally and externally prior to sign off.</p> <p>Changes to the building make up may require hold points to be included in the methodology and supervisors approval to check the correct methodology prior to continuing.</p> <p>Knocking down internal blockwork was perceived by the operatives and supervisor as straightforward and relatively routine. Knocking down internal blockwork across three previous floors had been incident-free and reinforced the perception of 'straightforwardness' and low-risk potential. Potentially leading to behaviours of simply 'getting on with it' without assessing risks.</p>
<b>Learnings and considerations</b>	<p>Demolition "Gate" to be produced to record why the proposed method of demolition has been selected – this is to be completed and signed off by TWC and Director prior to demolition contract being signed. This "gate" would be similar to AIP, CDS or NR Form 1</p>
