Safety Alert

Lighting column corrosion

30 August 2024

NHa354

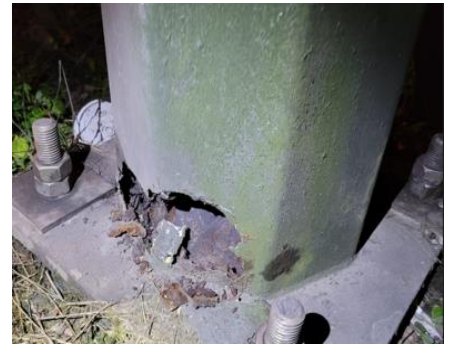
- During cyclic inspection and testing, 50 steel lighting columns have recently been cut down in one location on the strategic road network due to severe corrosion and loss of section. (Batch testing on 246 similar aged columns identified 45% of as amber or red).
- The steel columns were aged over 35 years and generally located in an exposed environment. Previous inspection reports were unavailable.
- Columns had corroded internally, either at or below ground level for planted columns, or just above the welded connection for flange plated (FP) columns. Corrosion to the FP column was internal and may not be apparent from inspection alone.

- Robust inspection and testing is essential to manage structures approaching service life end. The risk of corrosion failure increases with age (generally >30 years) and columns have a finite life. Untested installations should be prioritised for non-destructive testing in accordance with National Highways standards and procedures. See [GS801](#).
- The type and extent of any testing should be pertinent to the defect under consideration, i.e. corrosion could be missed if testing checks are not undertaken around the whole column circumference. Testing guidance is available within [ATOMS](#).
- The effect of corrosion reducing the structural thickness of the column wall should be considered by expert review, and where necessary analytical assessment.
