# Safety Alert

## Tipping Mechanism Mechanical Failure

## Tipping Mechanism Mechanical Failure - Update

Event Location: M27 Overlay Scheme

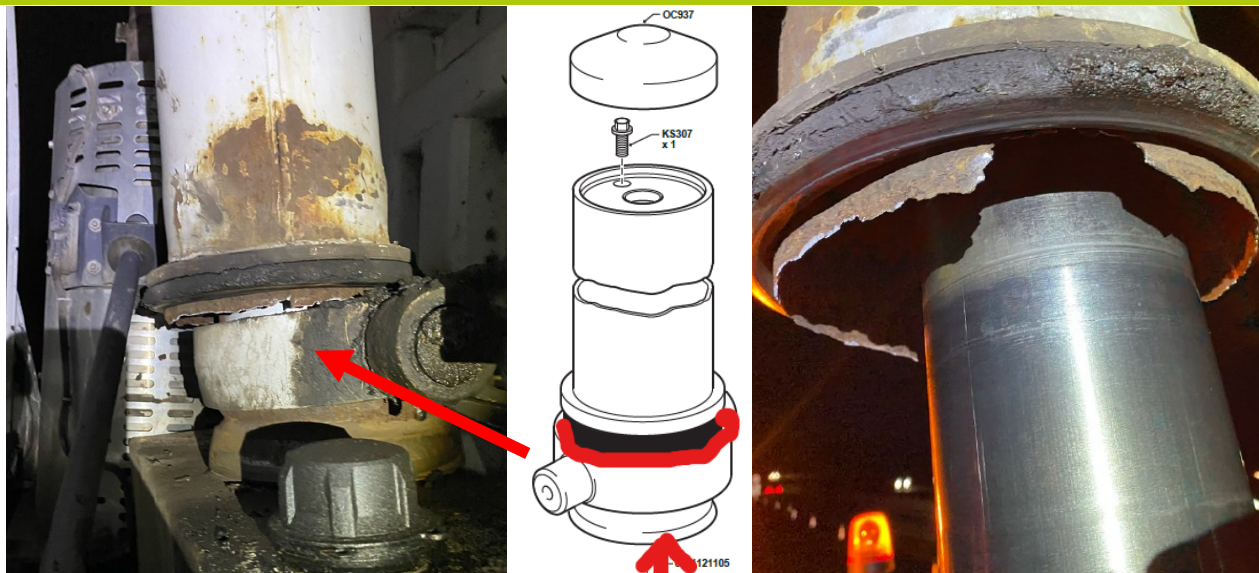
The failure appears to have occurred due to a fracture of the lower section of the outer cover, which supports the main ram

Subsequent inspection confirmed that the failure originated from severe internal corrosion within the outer sleeve of the hydraulic tipping mechanism. This corrosion had significantly reduced the wall thickness, leading to structural failure under normal tipping load.

A Mechanical inspection, supported by Edbro (manufacture) and Specialist, confirmed that the tipping mechanism sleeve failed due to internal corrosion. This corrosion developed following water ingress through the trunnion joint seal, reducing the wall thickness of the sleeve leading to structural failure during tipping.

- Where vehicles are manufactured before 2016 with Edbro tipping mechanism, ensure they are inspected by a competent engineer to confirm the integrity of the outer sleeve.
- Check for any corrosion, flaking paint, or pitting around the outer cover section.
- Ensure visual pre-use inspection for oil leaks, cracks, corrosion, or unusual movement at the ram base.
- Report and isolate any vehicle showing damage or signs of instability.

- Affected vehicles (registered 2015 or earlier) should be VOR'ed (Vehicle Off Road) until replacement sleeves or confirmed safe operation has been verified.
