| <b>Reference</b> | SA_20260311_2 | <b>Version</b> | 1.0 | <b>Date Issued</b> | 12/03/2026 |
| <b>Subject / Title</b> | Incorrectly wired secondary cut-out | | | | |

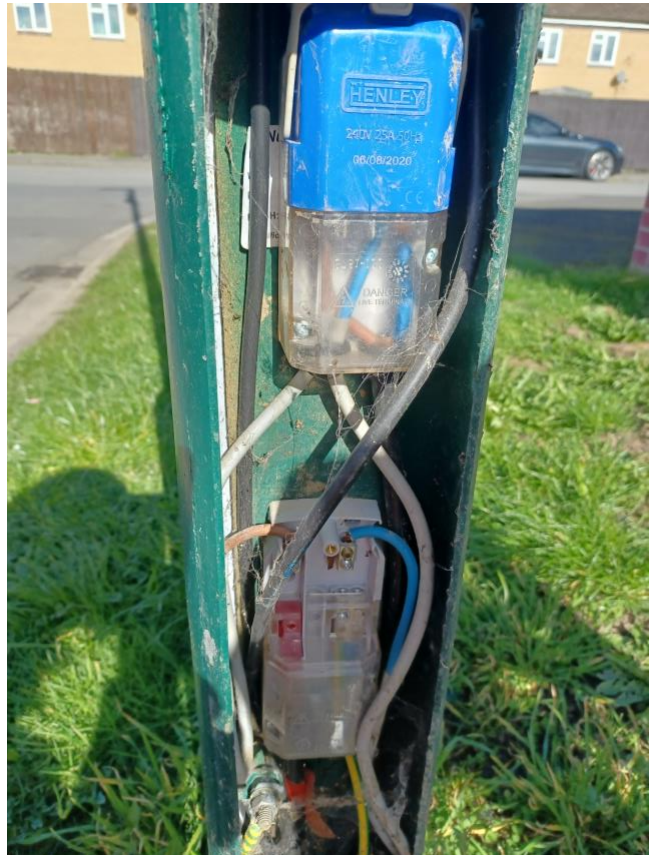
Although no injury was sustained, this incident had the potential to result in serious harm. Further examination identified that the DNO supply had been terminated into the incoming side (bottom) of the top cut-out, and insulated and sheathed tails within the same termination supplying the outgoing side (top) of the bottom cut-out.

As a result, those outgoing terminals on the lower cut-out were live. It was also found that the incoming side (bottom) of the bottom cut-out had in fact been used to supply an outgoing circuit. In effect, both cut-outs had been terminated incorrectly. This created a hazardous condition for any operative carrying out inspection, testing, maintenance or further connection works, as conductors that may have been assumed to be dead when in fact live.

- All operatives involved in inspection, testing, installation, alteration and commissioning of associated street furniture equipment and installations must ensure that incoming and outgoing terminations are positively identified and verified before any work proceeds or equipment is energised or re-energised.
- The alert is therefore intended to reinforce the importance of not assuming existing wiring arrangements are correct, even where equipment has already been installed.
- Any abnormal or unsafe wiring arrangement identified on site must be treated as a defect and escalated for technical review before work continues.
