Soil Nailing the A610 at Buckland Hollow, Derbyshire

Example of Collaborative Project Delivery

MHA Annual Conference 2018

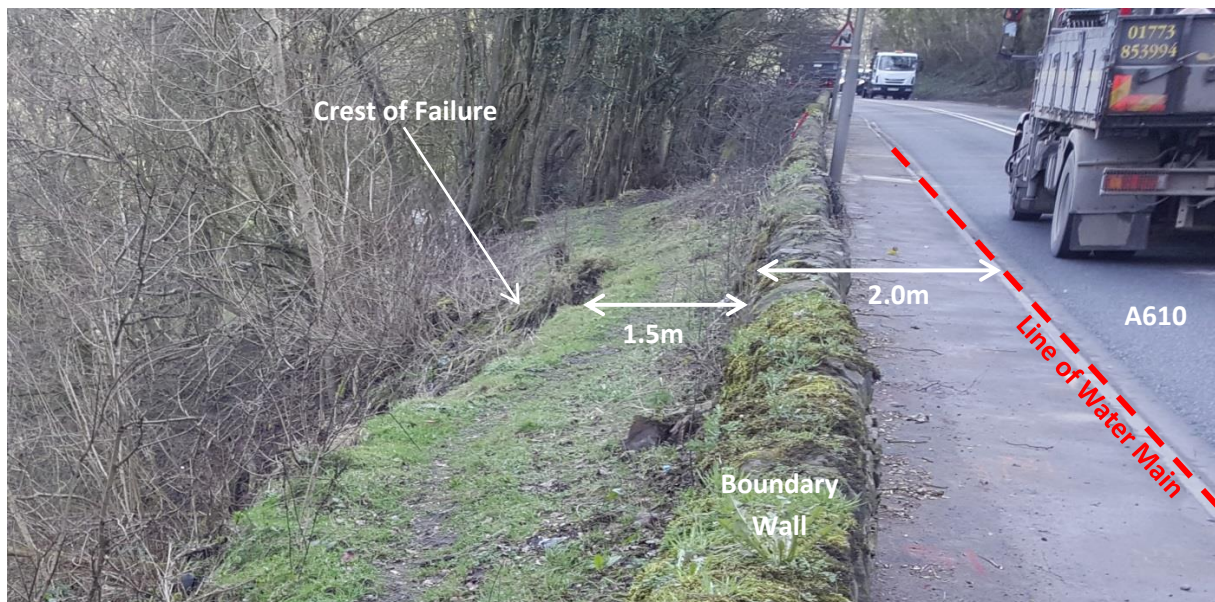
Figure 1 – Crest of Failed Slope

The inspection found that a shallow translational failure had occurred over a 10 m section of the slope below the road, completely removing the root zone and exposing bare ground beneath. Vegetation and earth was piled in the river, which lay directly at the toe of the slope. Due to the risk of the now bare and extremely steep slope eroding back the short distance to the infrastructure beyond, AECOM determined that the failure posed a significant risk to the future integrity of the road and water main.

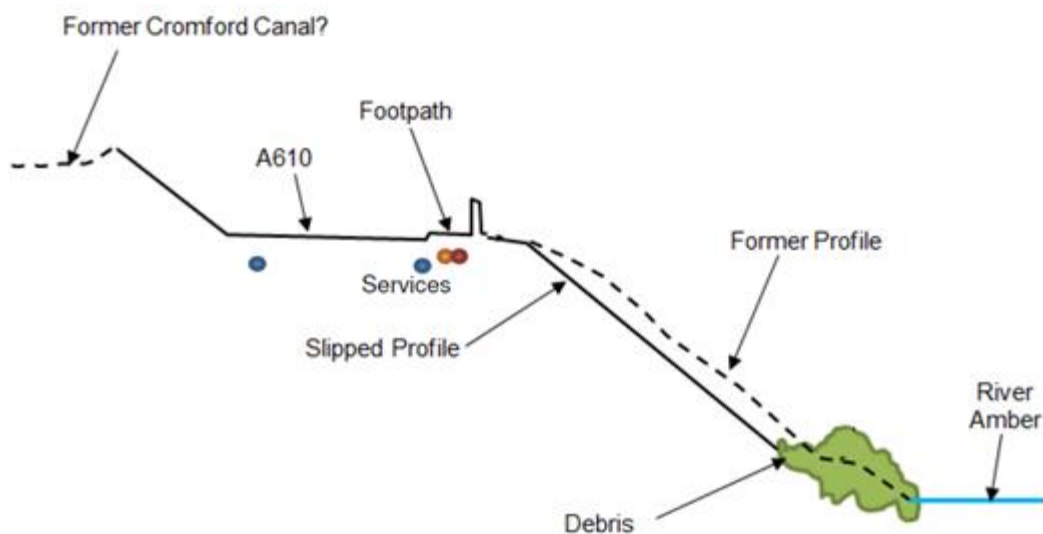
Figure 2 – Sketch of Failed Section

- The likely cause of the failure was saturation of the root zone by heavy rain, in an area of slope where few trees were present to provide deeper mechanical anchoring with their roots.
- The ground at the site comprised sandy gravelly clay, considered to be a colluvial material derived from sandstone bedrock higher up the river valley. Bedrock was only found to be present at around river bed level.

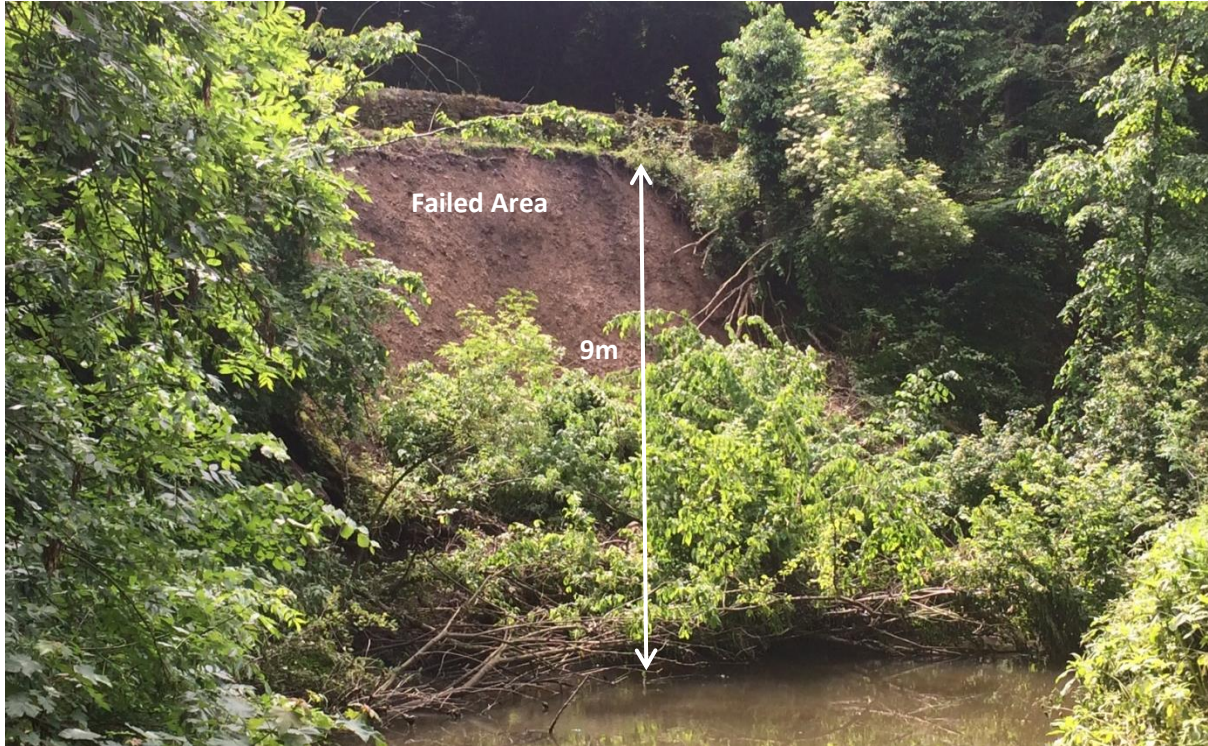
Figure 3 – View of Slope Failure

This information confirmed our initial assessment and the risks to the infrastructure, and that a total slope length of 40 m above the meander could pose a risk of similar failures in future. As a result, AECOM and DCC agreed on a full slope remediation.

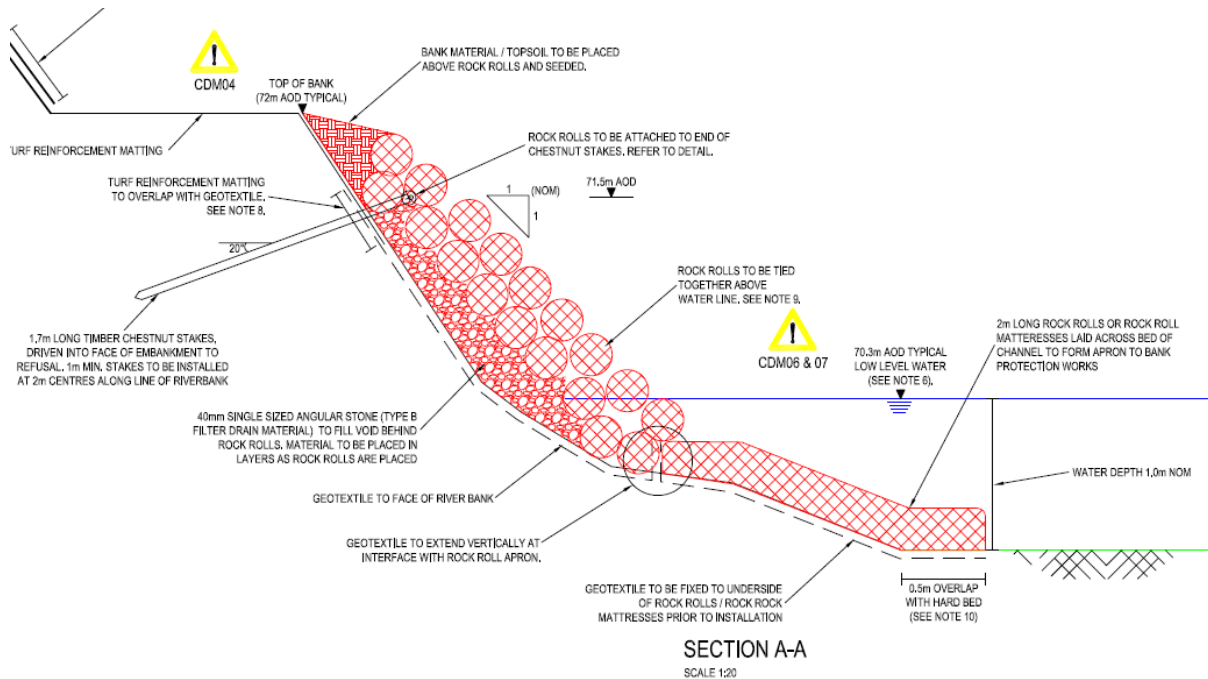
Figure 6 – Erosion Protection Solution

Although it was concluded that the river had not directly contributed to the June 2016 failure, it was considered that it still had significant potential to erode the toe of the slope. Only treating the upper part of the slope would therefore not be a sustainable long-term solution. As such, AECOM's water

Based on consideration of buildability, long-term stability and environmental impact, AECOM recommended rock-rolls as the most appropriate form of erosion protection. These comprise a roughly 2 m long geogrid tube filled with stone. Whilst soft protection options were explored, it was considered that these would not provide a viable long term solution due to the steepness of the river banks and potential difficulties with installation due to access constraints. The rock-rolls were also considered to provide a solution that would be safer and easier to install than conventional rip-rap. They also present a better habitat for ecologically beneficial vegetation growth.
