# Key Lessons

## Title Fire within Asphalt Plant

**Site:** Wembley Asphalt Plant

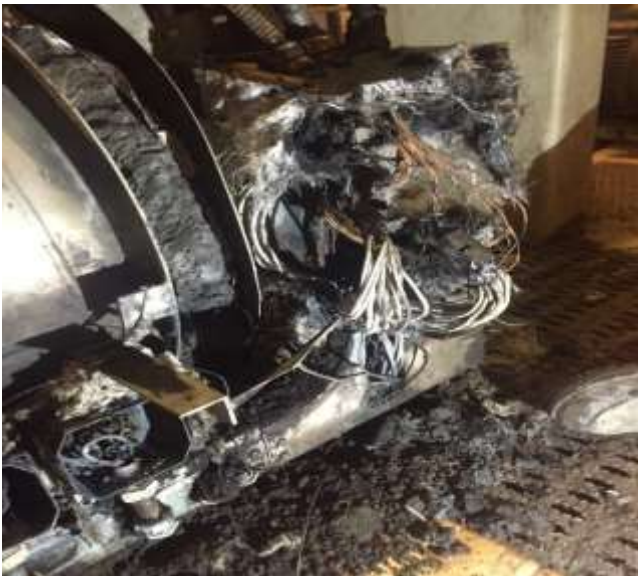
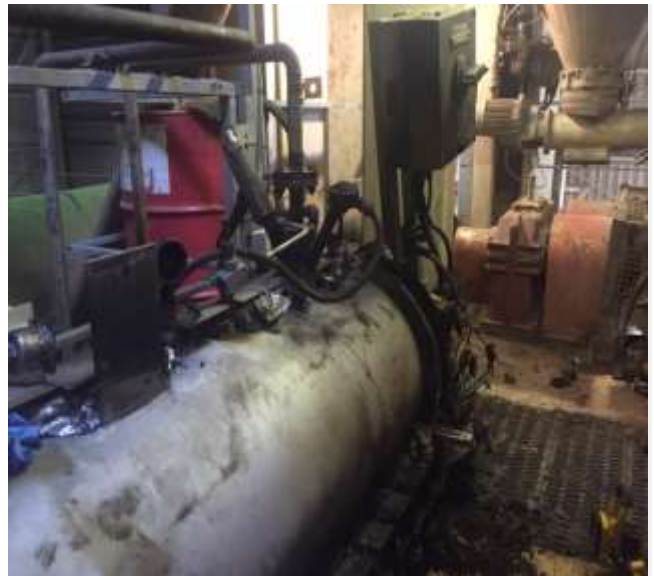
At just past midnight on the 11<sup>th</sup> May, a small fire broke out on the hot oil trace heating system at Wembley Asphalt plant. At the time a contracted security guard and electrician were at the site, the latter of which was investigating a low temperature warning that alarmed on the trace heating system. The fire broke out on the first floor landing, and was detected by both security guard and the electrician. The Plant Manager was indicated and he instructed that they should not tackle the fire and call the fire brigade. The fire brigade arrived promptly, and they were provided the fire grab pack for the site, this enabled the fire service to act quickly and the fire was extinguished by them.

Following the detailed investigation, it is believed that the fire was a consequence of electrical wires being loose in a terminal block that ignited loose fibres underneath the hot oil tank. These fibres had accumulated as a result of blockages in the fibre addition system, which is above the hot oil system on the floor above. These fibres are very flammable as they are paper based. The loose electrical connection may have occurred over time as a result of plant vibration.

- Asphalt Fibres are a fuel source for fire, ensure they are stored in an area that cannot be ignited.
- Carry out more regular checks of electrical connections to terminals where vibration issues could result in a loosening of connections. This should be as per your ESMS standard risk assessment – wiring in such conditions is of higher risk in areas subject to vibration.
- The system at Wembley has two independent thermostat's – although they did not act as a safety device in this incident, it is advised that all hot oil trace heating systems should be fitted with 2 independent thermostat's.
