INTERNAL SINGLE SKIN WALL COLLAPSE

Outline of Incident

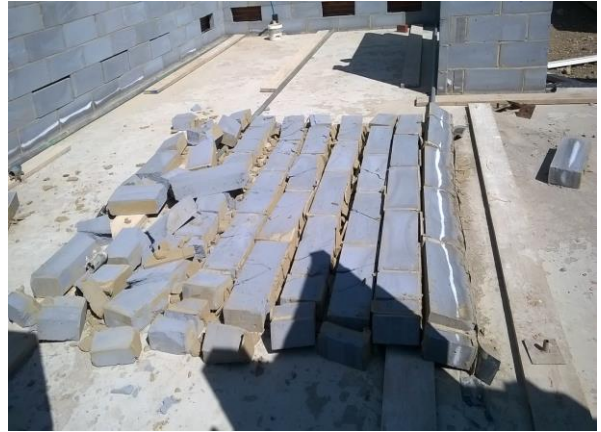
This alert has been produced following a recent incident in the Linden Homes Division where a single skin blockwork internal wall collapsed, injuring a Scaffolder who was erecting the internal bird cage scaffold.

The wall had been built on a 100mm standard damp course membrane, five blocks long and nine courses in height. No returns or lintels were in place and the temporary bracing had been removed prior to the incident.

1. Bricklayers to **stop laying** after building up to six courses
2. After **24 hours** the Bricklayers to progress wall to full height (underside joist) using proprietary access equipment and ensuring that all lintels are installed.
3. Access to the plot is to be prevented until the mortar has cured.

Any wall left in an unsupported condition, either by design or build sequence, **must** be treated as temporary works and have the appropriate temporary works support.
