SAFETY ALERT

OVERTURNING of ARTICULATED LORRY

An incident occurred on the project recently that resulted in an articulated lorry overturning adjacent to the A8 dual carriageway.

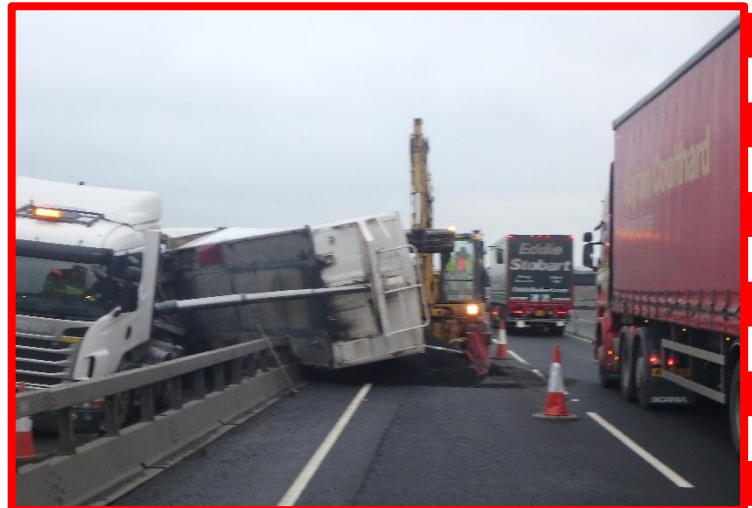
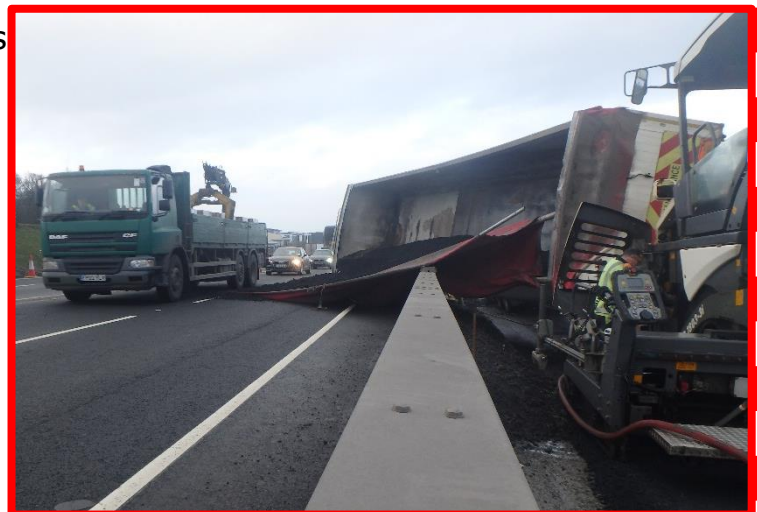
The exact causes are yet to be determined however preliminary findings suggest mechanical failure of the tipping mechanism on the vehicle.

- Tipper lorries must be strictly controlled regardless of the operation being undertaken.
- Exclusion zones must be established, maintained and strictly enforced wherever tipper lorries discharge their load.
- Where articulated lorries are employed no other works or public interface may encroach into their overturning radius.
- All operations must follow the approved safe systems that have been agreed and briefed to those on site.
