## RIDDOR: Specified Injury, Hip Fracture

iSMS Number:	677798	Client:	St Helens Borough Council
		Subcontractor:	Worrall & Batty (W&B)
Date:	13/09/2022	Time:	17:00hrs
SBU/DU:	UKCS Regional Civils - North West DU	Project:	CRMMS021   Parkside Link Road Project

## RIDDOR, Specified Injury: Fractured Ankle

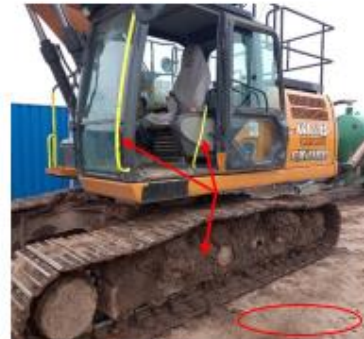
W&B are a specialist drainage contractor. The gang had completed their day's activities and returned to the Eastern Satellite compound to park up in the designated plant storage area. The operator of the 20t excavator isolated his machine and prepared to dismount from the cab, using the designated access/egress point. The IP's foot slipped on the heavily mudded step causing him to fall.

Access/Egress Points – IP Location after fall

- A toolbox talk has been drafted and briefed to ensure safe access/egress is in place, three points of contact are used, and all access steps are inspected and free of obstructions prior to access/egress.
- Ensure regular plant checks are completed to ensure cab access/egress points are free from obstructions.
- Ensure hi-visibility access steps and handrails are compliant with BB Plant Specifications.
- Where there is the possibility of mud/debris obstructing steps/safety features of plant, implement a system where work colleagues check them before the operator exits the vehicle.

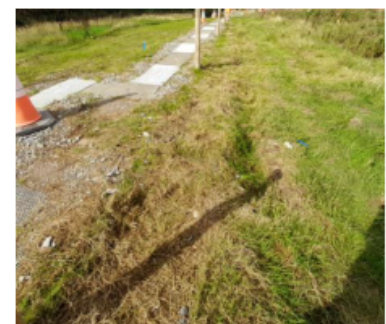
A chain-person, working with the survey team, was involved in checking monitoring stations for the Esso Pipeline at the Bromford East Portal. While walking between survey points carrying the survey staff and a bamboo stick, he inadvertently placed his foot into a wheel rut causing him to go over on his ankle.

The IP had received a full briefing and point of work risk assessment and was wearing serviceable boots that were fully laced up. The wheel rut was ankle deep and partially camouflaged by vegetation (grass), but it was still clearly visible to pedestrians.

- Review opportunities to allow remote monitoring of survey stations
- Conduct an audit of access routes including footpaths, work areas, steps in/out of plant and welfare.
- Remind everyone to use footpaths where provided. and raise observations where there are ruts, holes, trip hazards or obstructions.

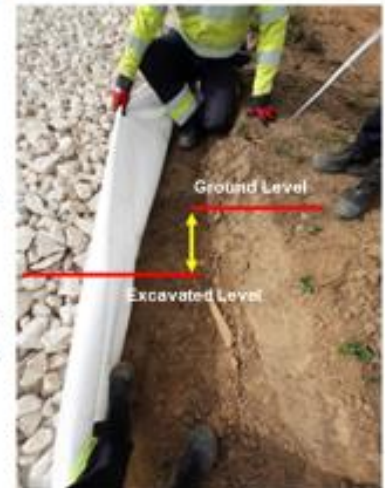
GPC, had completed the rolling out of terram geotextile during haul road construction. The IP stepped down a height of approximately nine inches, onto the terram (in the 'void' area where no stone is laid), and rolled their right ankle.

- Area of the incident has been checked for specific slip and trip hazards; none were found
- There is an increased risk of injury when stepping into an incomplete haul road where designed voids are present.
- Viking Link team had achieved 532 days LTI free until this point – we need to ensure our relentless focus on all aspects of HSES remains including the risk of injuries from slips and trips.
