Health & Safety Alert No. 92

Galliford Try Plc Group of Companies

27th January 2016

Fatal Injury on a Major Contractor's Site – Plant Interface

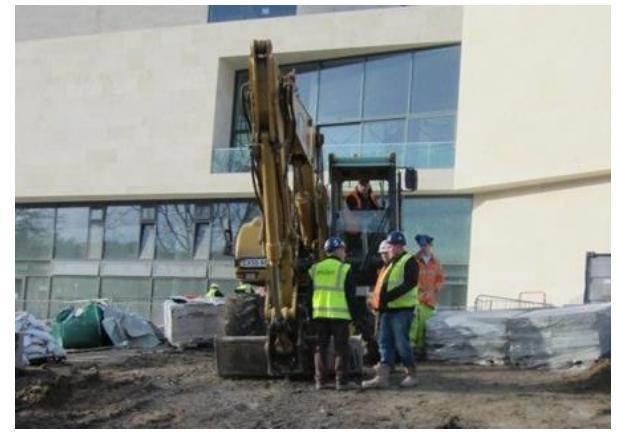
The incident involved a 14t wheeled excavator that had been refuelling from a static bunded "fuel" tank.

It is believed that the plant operator, having completed refuelling, slewed the cab 180 degrees to drive back to his workplace and the supervisor was trapped between the counterweight at the back of the machine and the fuel tank.

- Their plant/pedestrian traffic plan is sufficient to ensure that people and plant interface has been reduced to a minimum and that suitable segregation is in place.

- All activities involving plant, including refuelling, have been risk assessed to ensure suitable and sufficient control measures are in place; and relevant people have been briefed.

- Safe areas with sufficient space have been designated for refuelling and for operators to complete their daily safety checks.
- The appointed vehicle marshals/banksman competency has been checked and they are trained, experienced and competent.

- Where necessary exclusion zones are in place and people know to only enter the zone or approach mobile plant when the item of plant is immobilised.
- All excavators are equipped with adequate visibility aids to ensure drivers can see areas where people may be at risk from the operation of the machine.

- Suitable and sufficient lighting arrangements are in place for the duration of the working period.
- Plant selected to work in confined areas has minimal tail swing

• A clearance of at least 0.5m must be maintained between any part of the machine, particularly the ballast weight, and the nearest obstruction.
