# Critical Incident Notification

## Electrical Conductor Rail Burnout

**Site:** Eastleigh Rail Depot

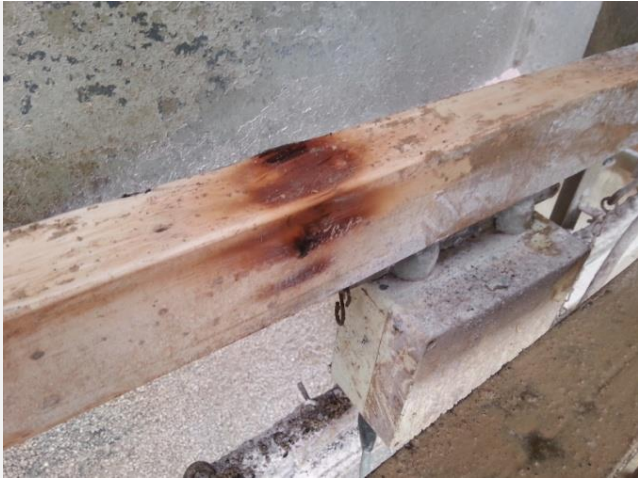
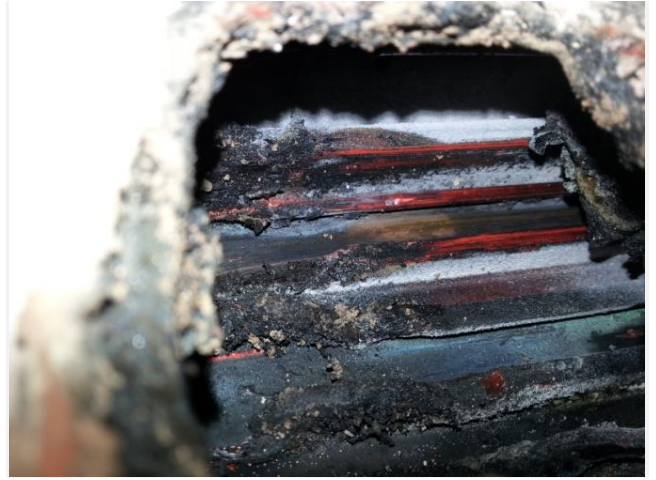
The system was immediately isolated and following inspection a failure on the AKAPP conductor rail, between the pickup trolley and conductor rail was identified.

The pickup trolley brushes were found to be in good condition; however the conductor rails were heavily corroded, poorly aligned and caked in carbon.

- ESMS and BV inspections do not cater for planned preventative maintenance (PPM) requirements
- PPM arrangement should be established at a site level in accordance with manufacturer's recommendations (along with site experience) for all electrical equipment, especially items such as conductor rail systems which consist of wearing parts
- There must be a clear and documented strategy (site level) for ongoing replacement of equipment reaching the end of its serviceable life
- Conductor rail systems should be protected by earth leakage devices
- Consider the use of a cleaning tool to ensure carbon build up and corrosion is kept to a minimum
- Routine 6 monthly thermographic surveys may be able to detect hot spots on some systems assisting with early failure identification
