Critical Incident Notification

Collision between D8T bulldozer & Light Vehicle

Site: Bardon Hill Extension - Project Sence (UK Aggregates)

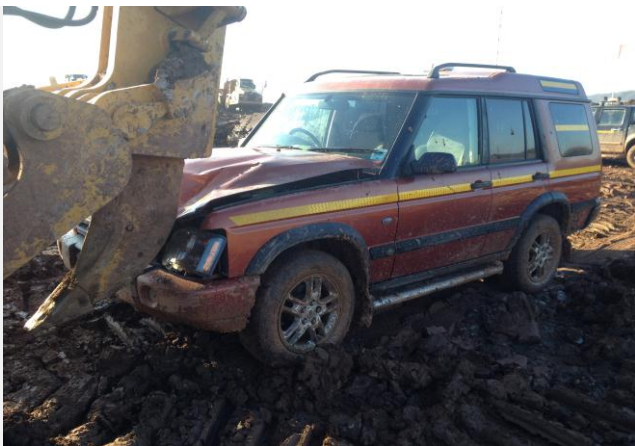
On Wednesday January 20, 2016, at 9.15am a Caterpillar D8T Dozer reversed into a parked Land Rover Discovery which was a site vehicle on the Northern Landform at the Bardon Hill Extension (Project Sence) in the United Kingdom.

During placement of fill materials on the Northern Landform a CAT D8T dozer owned and operated by Walters Plant Hire Ltd and driven by their operative reversed and into a light vehicle (a Land Rover Discovery) owned and operated by Walters Plant Hire which was being driven by a works Supervisor. The Supervisor had travelled to collect the CAT D8T operator from an agreed meeting point on the work site to return him to the Contractors Compound. The Supervisor proceeded past the agreed meeting point, without positive communication from the Operator, to the dozer as it was stationary in its work area. The Supervisor parked the light vehicle to the rear of the dozer and waited for the Operator to exit the dozer. The dozer then unexpectedly reversed from a stationary position into the stationary light vehicle. The Supervisor was sitting in the driver position of the light vehicle when the impact occurred. Nobody was injured in the incident, however the light vehicle sustained significant damage to its front as a result of the impact of the ripper fitted to the rear of the dozer.

Recreation of incident scene

- First consideration should be segregate light vehicles from heavy plant, where possible
- Where this is not possible, safety zones around all mobile equipment (parked or operating) must be maintained, with minimum separation distances formally established for both operating and stationary equipment
- Radio protocols to be reinforced with control of immediate areas around heavy equipment in the control of the equipment operator
- Approach procedures to be reviewed with the use of positive affirmation to approach heavy equipment from the vehicle operator
- Procedures revised to reinforce the use of all available visual aids (mirrors, cameras, direct vision)
- Review of “start up” direction for individual equipment types, ideally this should be first move forward

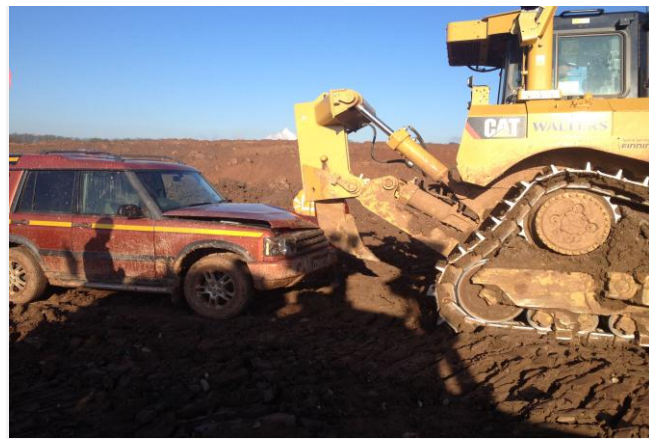
- The Land Rover Discovery was (clearly) visible in the reverse camera, the operator did not look at this prior to reversing
- The Operator energized the CAT D8T and immediately reversed
- The Supervisor sounded the horn of the light vehicle warning the CAT D8T operator what was happening.
- The dozer Operator immediately stopped and de-energized the CAT D8T
- When the CCTV system initiates a message comes up with information from the manufacturer, this makes the picture difficult to view

Recreation of incident scene
