Critical Incident Notification

Slip of material on stockpile engulfed Bulldozer

Site: Glensanda Quarry – Primary Stockpile

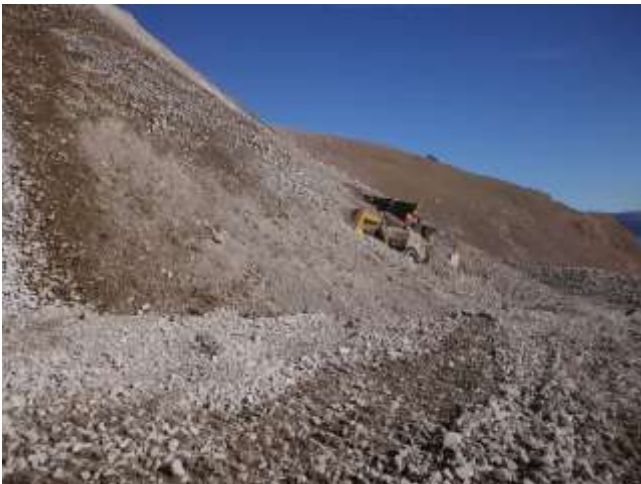
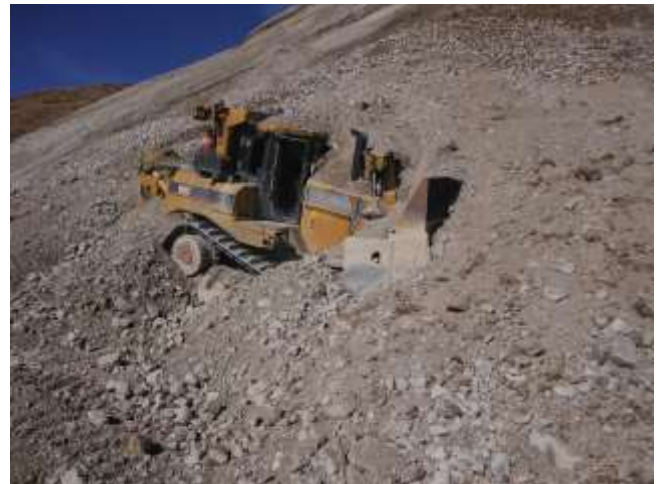
The task was reassessed on Tuesday 13th. Following the briefing the operator was taken to the work area to commence work. No issues were noted by either the operator or the Shift Manager and work commenced. The Shift Manager visited the area to check on progress at 1000 with no issues observed or raised. At 1140 the Shift Manager received a call on the radio from the operator advising that the D9T had become trapped by a slip of material on the stockpile. He immediately attended the site and the operator was able to leave the machine without having sustained any injury.

- The breakdown of the Primary conveyor led to the requirement to push material into the stockpile feeders.
- Correct process was followed with respect to carrying out of Risk Assessment and Method Statement.
- Flawed decision making allowed the D9 dozer to be used in an area too close to a high face.
- Machine selection not appropriate for conditions on day of incident. Dozer should not have been working at the level on the stockpile it was.
- The Shift Manager had received L3 Geotechnical training.
- The contractor's operator was experienced on dozer operations, had carried out the task on a number of previous occasions but had no L2 Geotechnical training.

- Although the risk assessment for the task was reviewed dynamically the process did not fully consider the prevailing condition of the stockpile at the time.
- The task had become 'routine' due to disruption to Primary production associated with the delivery and commissioning of the new primary crushing plant.
- Complacency had become a factor due to the previous point.

- Operations suspended pending review of procedures, risk assessment and method statements.
- Situation reviewed by EXCO Director, Senior Management, H&S & Geotechnical departments.
- Reviewed competence of mobile plant operators and managers.
- Refresher Geotechnical training organized for all managers and operators.
- Specific training package for large stockpiles and tips to be developed by Geotechnical department for delivery to appropriate personnel.
- Review of Geotechnical Assessments for management of stockpiles to be carried out clearly identifying suitability and limitations of available equipment for intended tasks.
