Safety Alert

Road Bridge Crane Strike

HI-POTENTIAL NEAR MISS CRANE STRIKING ROAD BRIDGE

Lifting Chains failure

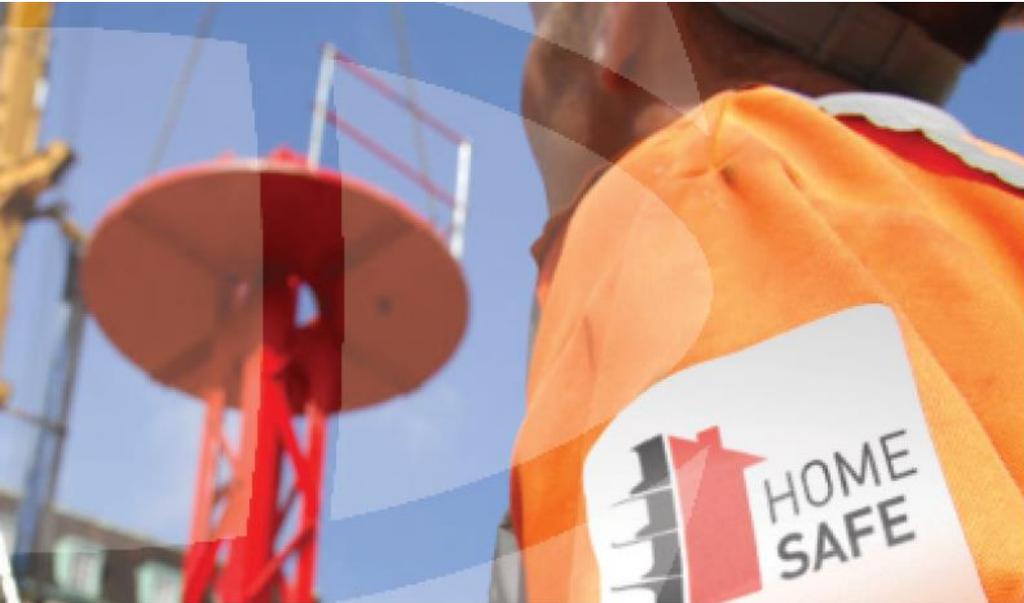
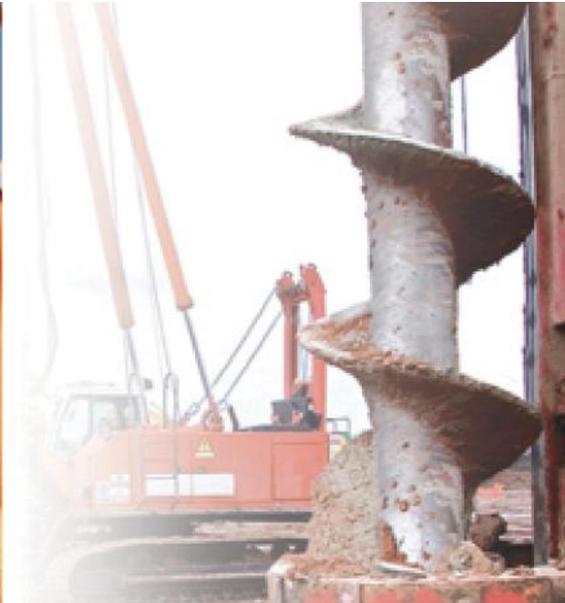
At 16:07 on the 18th February 2019 a mobile crane struck a bridge while exiting the site along the hard shoulder of the M49 Motorway.

Once instructed by the crane operator he was no longer required, the CSSS left the immediate area at 15:50 to conduct other works. Immediately before the time of impact the crane was witnessed travelling along the hard shoulder of the M49 with the jib still erect. The CSSS along with other site staff tried to warn the crane operator the mast was still erect but unfortunately the driver did not respond resulting in the jib striking the bridge deck.

- All crane supervisors must always remain with the crane whilst it is rigging/derigging or lifting.
 - The above will also apply to all haulage companies delivering/removing plant from our work sites.
 - All VM supervisors are to check with the operator/driver of subcontract plant equipment or haulage before it leaves their worksites, that they have conducted a visual inspection to ensure they have stowed and secured their equipment correctly before it leaves.
 - Debrief of all supervisors on the start of shift briefings with regards to capturing roles and responsibilities and supervision of subcontractors.
 - Other recommendations have been made to crane supplier regarding the fitting of additional alarms and post de-rigging inspections before they leave site.
-

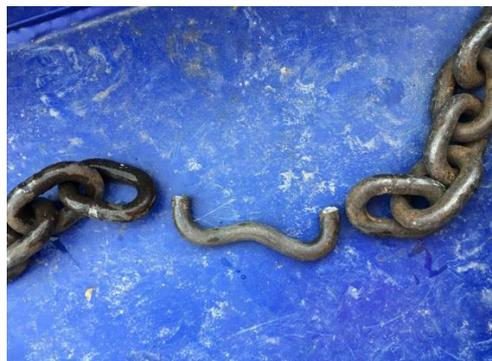
Photo A

During a routine lifting operation on site a 13mm Grade 8 chain with a SWL of 5.3 tonne failed at a weld on one of the links, with a load of less than 2.5te (Photo A).

There was no deformation either side (i.e. no warning) of the link that snapped as can be seen in Photo A, of the actual chain that failed.

With immediate effect, all chains manufactured by “Force” must be quarantined until further notice. **This applies to all Severfield construction sites and factories.**

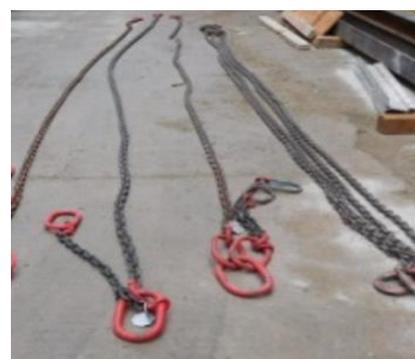
Photo B

The chain was quarantined and sent for examination by a metallurgist and all 13mm chains by the same manufacturer (Force) were traced through orders (6 months either side of the supply of the failed chain) and quarantined (Photo B, Similar chains on site).

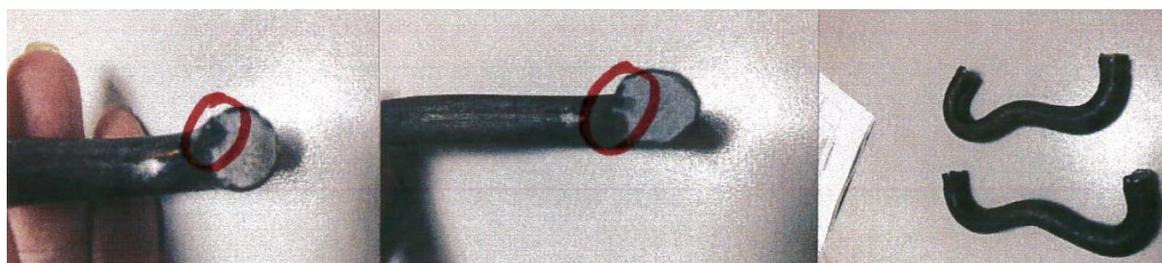
Photo C shows a slight inclusion in the weld on the additional part of chain that was tested, which is like the failure identified at the original site incident.

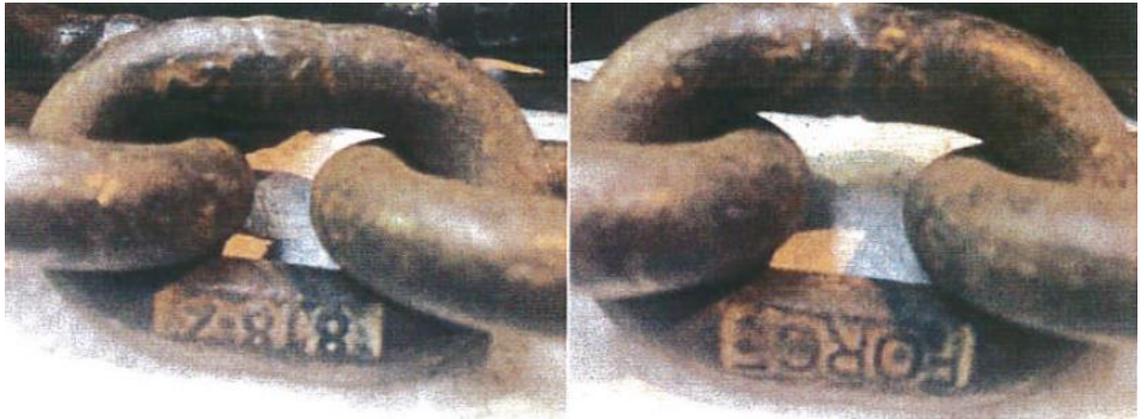
Photo D

Force chains are stamped on every tenth link on the chain (If there is an ID tag this does not display as these get damaged over time) as below Photo D.

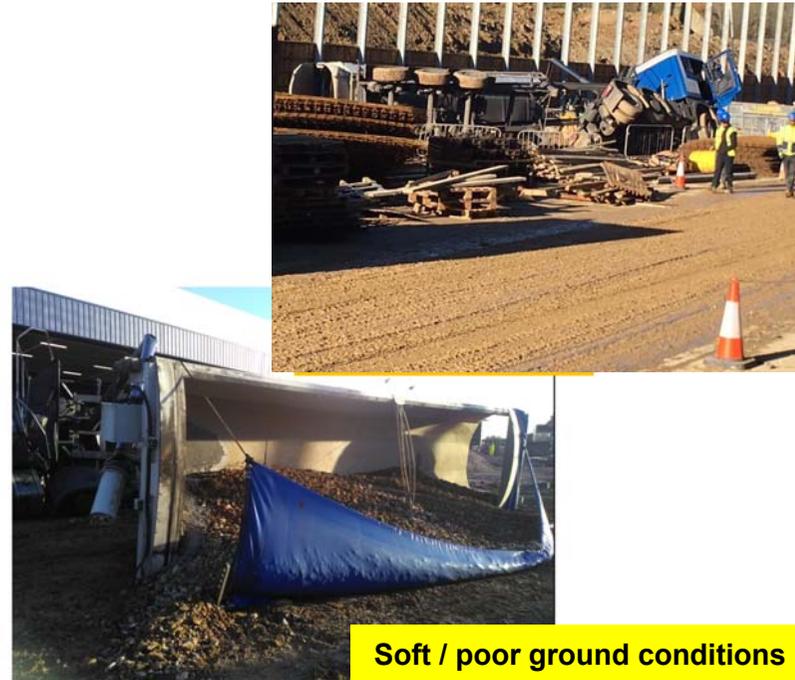
A contract tipper driver was delivering to an external customer site with an articulated vehicle. The driver proceeded onto site to the tipping area and his reverse manoeuvre was assisted by the site banksman. After discharging between 6/7 ton, the vehicle overturned onto the near side. Fortunately, the driver did not have any injuries and no other vehicles or people were within the exclusion zone at the time of incident.

Soft / poor ground conditions

- The driver should have checked the ground conditions before tipping the material.
- The hazard of an uneven or soft tipping area should have been highlighted by Banksman or during a site induction.
- The Artic unit should of been in line with the trailer vehicle and unsheeted before tipping material.
- The fitment of an audible inclinometer could have warned the driver it wasn't safe to tip
