# Development of a 'Bus Biased' Corridor

Midlands Highways Alliance

September 2025

AECOM – Mark Stapley

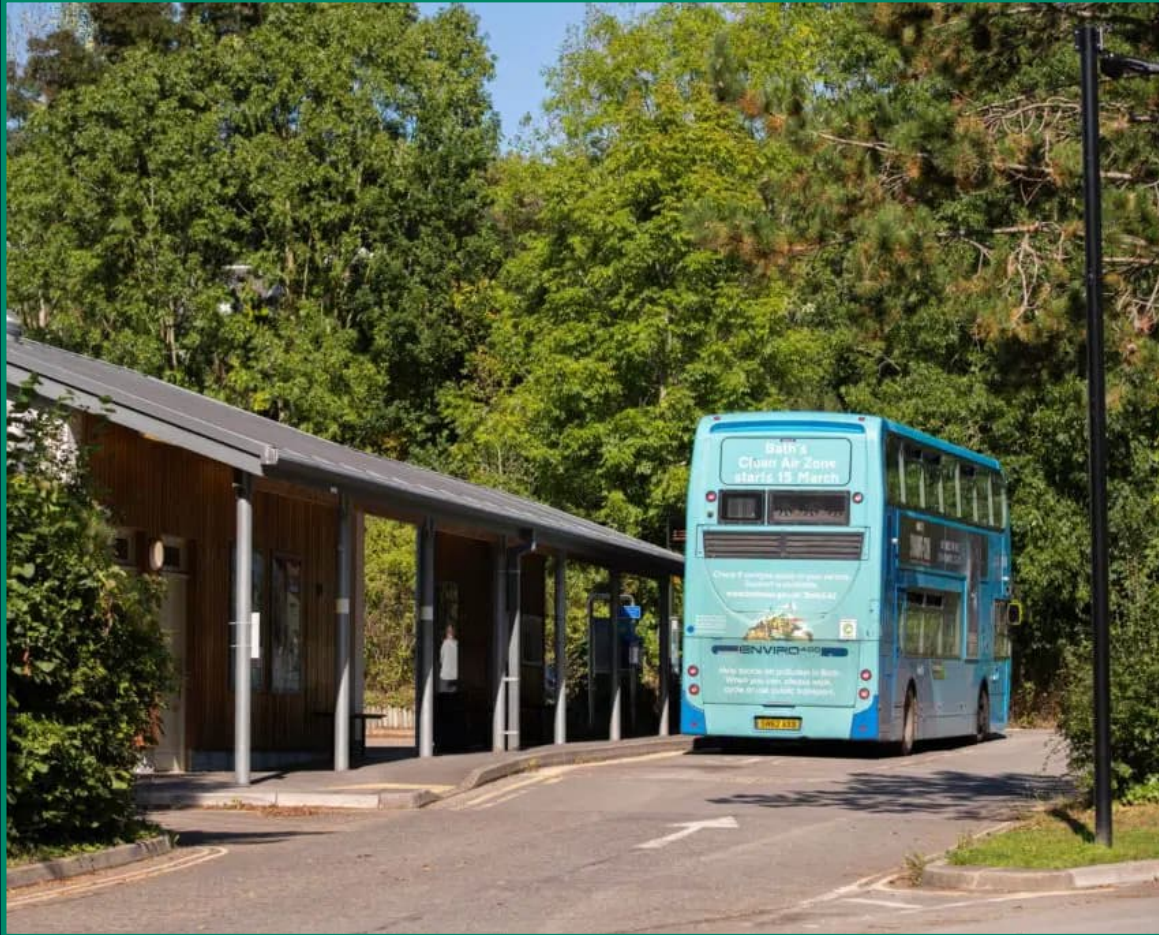
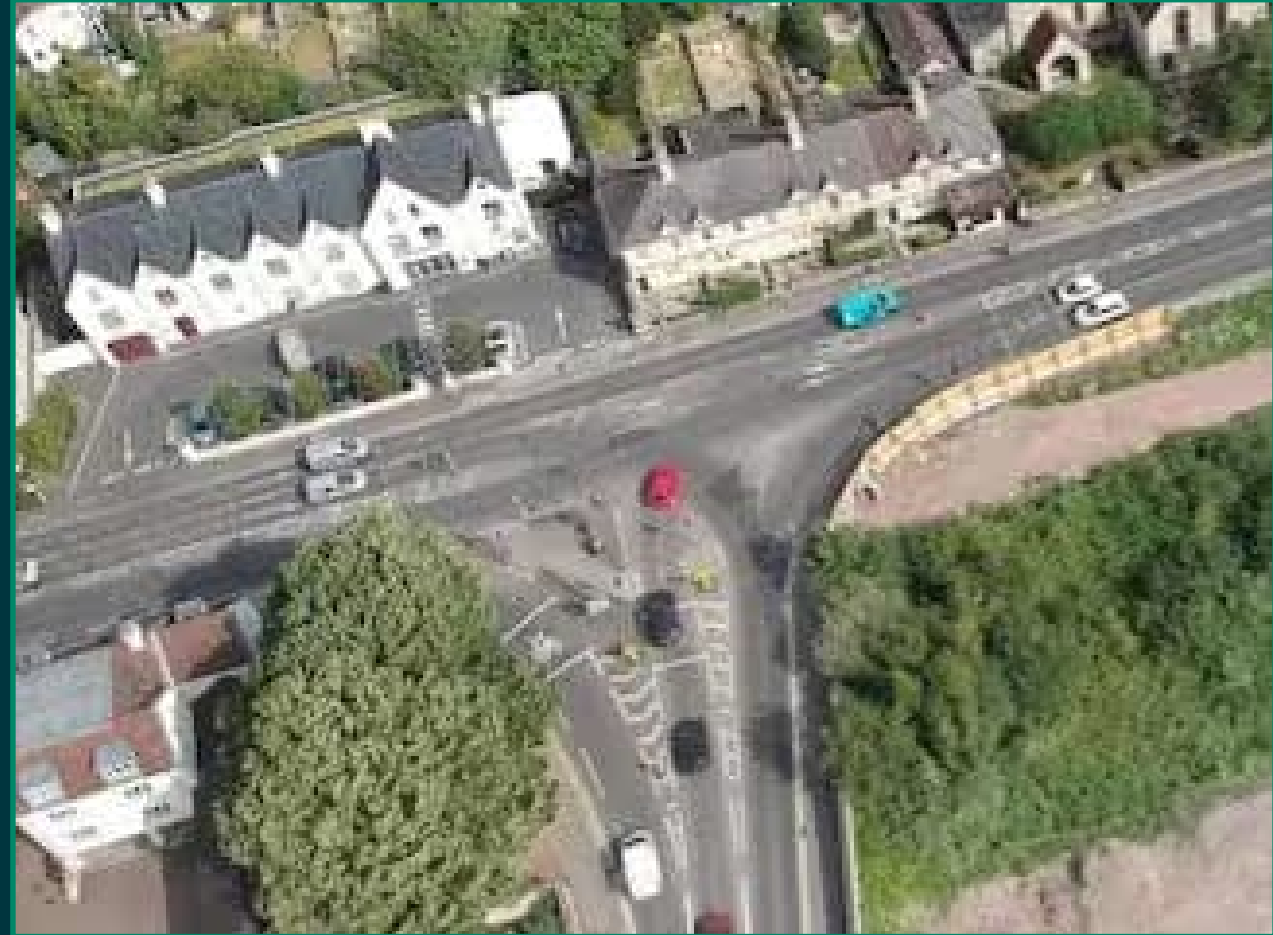
## Newbridge P&R to Winsor Bridge Junction

Initial concept design proposed a bus lane from P&R to Windsor Bridge, eastbound only. Estimated reduction for bus journey time was 60 seconds (E/B Only). High cost, time and environmental impacts.

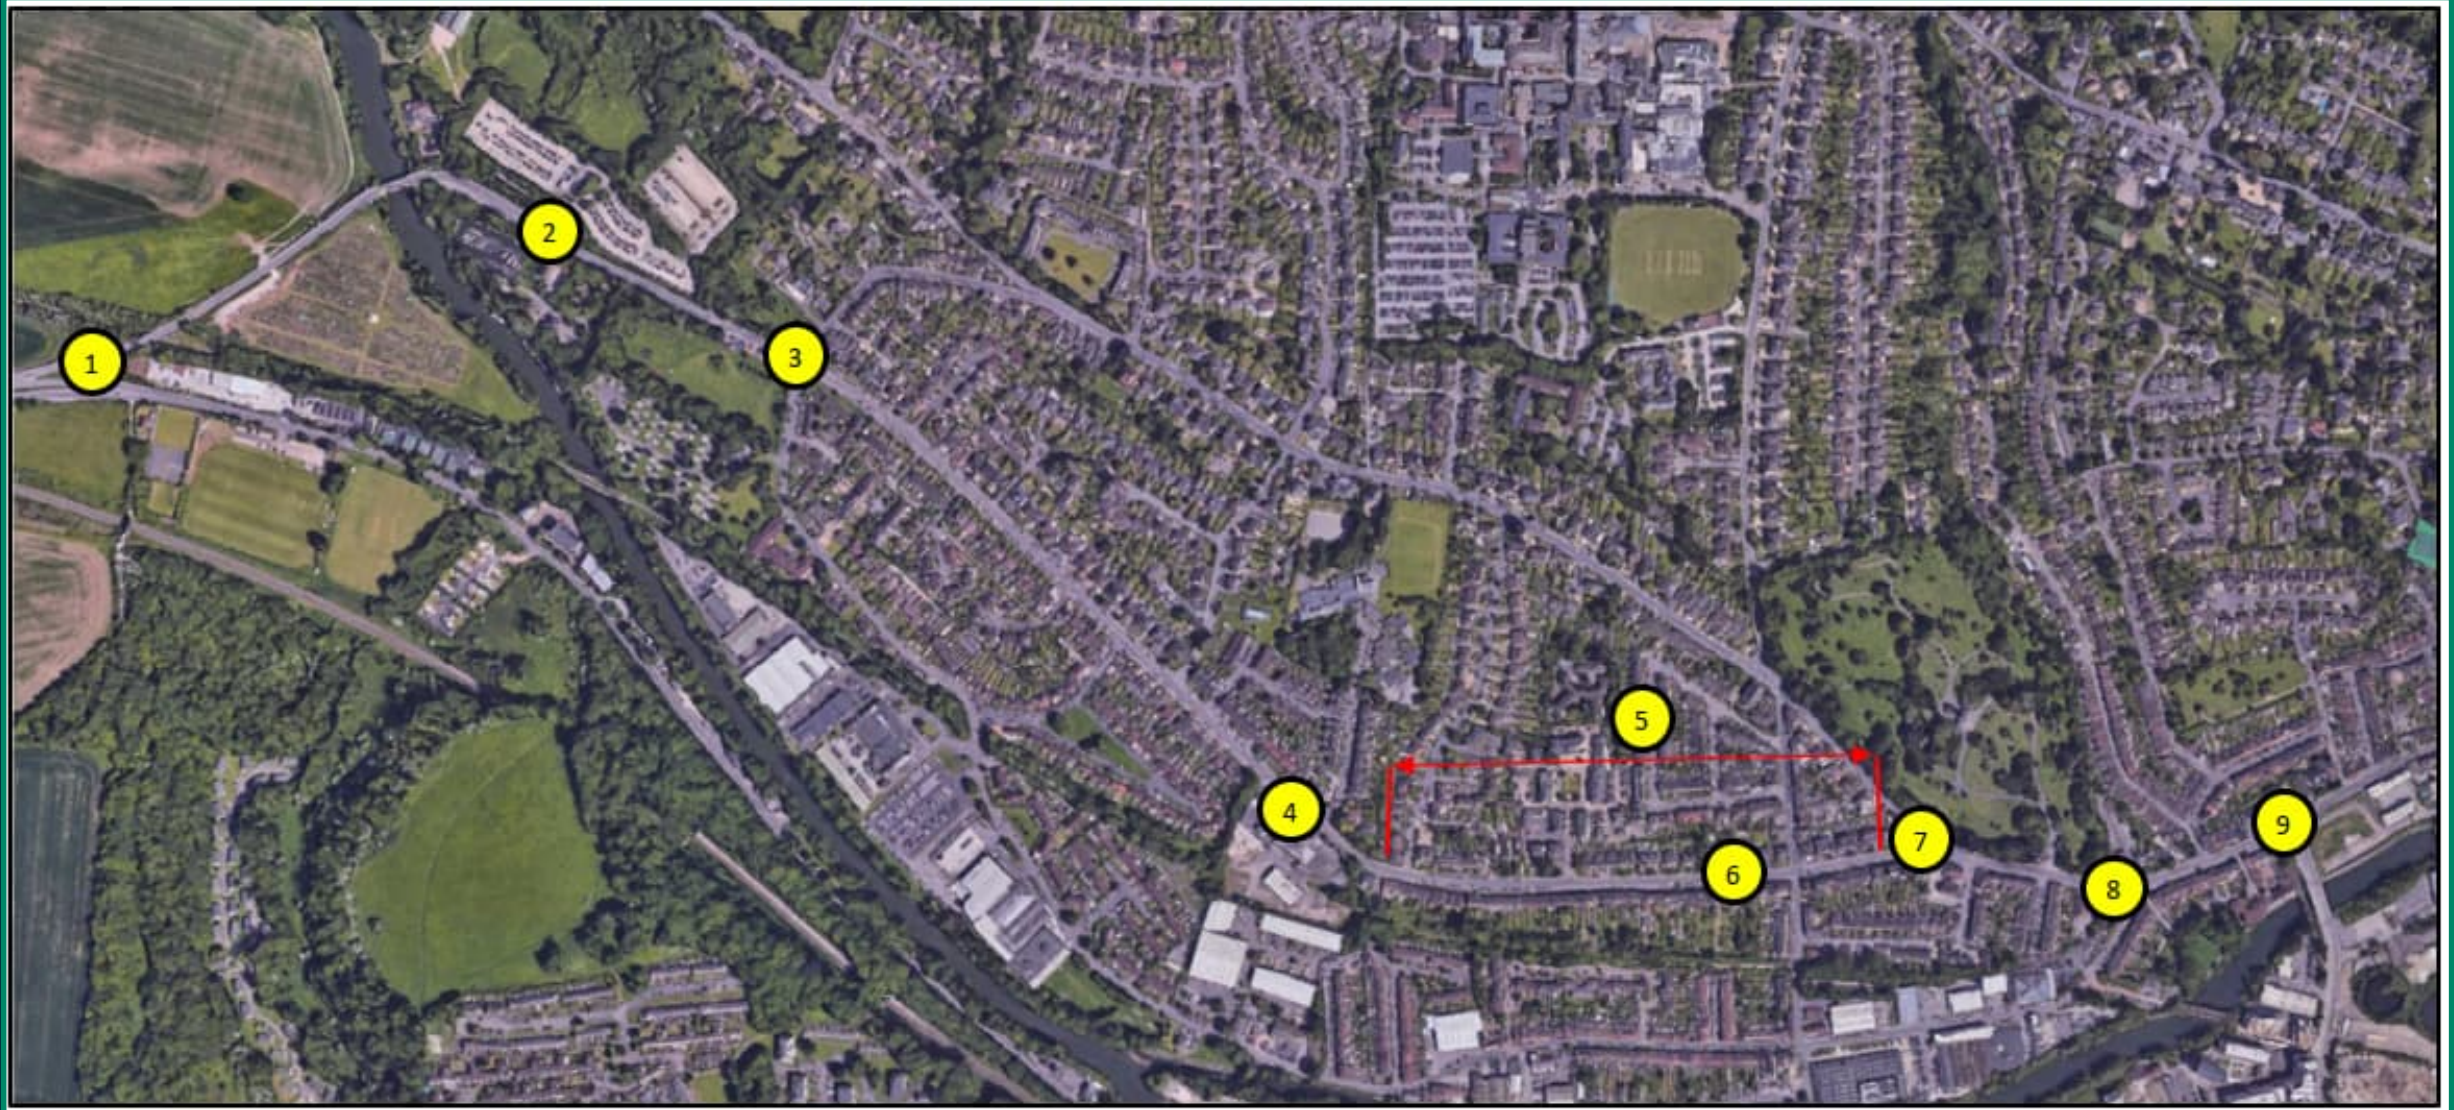
## 'Hot Spots' - Site Locations

ID No.	Location	Operation	Observations	Initial Solution	Additional Solutions	Further Benefits
1	Twerton Fork Junction (5001)	T-Junction with separate, non-signalised, LT slip E/B. MOVA Control with no BP. No controlled pedestrian facilities	Free Flow A4 E/B, though slow-moving queue does form up to junction from river bridge (traffic slows to go over bridge especially big vehicles)			
			RT from A36 occasionally blocks traffic exiting A4 W/B and A36 E/B due to layout of junction (GW to E/B A4) In general, the junction appeared to operate well in the AM peak with minimal delays.  Visibility issue on A4 W/B approach due to junction layout, this caused vehicles to approach slowly, (more noticeable in the PM Peak) and causes delay as signals are configured to hold on to the phase to allow for this slow movement.  In PM creates a slow-moving queue back through the upstream P&R junction			
2	Newbridge Rd P&R Junction (1081)	T-Junction accessing P&R. MOVA control with No BP. No controlled pedestrian facilities	Fairly Quiet early in AM peak, in general site operates well with minor delay. However, LT filter / RTIGA usage sometimes causes delay due to the way they terminate.

Queue from downstream junction started to form later in AM peak. Downstream junction is busy (rat run) with vehicles forcing their way-out creating delay on A4.  In addition, a lot of bad parking around the junction causes delay to big vehicles, especially around the traffic island.  Low cycle usage, ASLs not being used. P&R was not too busy in AM peak, plenty of spaces, suggests opportunity for promoting modal shift

ID No.	Location	Operation	Observations	Initial Solution	Additional Solutions	Further Benefits
3	Newbridge Road/Old Bridge Hill/Brassmill Lane junction	Priority crossroads	Significant left in/right in flows from traffic accessing A4 to A431. Creating friction and generating traffic flows.			
4	Newbridge Rd nr Charmouth Rd	Mid-Block Crossing. VA with no BP.	Heavily used crossing due to nearby school. Delay due to crossing not clear of pedestrians, mostly school kids			
5	Newbridge Road from Charmouth Road to Ashley Terrace	Kerbside parking	Kerbside parking and Inconsistent parking restrictions narrowing the road and causing friction and delay to larger vehicles including buses.			
6	Newbridge Rd nr Station Rd	Mid-Block Crossing. VA with no BP.	Crossing being called despite no pedestrians wanting to cross (already crossed in gaps or walked away)

ID No.	Location	Operation	Observations	Initial Solution	Additional Solutions	Further Benefits
7	Newbridge Rd / Upper Bristol Street (1026)	Fork Junction. UTC / SCOOT control with no BP. Pedestrian controlled facilities on Newbridge Rd West and Newbridge Hill.	<p>Simple operation but queuing from upstream junction E/B causes delay.</p> <p>When bus is at bus stops on exits of junction, more noticeable on Newbridge Hill, this causes delay at junction.</p> <p>Pedestrian crossing on Newbridge Rd west is in front of private drive.</p> <p>Phase B (Traffic W/B) is quite far from opposing crossing phase</p>			
8	Locksbrook Road/Upper Bristol Road	Priority junction	<p>Wide junctions with generous kerbline and a combined double exit to both Windsor Villas and Locksbrook Road. Drivers fail to give way to pedestrians and pedestrian movement is inhibited by the current layout.</p> <p>Locksbrook Road serves as various industrial/commercial units.</p>

ID No.	Location	Operation	Observations	Initial Solution	Additional Solutions	Further Benefits
9	Upper Bristol St / Windsor Bridge Rd Junction (1040)	T-Junction. UTC / SCOOT control with no BP. Pedestrian controlled facilities across Upper Bristol Street & Windsor Bridge LT Slip	Junction operates fairly well considering how busy it is and restrictions of junction.			
			<p>Queue back along Windsor Bridge Rd sometimes effects junction movements.</p> <p>Entry / Exit of TESCO car park causes some delay.</p> <p>Due to width of lanes on A4 E/B, ASLs are not being used.</p> <p>Bus stopped at bus stop on W/B exit sometimes blocks LT slip from Windsor Bridge Rd</p>			
10	Corridor Wide	CCTV Monitoring	CCTV monitoring appears to only be present at the traffic signal junctions			
11	Corridor Wide	Enforcement	Vehicles parking on sections subject to waiting restrictions.

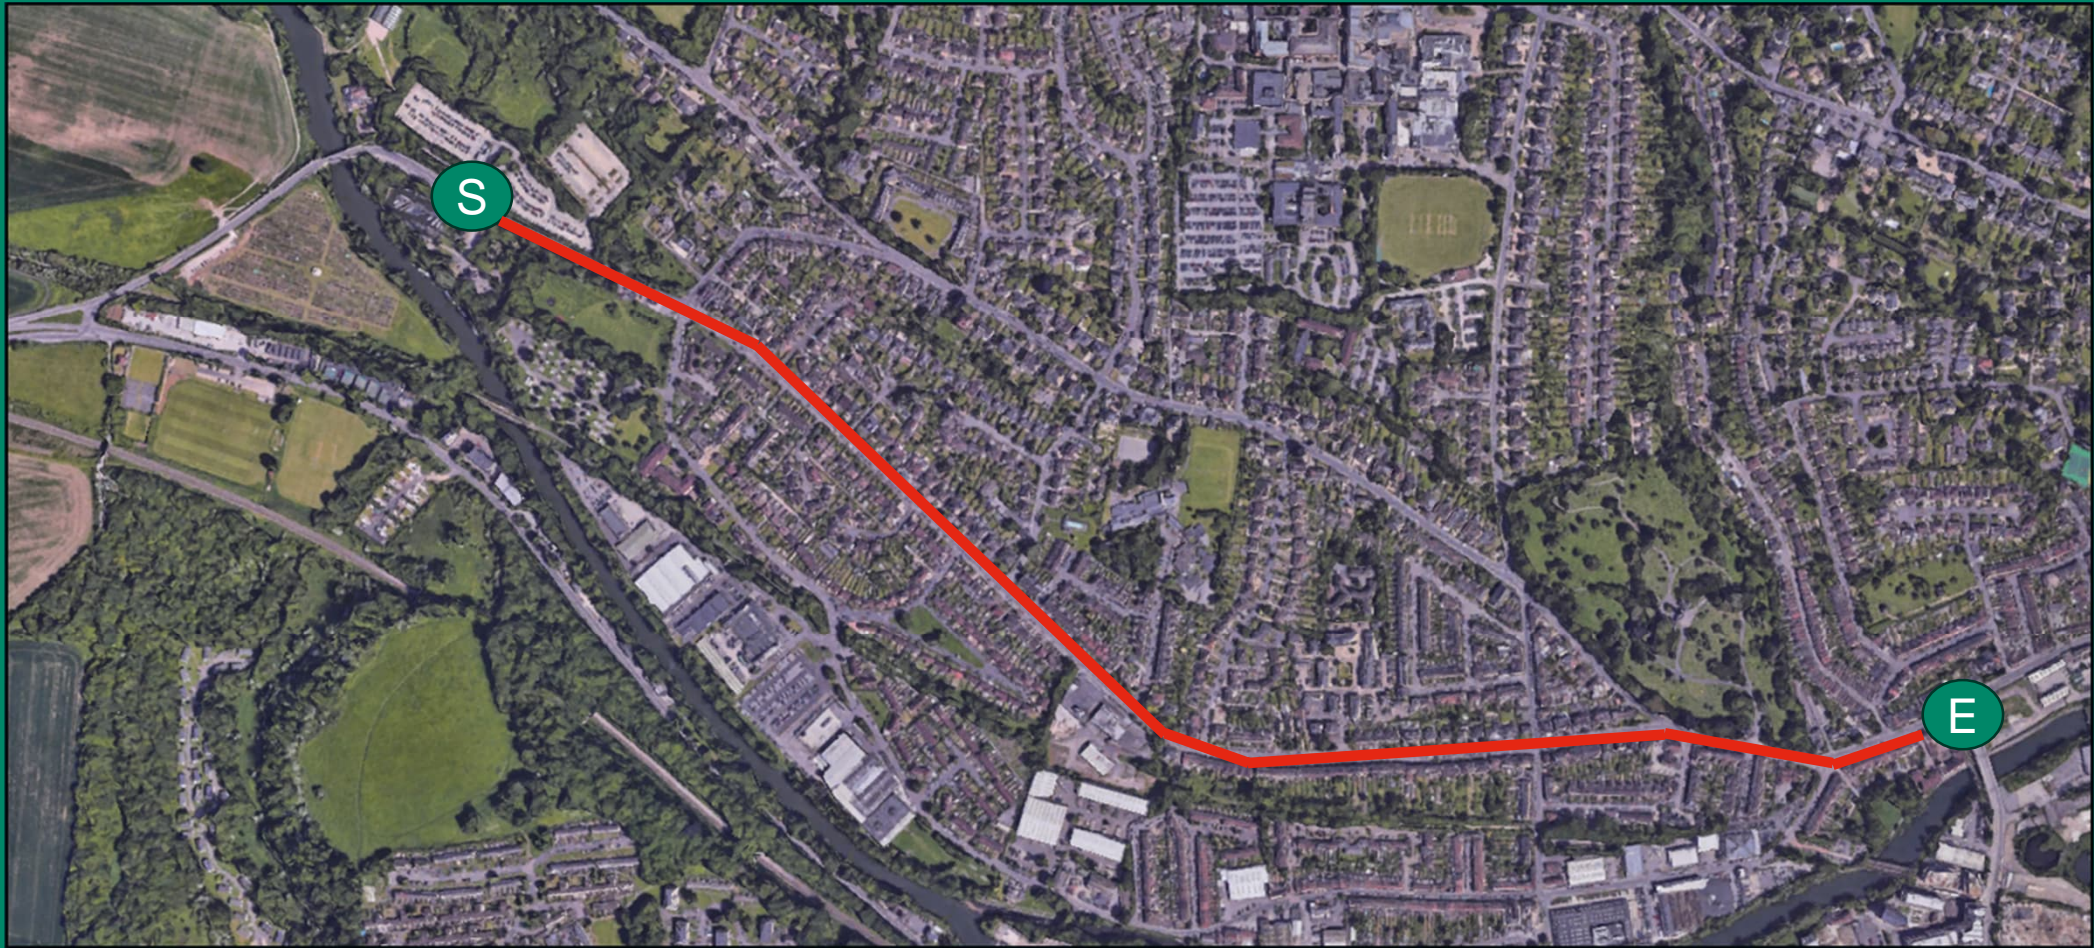
Initial concept design proposed a bus lane from P&R to Windsor Bridge, eastbound only.  
Estimated reduction for bus journey time was 60 seconds (E/B Only).  
High cost, time and environmental impacts.
