# Vehicle Battery Fire

## LEAD ACID BATTERIES

### Summary of the incident

There was a recent incident involving a fire in a City of Doncaster Council Ford Transit-type van while was being driven on the highway to the employees next work task.

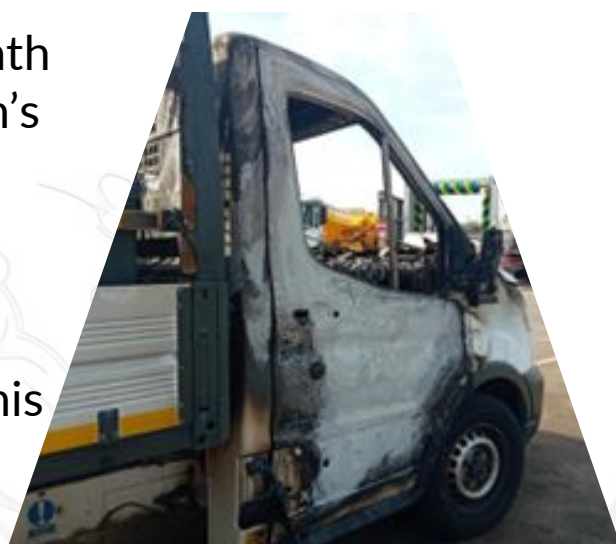
- Two lead acid batteries located beneath the driver's seat, which power the van's tail-lift, were involved in the incident.
- The battery cover had become dislodged - and metal items of equipment appear to have come contact with the battery terminals. This likely caused electrical arcing, which subsequently ignited the fire.

- **Battery storage compartments/boxes are kept free of any other items.**
- **Battery storage compartments need to be kept secure at all times.**
- **Vehicle cab cleaning and housekeeping is and remains a priority.**
- **Adequate storage should be fitted to all vehicles.**
