Asbestos

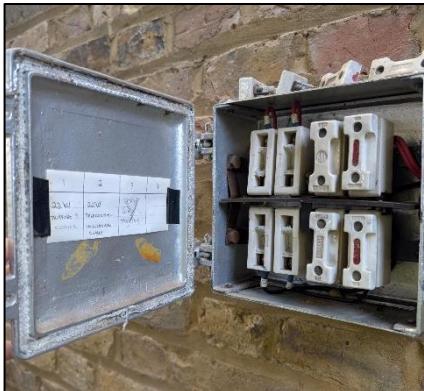
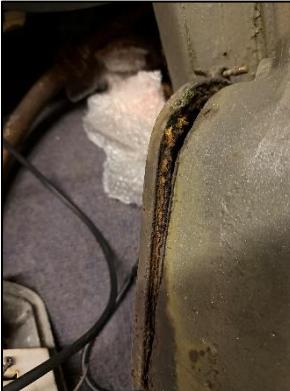
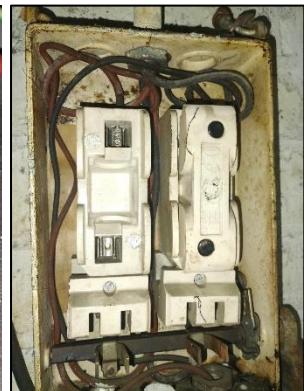
The images in this safety alert are examples of, or locations where, asbestos may be found in electrical, including highway electrical, equipment. Locations include old pillars, cabinets and pole cut-out housings (2nd image from the left above), including sealing bead around the access door; porcelain rewireable fuse carriers or housings, around the fuse wire to quench the arc; and in very old luminaires, such as asbestos-covered conductors between the lamp holder and connector block. Asbestos is covered by the Control of Asbestos Regulations 2012. Asbestos fibres can cause fatal lung disease and lung cancer. Asbestos isn't always obvious. There are three 'colours' of asbestos, but you can't tell just by the colour what you have found; it could be mixed with other materials which change its appearance.

If during your work you discover materials which you believe to be asbestos stop work immediately. Secure the equipment and ensure nobody accesses it. **Report the problem to whoever is in charge** and they must arrange to have a sample of the material analysed, or alternatively, they could presume that the material contains the worst type of asbestos and apply the appropriate controls, using a licensed contractor if required. (If the item is tested and is proved to not contain asbestos, then work can continue.)

If during your work you discover materials which you believe to be asbestos stop work immediately.

✓ **Secure the equipment and ensure nobody accesses it.**

✓ **Report the problem to whoever is in charge**
