Dangerous Occurrence

August 2016

Health and Safety Alert

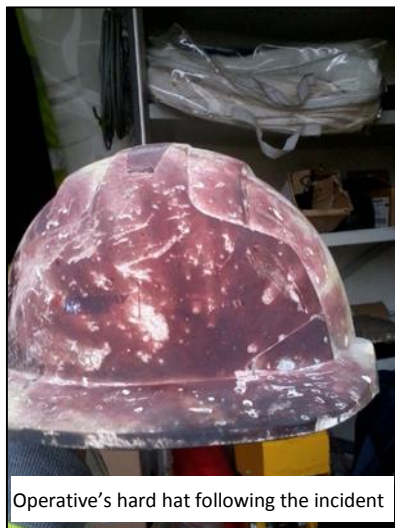
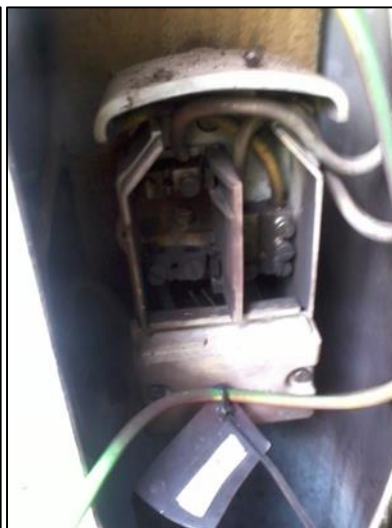
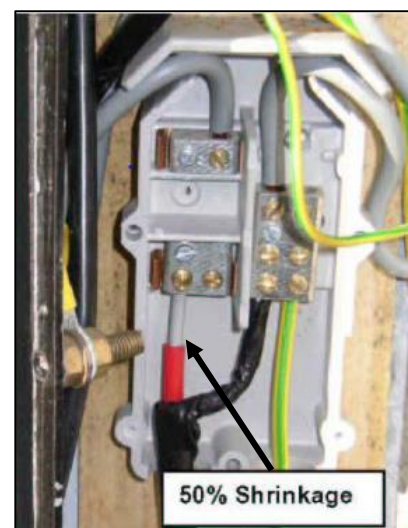
A Street Lighting Operative working on our Essex Highways contract sustained minor injuries that required hospital treatment when the main power cable going into the street lighting column (the Distribution Network Operator's cable) created an electrical arc flash which engulfed the operative in hot fumes and debris.

A tool kit investigation is underway on the incident, but following the initial investigation it is believed that the outer sleeving of the live conductor had shrunk on the Protected Multiple Earth cable, causing it to arc between the live cable and the earth / neutral.

- Always wear the correct PPE for the task you are undertaking
- Ensure you are appropriately trained, including working in the vicinity of Distribution Network Operator's (DNO) / Independent Distribution Network Operator's (IDNO) equipment
- Your competence has been assessed on site in accordance with H.E.R.S.
- You visually inspect the items before work starts, as part of your standard process
- Report any defects to your Supervisor/Line Manager. If insulation shrinkage is found, stop work and report the shrinkage to your Supervisor/Line Manager who will report this to the DNO/IDNO
- Follow your method statements and risk assessments
- If you are unsure, stop works and report your concerns to your Supervisor/Line Manager
