HiPo: Uncontrolled Vehicle Movement

Highways - Initial Incident Notification

SAFETY ALERT

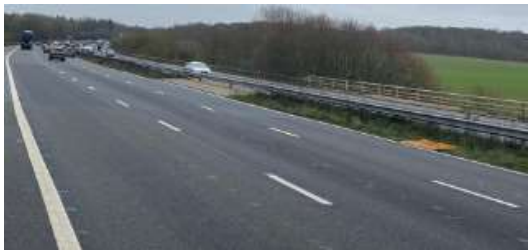
Location: Between Junctions 13 and 12 Eastbound
Traffic Management pickup returning to Compound 3C at shift end was flagged down by an MOP vehicle and informed that a sign had fallen from their vehicle and caused damage to the MOP vehicle.
MOP was provided with the TM company's standard damage escalation insurance document.

No injuries – alleged damage only (TBC) to MOP vehicle

RCC contacted and 'Obstruction in Road' matrixes activated.
Deactivated once initial sweep by TSCO and attending HETO found no sign but confirmed all lanes were clear of any obstruction between 13 and 12.
Sign was subsequently found at 1230hrs. and removed (use of rolling block) from the central reservation some 3Km from where it was believed the incident had occurred.
HIPO investigation launched.

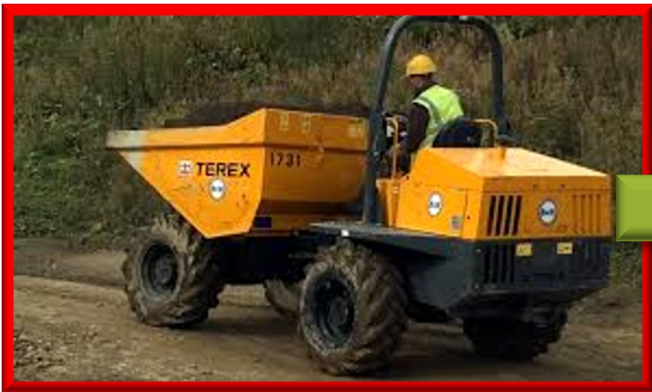
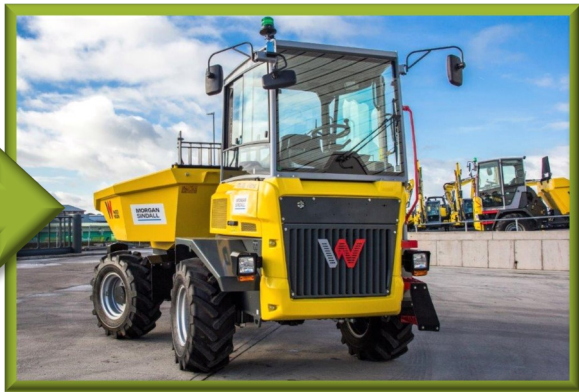
From 1 February 2020, all new orders for dumpers six ton and above must be for the Dual View Dumper model (pictured bottom right).

This is because these Dual View Dumpers set new standards in terms of operator and construction site safety, flexibility and economic efficiency. Their design ensures that the operator always has perfect vision in the direction of travel, during transportation, loading and unloading.

All subcontractor-owned assets (not machines obtained through the rental market) working on Morgan Sindall Infrastructure projects will have a six month transition period (1 August 2020 deadline) to transition all six ton dumpers and above to Dual View models.
