# Major Projects, Connect Plus Services: Traffic Management Vehicle Good Practice

# UKCS Scotland SBU, Central DU, Crystal Rig Sub-Stn: High Potential Incident – ADT Overturn – 16/08/16

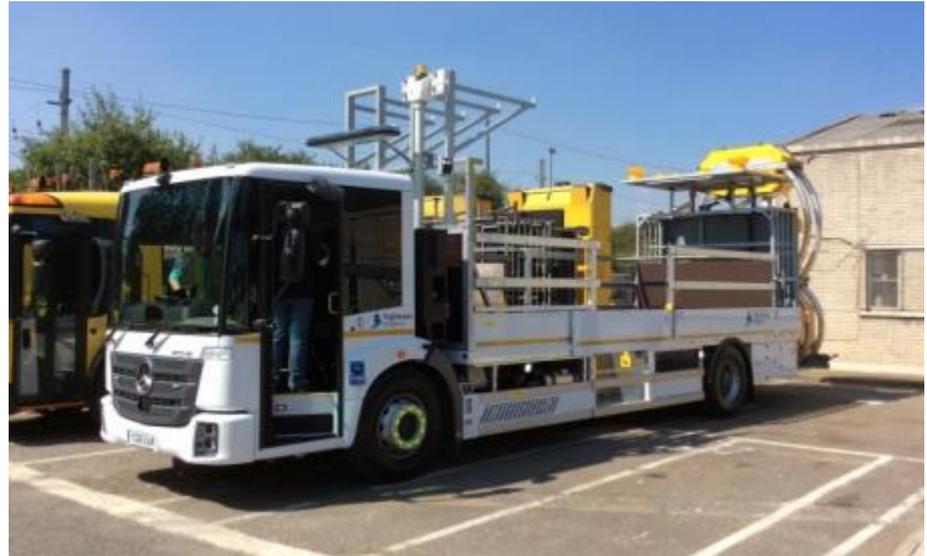
- The M25 DBFO contract has received delivery of the first of its new TM fleet.
- There are a number of safety innovations and features that will benefit our operatives.

- The new vehicle includes an industry first, a sliding access system to the cone well, reducing working at height and trapping risks.
- A night owl lighting system – illuminating working areas and vehicle bed and 360 CCTV recording

- During vehicle procurement or plant specification, use previous incidents, industry good practice and workforce engagement to specify and innovate safety features.

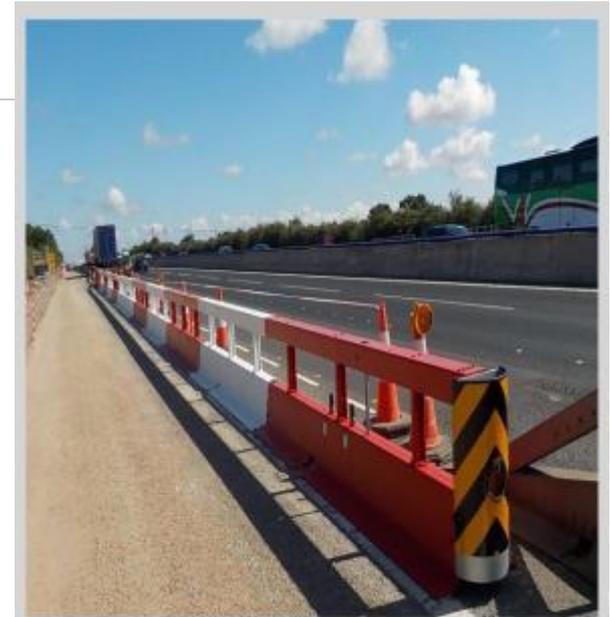
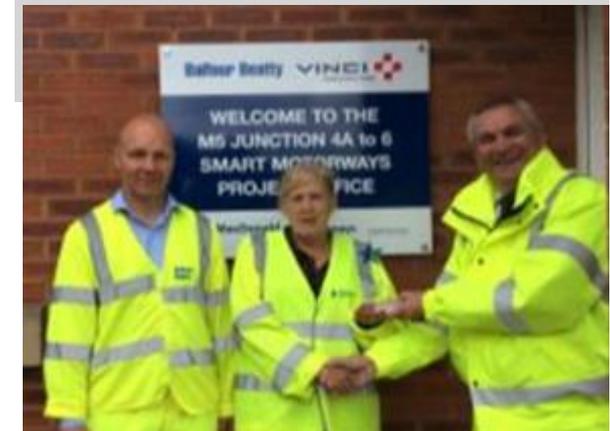
- During a client audit it was recognised that there was an industry problem with working in closed accesses behind a line of cones through which an errant vehicle may gain access.

- Assett International and the Balfour Beatty / Vinci Joint Venture have been working on and developing a moveable barrier system that can temporary close works access/exit points to enable construction works to be undertaken at these points.
- The Works Access Gate (WAG) is based on Assett's Solarguard temporary barrier system. It can be moved and positioned manually by "jacking" the system up on to fixed trolley types wheels. This allows the system to be moved in and out of place at any works access/ exit point.
- The barrier can be slid into position at any time without affecting the traffic flows (lane closures) as it is assembled behind a safety zone within the works. Once the WAG is in place it is secured by drilling specifically sized holes and bolts dropped in place.

- Lane closures are not required for installation and the barrier gives the workforce increased confidence when working as it offers greater protection than cones.
- The barrier can be installed by the trained operatives within 30 minutes
