# SHE ALERT

Ref: SHE H125 A 19 Ride on roller  
Issued by: Kier Highway SHE  
Department  
Date: 25/03/2019

## Overturned Rider on Roller

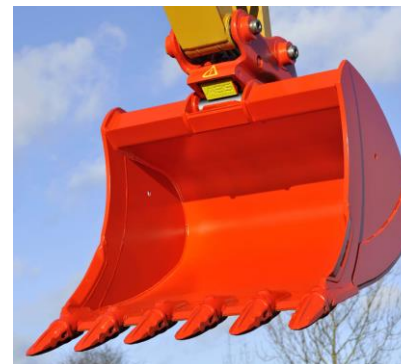
Image to the right illustrates an example of an acceptable fully automatic Quick Hitch device and attachment

- Plant standards to clearly state requirements for direct attachment or attachment of accessories by "second generation" and later fully automatic Quick Hitches ("Double Claw"/ "Twinlocking" Lock Type)
- Plant Arrival checks to identify suitable Quick Hitch systems fitted to excavators
- Operators to be trained in specific Quick Hitch device and safe attachment routine
- Process to be in place for plant operators to check, test and record correct attachment of accessories in a safe area
- Dedicated and segregated areas to be established and used for storage, exchange and attachment testing of excavator attachments
- Exclusion zone to be in place which excludes all personnel from the area into which an excavator attachment can fall when in use (including in any accessory exchange area)

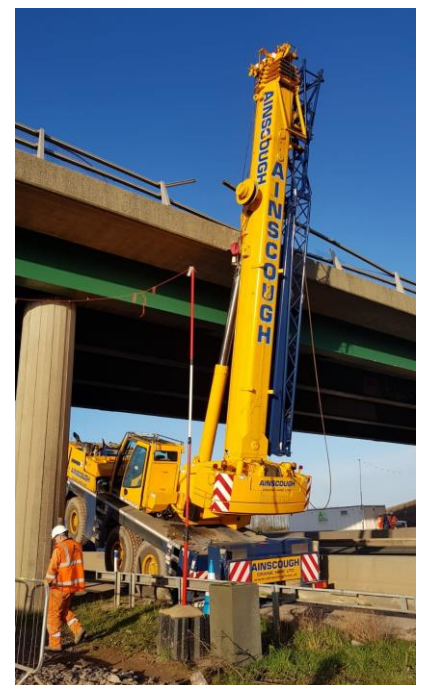
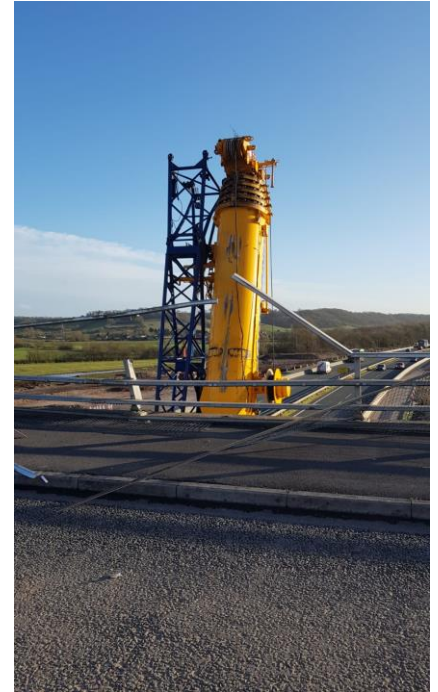
Once instructed by the crane operator he was no longer required, the CSSS left the immediate area at 15:50 to conduct other works. Immediately before the time of impact the crane was witnessed travelling along the hard shoulder of the M49 with the jib still erect. The CSSS along with other site staff tried to warn the crane operator the mast was still erect but unfortunately the driver did not respond resulting in the jib striking the bridge deck.

- If the crane operator had not inserted the slew lock it is highly likely the crane would have overturned with the mast landing on the M49 motorway potentially leading to fatal or very serious injuries to other road users or site workers.
- The crane operator had received all the necessary inductions including a briefing on the NDT RAMS and lift plan.
- The crane operator had the required competencies, experience and qualifications to operate the crane.
- Following the initial investigation, it was found that the crane did not have any warning systems fitted to the crane to indicate that the jib was still elevated while being operated from the road driving cab. This was in line with the manufacturer's instructions.
- It was reported by ACH, the crane operator was not deemed to be suffering from fatigue and tested negative for alcohol.

- All crane supervisors must always remain with the crane whilst it is rigging/derigging or lifting.
  - The above will also apply to all haulage companies delivering/removing plant from our work sites.
  - All VM supervisors are to check with the operator/driver of subcontract plant equipment or haulage before it leaves their worksites, that they have conducted a visual inspection to ensure they have stowed and secured their equipment correctly before it leaves.
  - Debrief of all supervisors on the start of shift briefings with regards to capturing roles and responsibilities and supervision of subcontractors.
  - Other recommendations have been made to crane supplier regarding the fitting of additional alarms and post de-rigging inspections before they leave site.
-

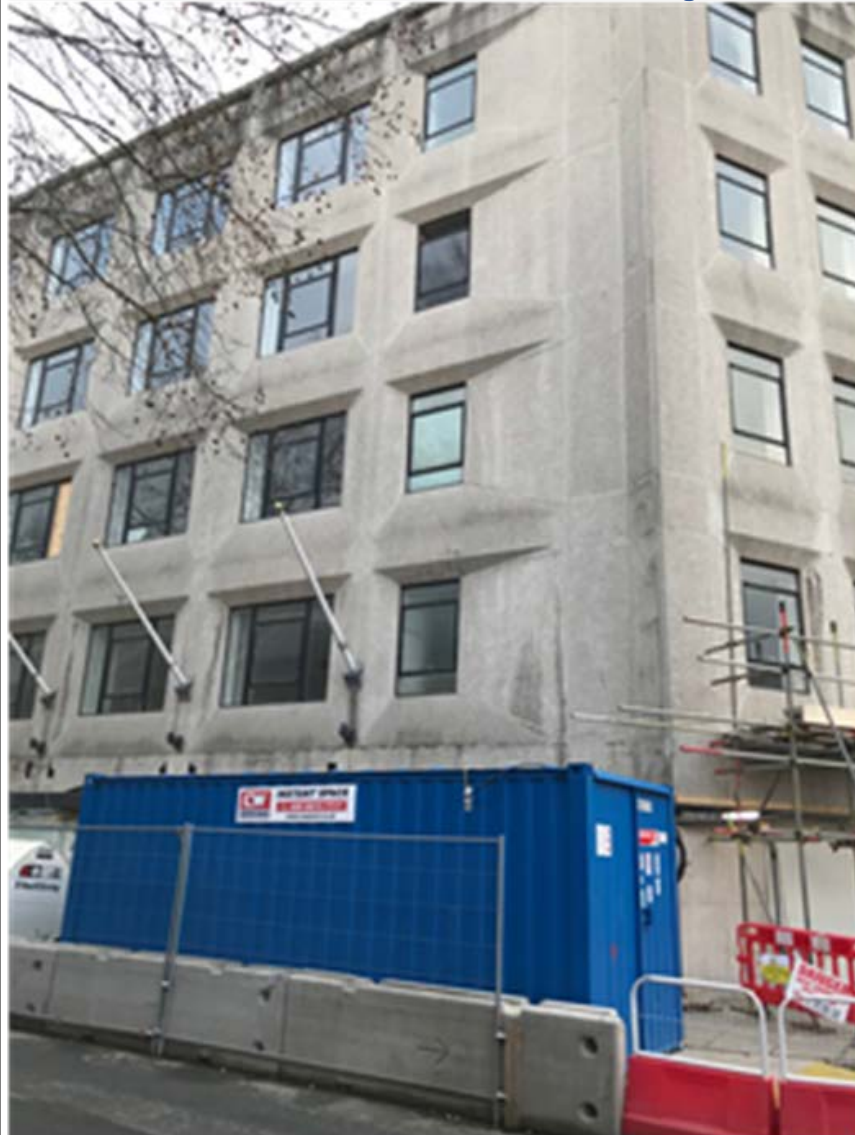
External view of building

<b>Background to the incident</b>	<p>On the 23rd January 2019, in the building formerly known as the Thistle hotel, soft-strip demolition was being undertaken on all floors to allow “Top Down” hard demolition to proceed.</p> <p>As the bathroom suites were being soft-stripped on the 3rd floor, the internal non-structural bathroom wall was to be demolished. An Operative used a sledge hammer to expose the top right hand corner of the wall. The force fractured part of the thermalite block which sent it through the top section of a hidden window pane behind, which then fell 12mtrs into the footway of the asbestos transit route. The transit route was not in use that day.</p>
<b>Action taken</b> Include action taken both at and after the incident.	Work was stopped immediately, appropriate notifications made. Area made safe within building and drop zone in Cardington Street.

<p><b>Key findings</b></p>	<p>As a result of the historical and largely undocumented structural changes, there was a lack of information available to the site team to identify accurately, the layout and construction methodology of the structure, including the bathroom wall being demolished.</p> <p>The pre-soft strip survey did not identify the difference in fabrication of the walls blocking the windows. This resulted in a failure to identify wall construction and thus the incorrect selection of the most appropriate method of demolition.</p> <p>As insufficient structural information was available, the RAMS did not identify different wall construction methods and that there were windows in close proximity to walls that were to be demolished. This feed into the Task Briefings, SoS and Cascade briefings not identifying the risk of falling objects.</p> <p>The operatives had previously encountered stud walls and assumed that this wall was the same.</p>

<b>Recommendations and key points to be discussed in team talks or meetings</b>	<p>Permit to Demolish to include a check to ensure that the structure has been surveyed both internally and externally prior to sign off.</p> <p>Changes to the building make up may require hold points to be included in the methodology and supervisors approval to check the correct methodology prior to continuing.</p> <p>Knocking down internal blockwork was perceived by the operatives and supervisor as straightforward and relatively routine. Knocking down internal blockwork across three previous floors had been incident-free and reinforced the perception of 'straightforwardness' and low-risk potential. Potentially leading to behaviours of simply 'getting on with it' without assessing risks.</p>
<b>Learnings and considerations</b>	<p>Demolition "Gate" to be produced to record why the proposed method of demolition has been selected – this is to be completed and signed off by TWC and Director prior to demolition contract being signed. This "gate" would be similar to AIP, CDS or NR Form 1</p>
