Safety alert – Pass Safe Sign Pole – Fibre Glass

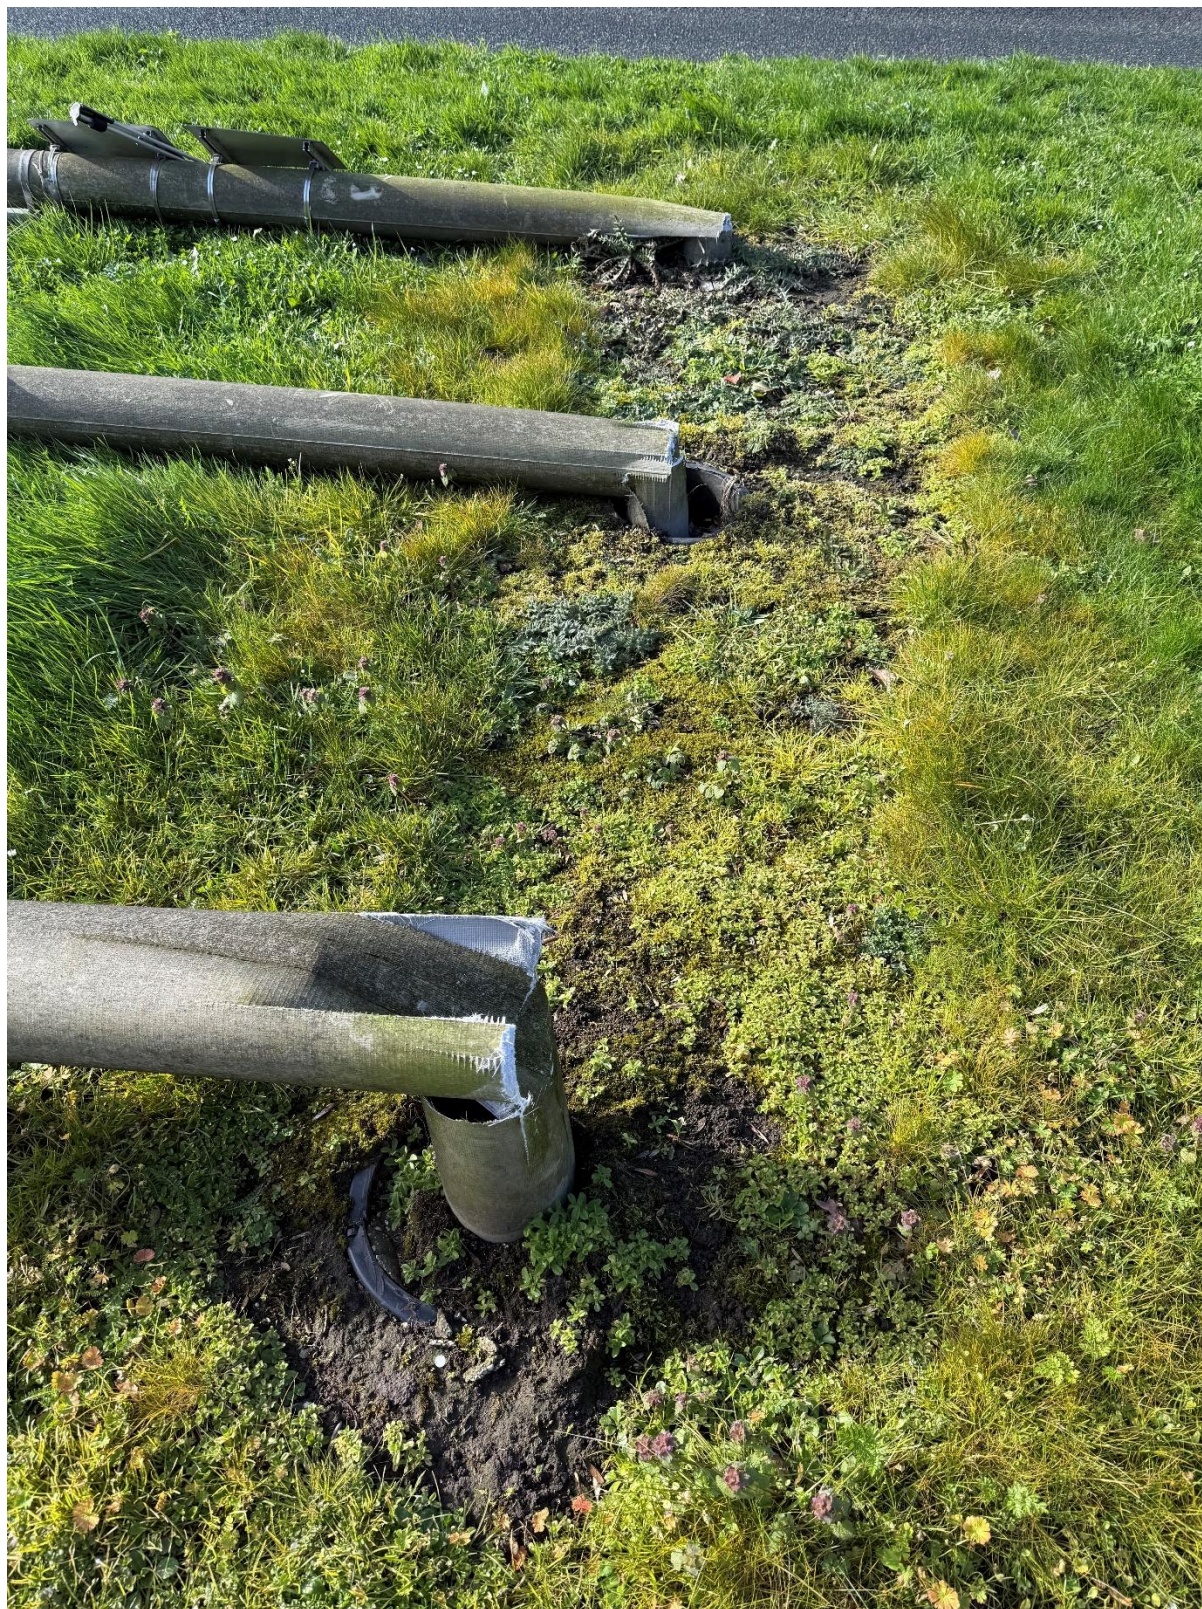
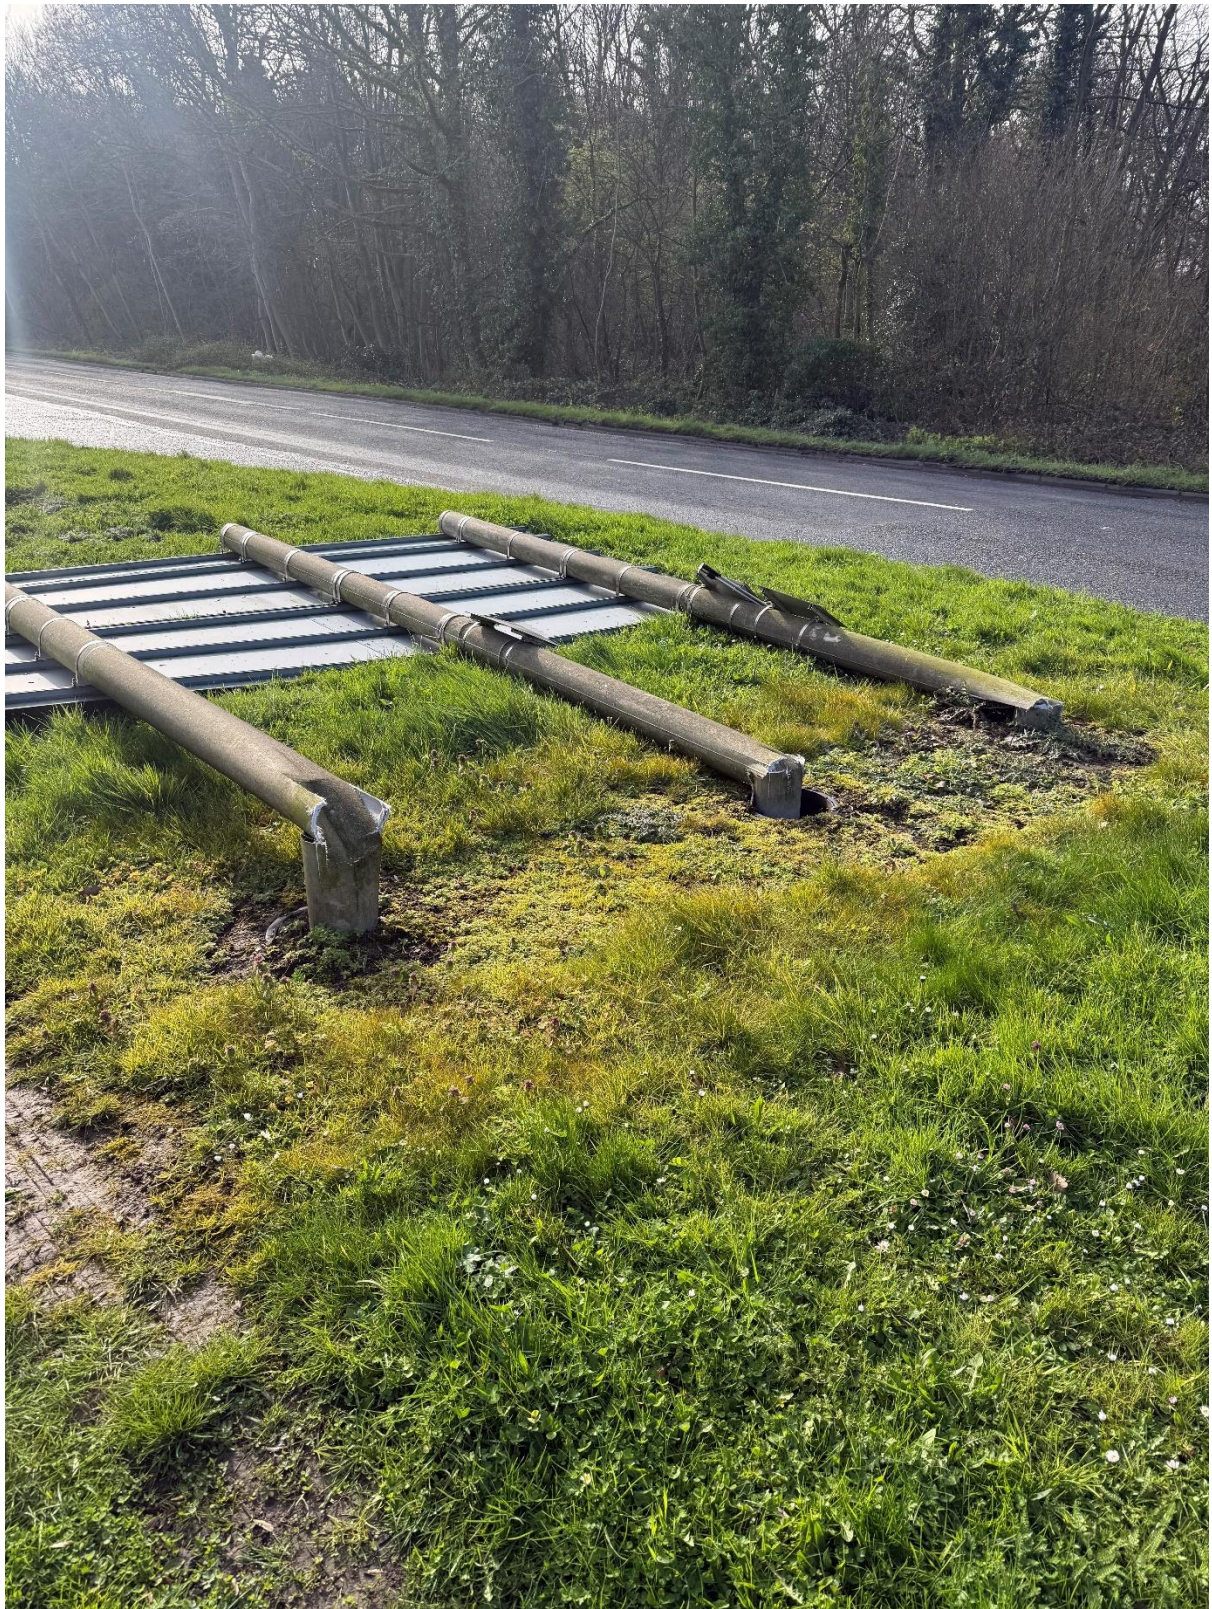
Sign collapse because of high winds. The post were 168mm Glass fibred Pass safe poles. At this point considering investigating the condition of all similar poles. Not sure if there is a particular structural test that we can undertake but I am trying to contact test houses to see if there is anything we should be doing to prevent this type of failure. The sign poles were approx. 15 years old.
